FINAL REPORT

Mountain Loop Highway Feasibility Study
WA SNOHOMISH 20(1)
IDIQ Contract No. DTFH70-15-D-00007
Task Order No. 69056718F000005

WESTERN FEDERAL LANDS HIGHWAY DIVISION

December 31, 2019

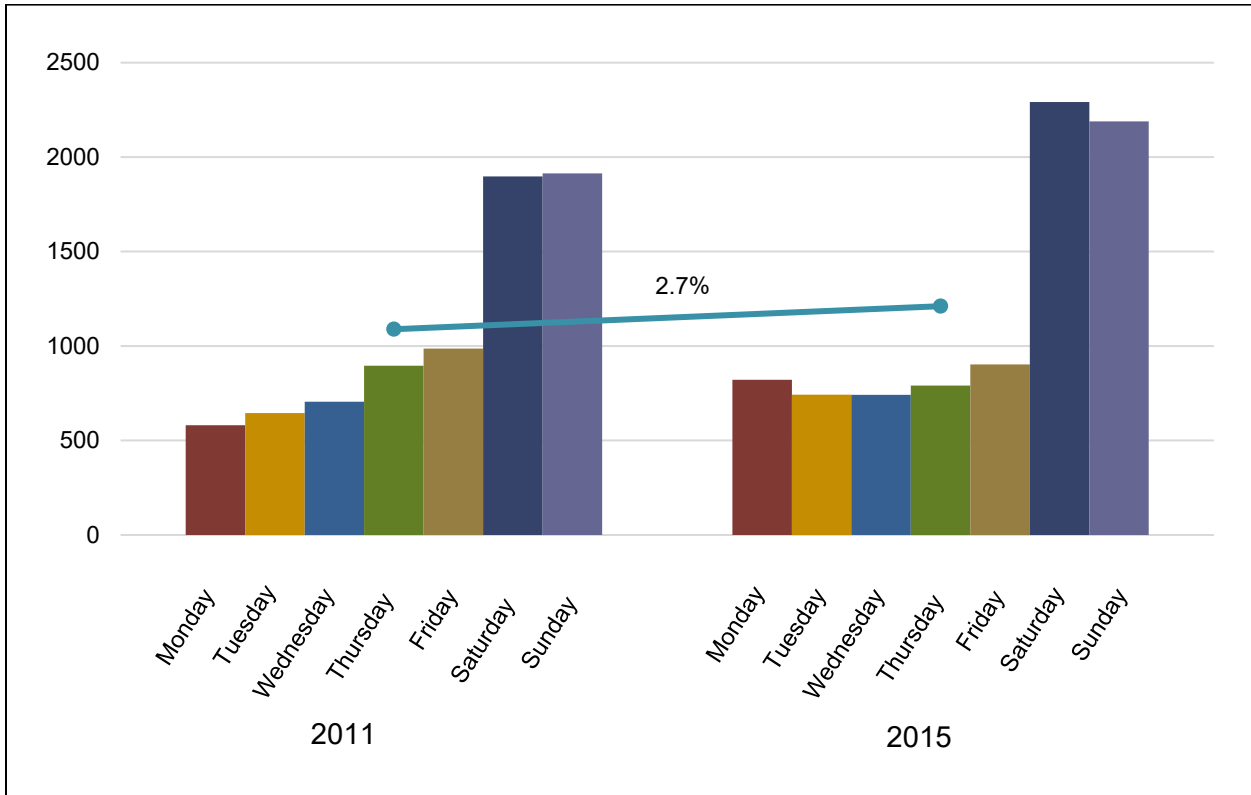
Figure 8. Traffic Volumes MP 10.76 - MP 19.99 (Verlot to Marten Creek)

The traffic volumes on the Mountain Loop Highway range from 156 vehicles per day near White Chuck, to as high as 1,767 vpd near the Verlot campground. **Figures 8** through **10** show a yearly comparison of the daily variations in traffic. Since ADT values are not provided, the values in the following figures represent an average of the known volumes across the corridor. Also shown on the figures is a trendline indicating the compound average growth rates (CAGR) of traffic volumes. The trendline uses the average day for each year of data to calculate the growth rate.

Due to the limited availability of data, the data have been separated into three figures based on their location along the corridor (MP 10.76 – 19.99, MP 20.00 – 30.68, and MP 44.65 – 50.99). As noted previously, data was unavailable for the gravel portion (MP 30.68 to MP 44.65).

As the figures show, the section of the Mountain Loop Highway between White Chuck and Darrington has the lowest traffic volumes and the section between the Verlot Ranger Station and Marten Creek has the highest traffic volumes. Population centers, as well as recreational opportunities such as camping and hiking, are concentrated near the beginning of the study area so the distribution of traffic volumes reflects this demand. As mentioned previously, traffic volumes are generally lesser during the weekdays (Monday through Friday) and are significantly higher during the weekend (Saturday and Sunday).

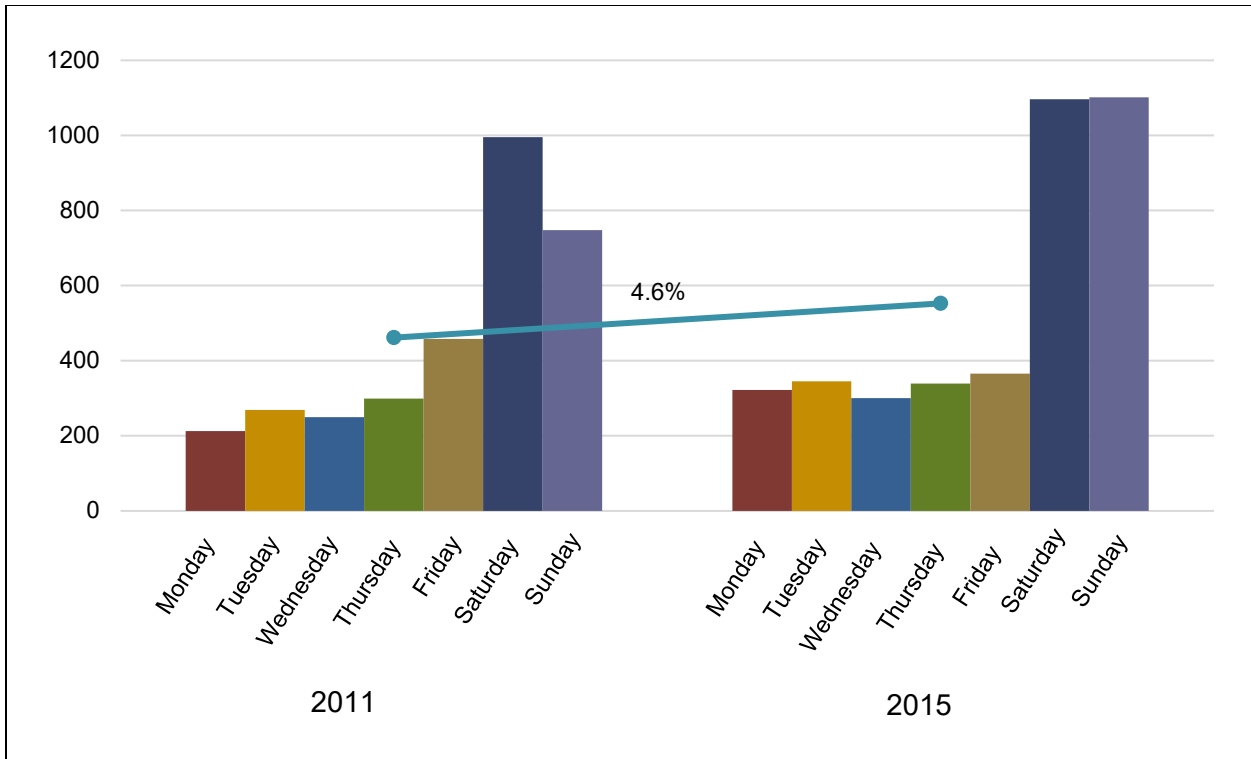
Figure 9. Traffic Volumes MP 20.00-30.68 (Marten Creek to Barlow Pass)

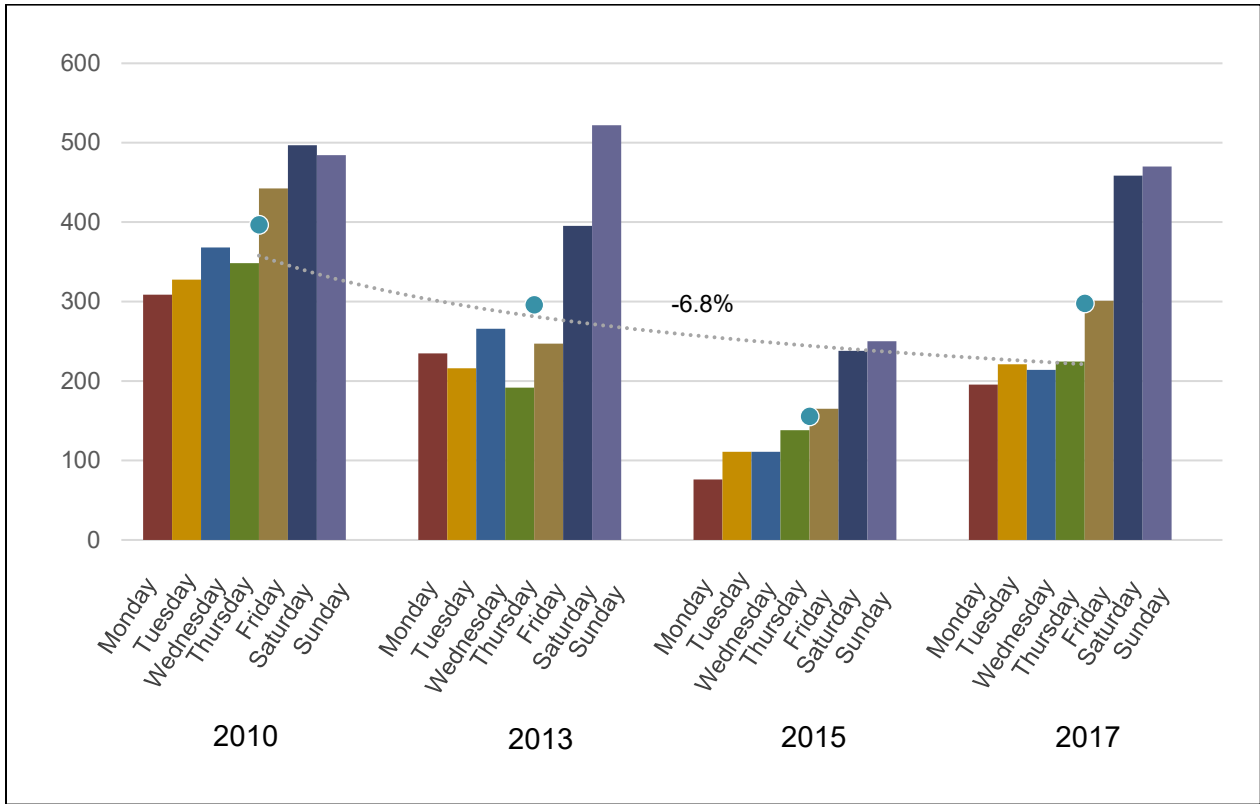
Figure 10. Traffic Volumes MP 44.65 - MP 50.99 (Dutch Creek to Clear Creek)

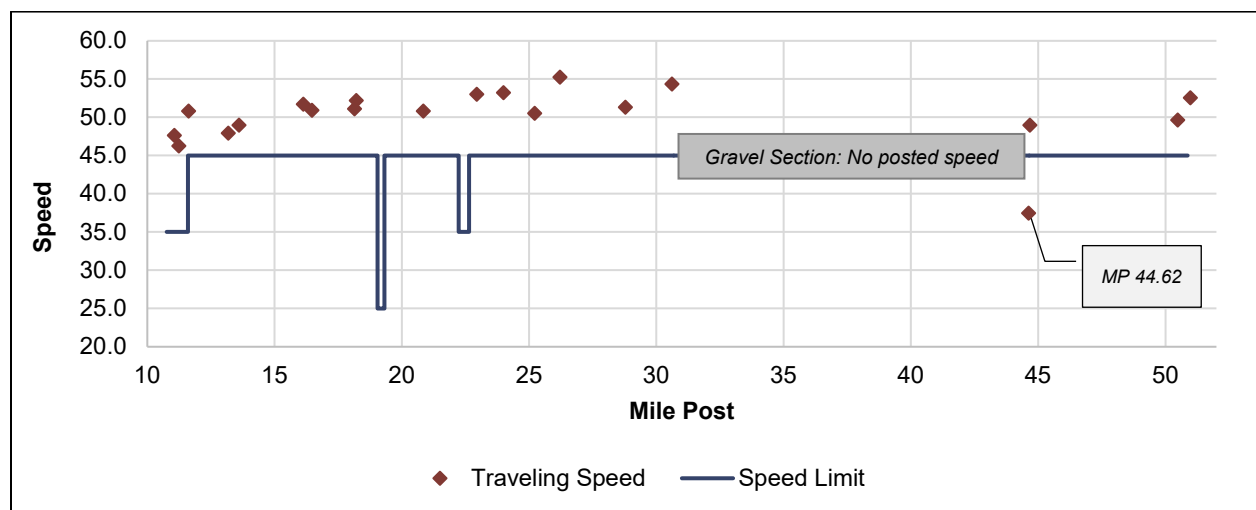
Figure 11 shows the results of the speed data collection. The figure shows the 85th percentile speed at the various points throughout the corridor. The 85th percentile speed is the primary factor for determining the validity of the posted speed limit. The 85th percentile speed is that speed at or below which 85 percent of vehicles are traveling. For example, if the 85th percentile speed is 45 mph, it means that 85 percent of vehicles are traveling 45 mph or below.

Figure 11. 85th Percentile Speed

Average speeds varied from 37.5 mph at White Chuck to 55.3 mph at Perry Creek. More than 90 percent of vehicles traveled between 45 and 55 mph. Throughout the corridor, vehicles traveled at an average speed of 51 mph. Speed data for the gravel section was not available for this analysis.

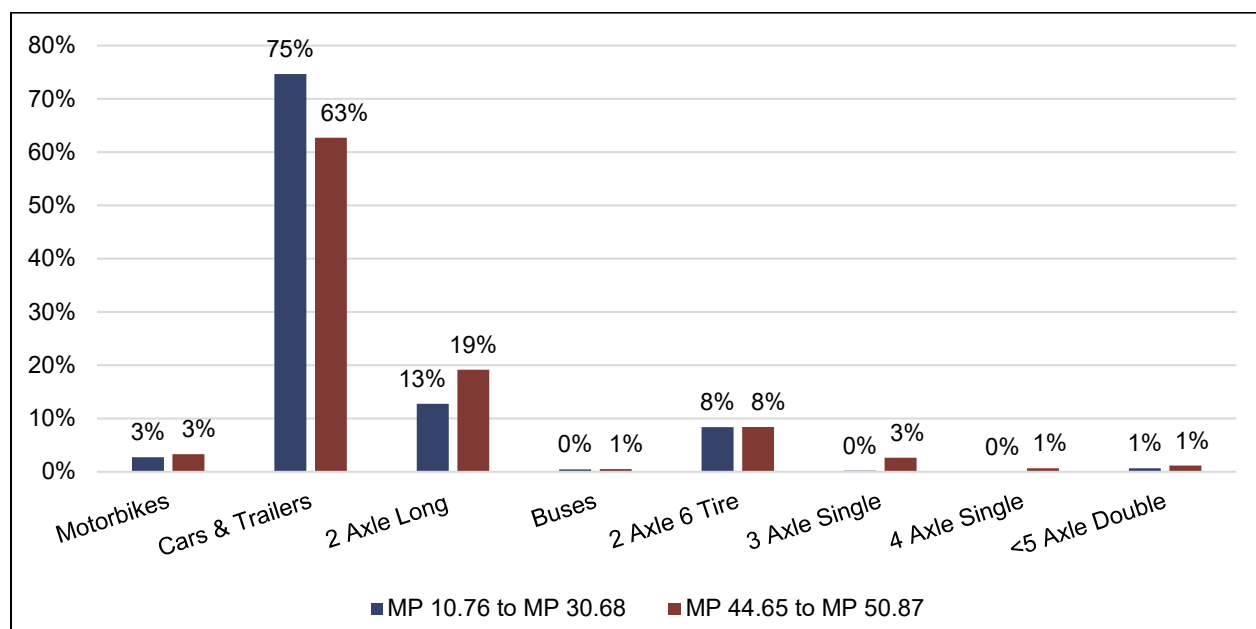
A variety of vehicles travel throughout the corridor including motorcycles, passenger cars, buses, and a variety of heavy trucks. Portions of the corridor are not designed nor maintained to sustain the impact of heavy vehicles use, although it does occur. From MP 10.76 to MP 30.68 approximately 9 percent of vehicles are two axle six tire trucks or larger and from MP 44.65 to MP 50.87 approximately 14 percent of vehicles meet this large truck classification. However, the majority of vehicles traveling on the corridor are passenger cars (approximately 75 and 63 percent on the first and second paved sections, respectively) and two axle single unit vehicles (approximately 13 and 19 percent) which includes pickups, vans, and other vehicles such as campers, motorhomes, or vehicles pulling recreational trailers. **Figure 12** shows the vehicle classifications experienced along the corridor in the summer.

Figure 12. Summer Vehicle Classification

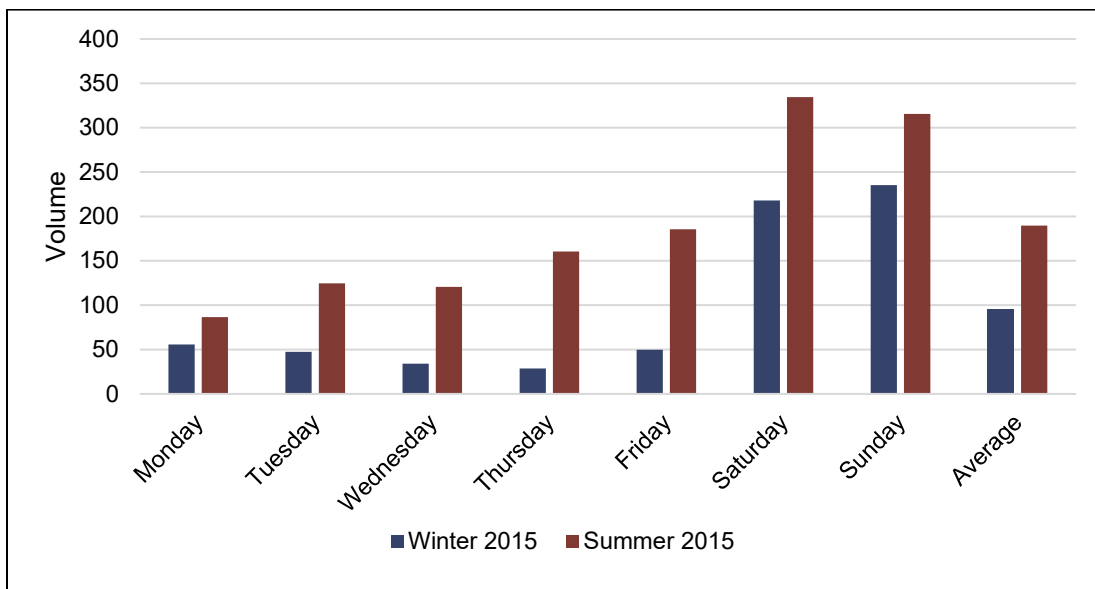
On average, there about half as many vehicles traveling the paved portions of the corridor in the wintertime as compared to the summertime. Volumes are significantly less in winter than in summer on the weekdays (Tuesday through Friday). **Figure 13** shows the seasonal variation in traffic volumes.

Figure 13. Seasonal Traffic Variation (2015)

The speeds at the count locations are essentially the same in both the winter and summertime. It is common to see slower speeds during the winter as compared to the summer due to adverse weather and road conditions. However, the average speed at the count locations during the winter (46.3 mph) was slightly higher than the average speed in the summer (45.9 mph). This could be due to a fewer number of slow moving vehicles such as campers and RVs and overall lower volumes of traffic allowing vehicles to travel more freely.

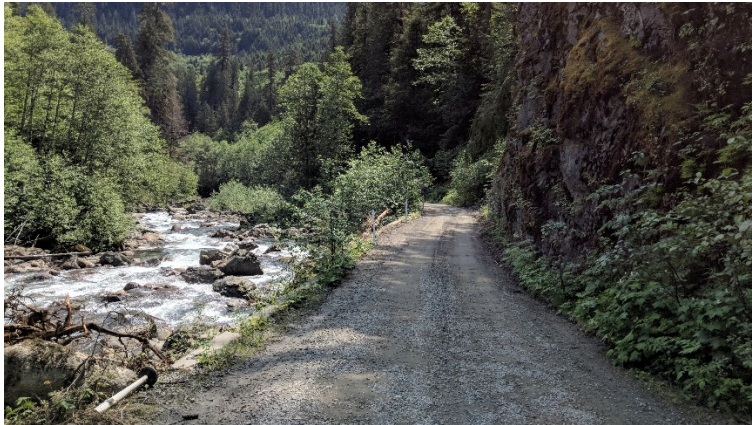
Areas of concern with the existing 14-mile gravel section have been well articulated throughout the entire planning process and is documented more fully in **Chapter 3** of this report. One option that should remain under consideration would be the “Do Nothing” option. Under this scenario, there would be no improvement(s) made to the 14-mile gravel section, and the status quo would remain related to ongoing maintenance activities. Existing concerns expressed about the existing gravel portion include inadequate width, poor driving surface, poor drainage off the roadway due to loss of roadway crown, poor sight distance, and excessive dust. Some have argued that the current condition of the road inherently limits traffic, controls excessive speed, and is more appropriate in context to the scenic and recreational nature of the corridor.

Figure 15: Narrow Width of Existing Gravel Section

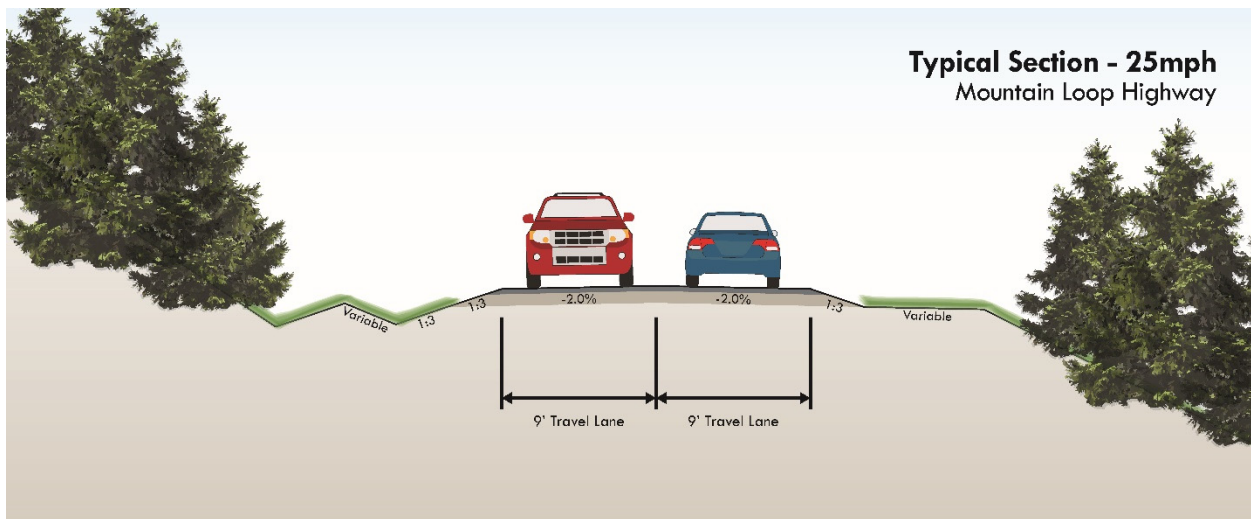
Option 3 could realize a roadway width of anywhere between 18 feet (minimum) to 32 feet (maximum). The minimum roadway width of 18 feet would allow for two 9-foot lanes with no shoulders and would strive to meet standards contained in AASHTO Geometric Design of Very Low-Volume Local Roads guidelines. This type of roadway section was recently constructed on the Middle Fork Snoqualmie Road project. This option would widen the roadway in the narrow areas and better accommodate 2-way traffic within the corridor limits. Substandard horizontal and vertical curves in the road will require localized realignment.

Figure 16: 18-Foot Roadway Width (w/Asphalt Surfacing) for 25 mph

include 8" of base course. Regulatory and/or advisory signage, as appropriate, would be utilized to warn of curves, identify turnouts (if placed) and post speeds. If asphalt surfacing is used, paint striping may be utilized to match the currently paved portions of the corridor. New culverts and ditches would be incorporated to improve drainage characteristics.

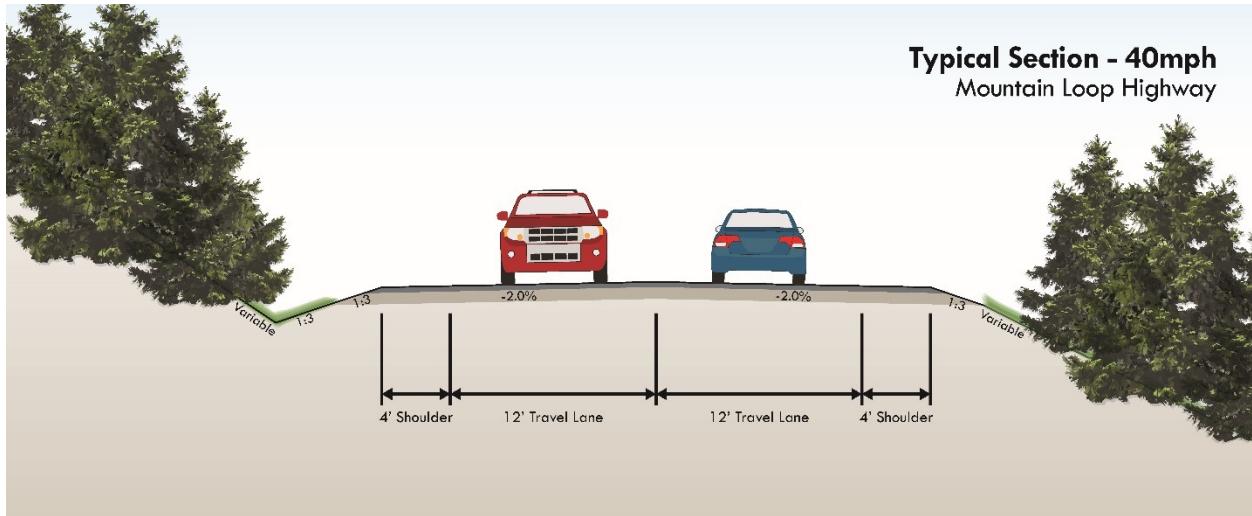
Option 4 would necessitate a roadway width of 32 feet (minimum) to 40 feet (maximum). The minimum roadway width of 32 feet would provide two 12-foot lanes with 4-foot shoulders and would meet AASHTO standards for expected traffic volume and design speed.

Figure 17: 32-Foot Roadway Width (w/Asphalt Surfacing) for 40 mph

This option would provide a good roadway crown to promote drainage off of the roadway, and more closely mimic driver expectations similar to the currently paved portions of the roadway on either side of the 14-mile gravel section. The new driving surface could consist of either gravel surfacing or asphalt surfacing. Both surfacing options would be 4" and include 8" of base course. Regulatory and/or advisory signage, as appropriate, would be utilized to warn of curves, identify turnouts (if placed) and post speeds. If asphalt surfacing is used, paint striping may be utilized to match the currently paved portions of the corridor. New culverts and ditches would be incorporated to improve drainage characteristics.
