2018

Sawmill Creek Road Transportation Corridor Assessment

AK NPS SITK 2015(2)

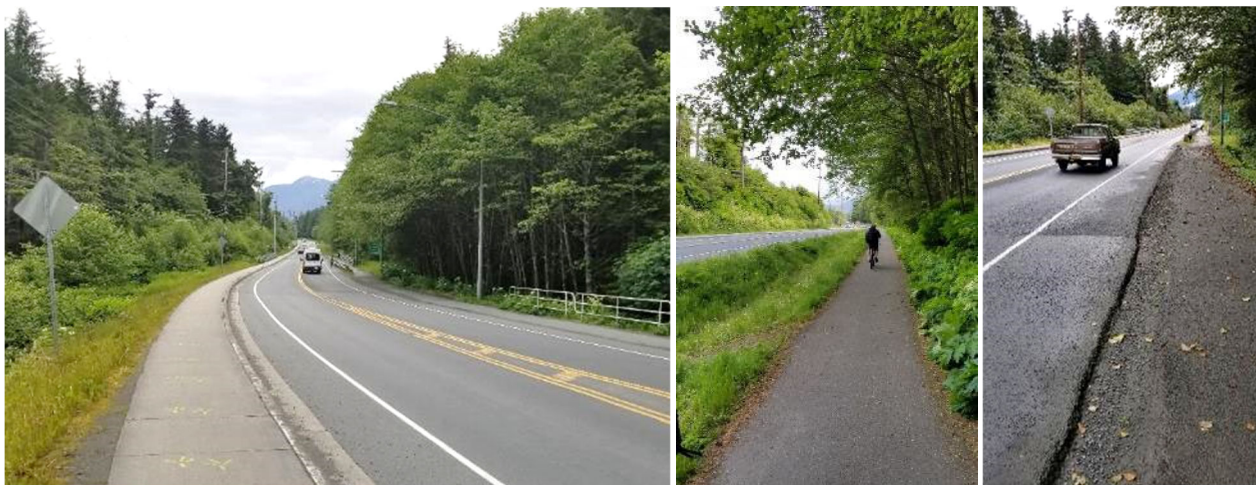
The section of road under evaluation extends from Indian River Road (MP 0.4) to just south of Jarvis Street (MP 0.95, including an area of mid-block pedestrian crossing near the convenience store), and consists of a two-lane roadway with left turn lanes at intersections. A 5' bike lane, curb and gutter, and a concrete sidewalk extend the length of the corridor on the westbound side of Sawmill Creek Road. On the eastbound side, there is a 5' bike lane, no curb, a ditch and a

Figure 4 - (L) Sawmill Creek Road looking South from Indian River Road. Figure 5 - (C) Multi-use path looking south. Figure 6 - (R) Multi-use path where it abuts the roadway.

separated variable width, but 6' typical, shared-use asphalt path. The shared-use path is detached from the roadway, except where it crosses Indian River (Figure 42).

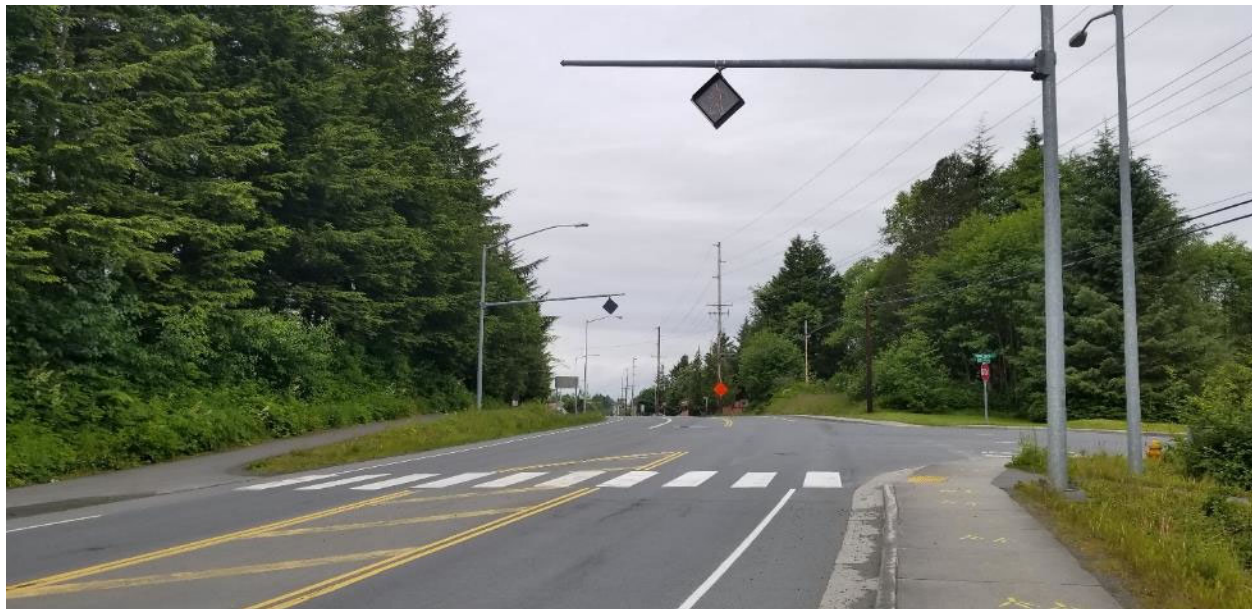
The project team identified an additional conflict point, and extended the study corridor to include in this evaluation. The marked crossing at Indian River Road is equipped with an overhead pedestrian crossing pendent light. The light is activated at all times, and hangs above the crossing. The striping in this location is of the high-visibility continental style. This crossing appears to be ADA accessible, and provides a connection to the multi-use trail and the sidewalk on either side of Sawmill Creek Road. The crossing is near the apex of a horizontal curve.

Figure 7 - A lighted sign hangs above a crosswalk at the intersection of Indian River Road and Sawmill Creek Road.

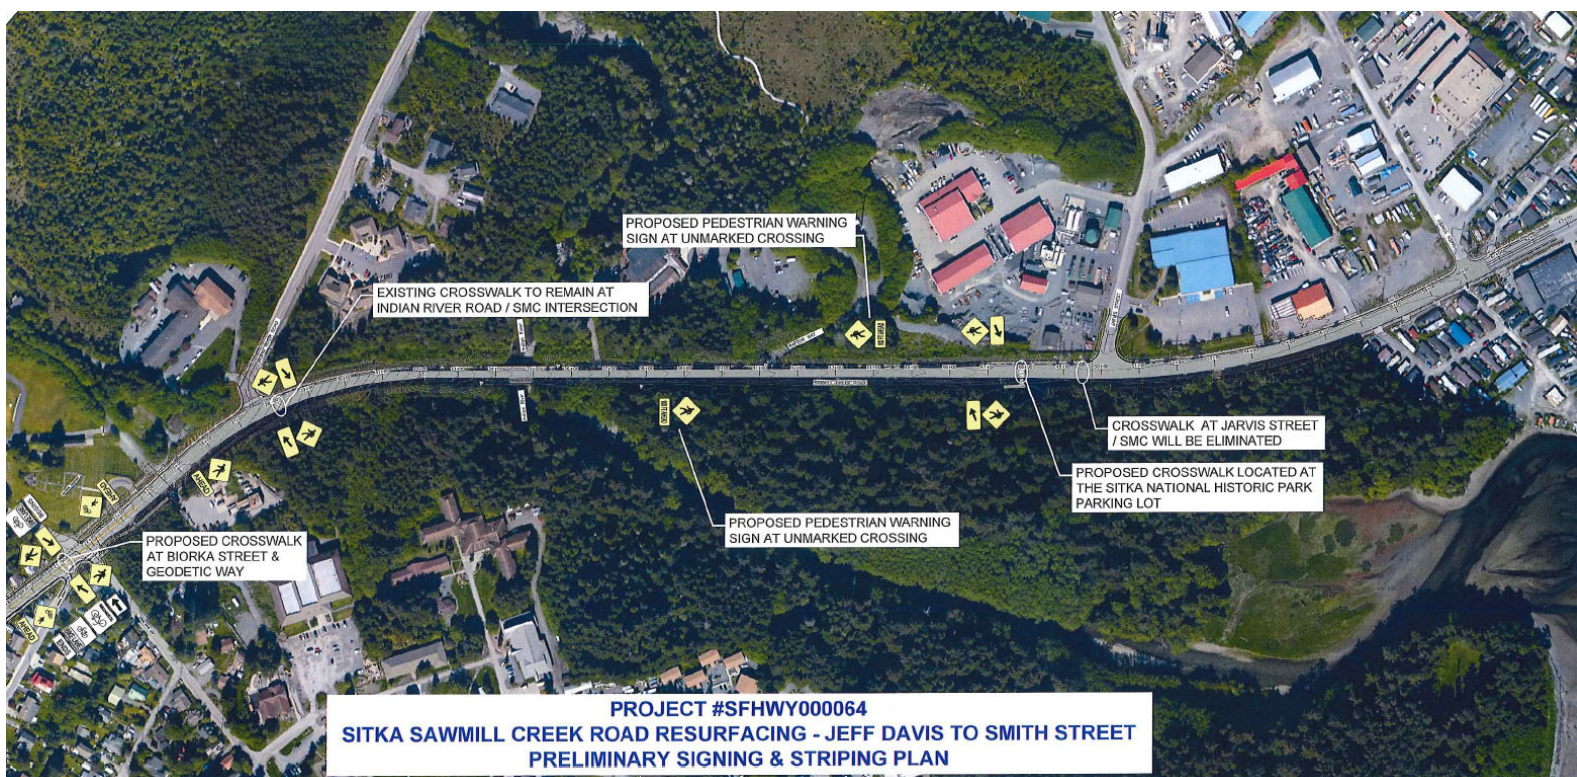
The roadway will get resurfaced from Jeff Davis Street to Smith Street. In conjunction with the repaving project, some of the signage will be updated and the pavement markings on the roadway

Figure 35 - Planned ADOT&PF resurfacing project.

will be reapplied. It is anticipated that many of the retroreflectivity recommendations from the report will or should be incorporated into the resurfacing project. The project intends to repair and improve curb ramps as needed and address drainage and other roadway related needs.
