## BRIDGE INSPECTION REPORT

INSPECTION TYPE: ROUTINE

SUN RIVER BRIDGE

STRUCTURE NO. MTA-SR-001

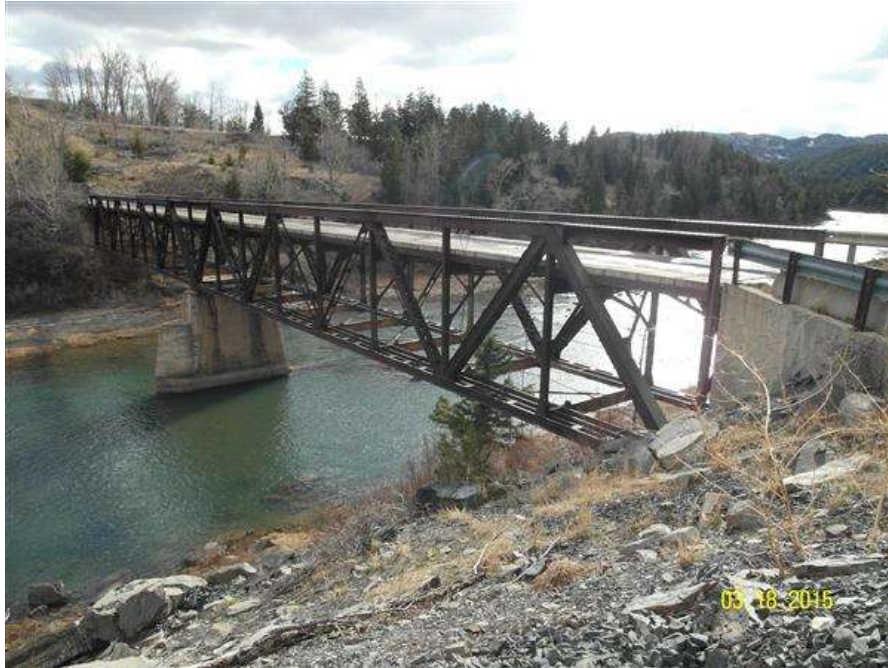
PHOTO #1 MTA-SR-001, SUN RIVER BRIDGE, PHOTO BY GARY GRASSEL. VIEW LOOKING AT THE UPSTREAM SIDE OF THE BRIDGE. (03/18/2015)

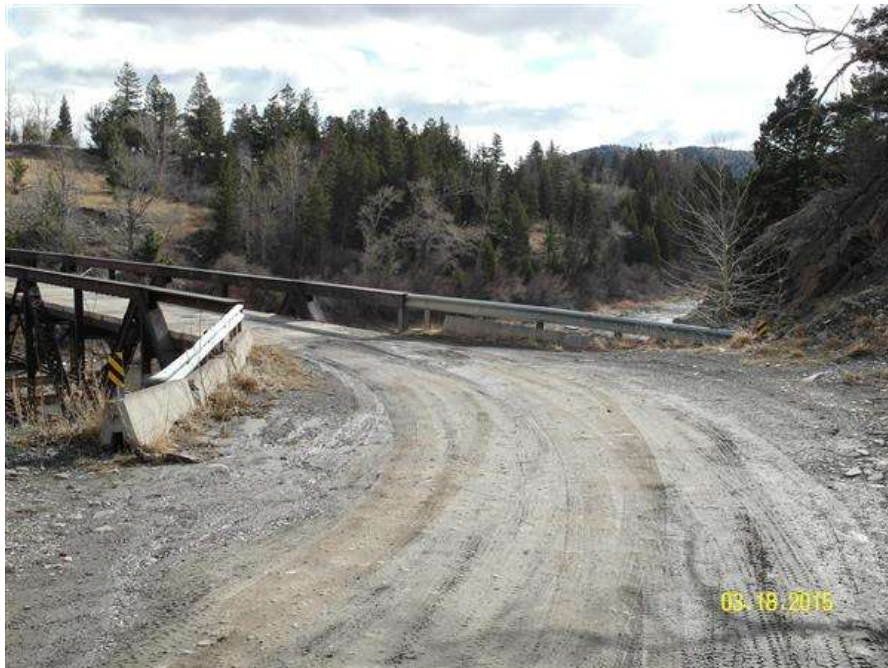
**PHOTO #6 MTA-SR-001, SUN RIVER BRIDGE, PHOTO BY GARY GRASSEL. THIS IS A VIEW OF THE RIGHT APPROACH TO THE BRIDGE. (03/18/2015)**

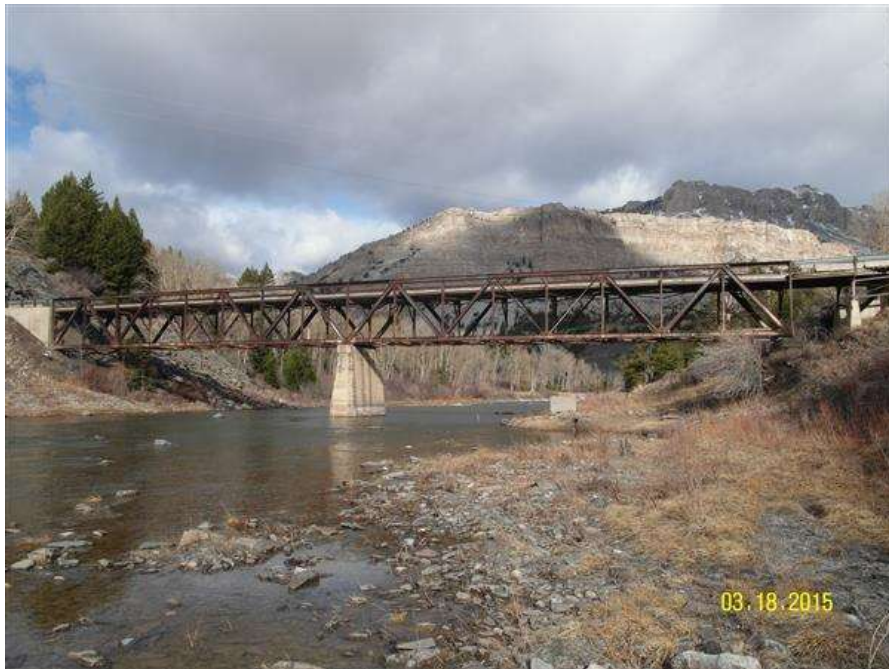
**PHOTO #14 MTA-SR-001, SUN RIVER BRIDGE, PHOTO BY GARY GRASSEL. THIS IS A VIEW LOOKING AT THE DOWNSTREAM SIDE OF THE BRIDGE. (03/18/2015)**

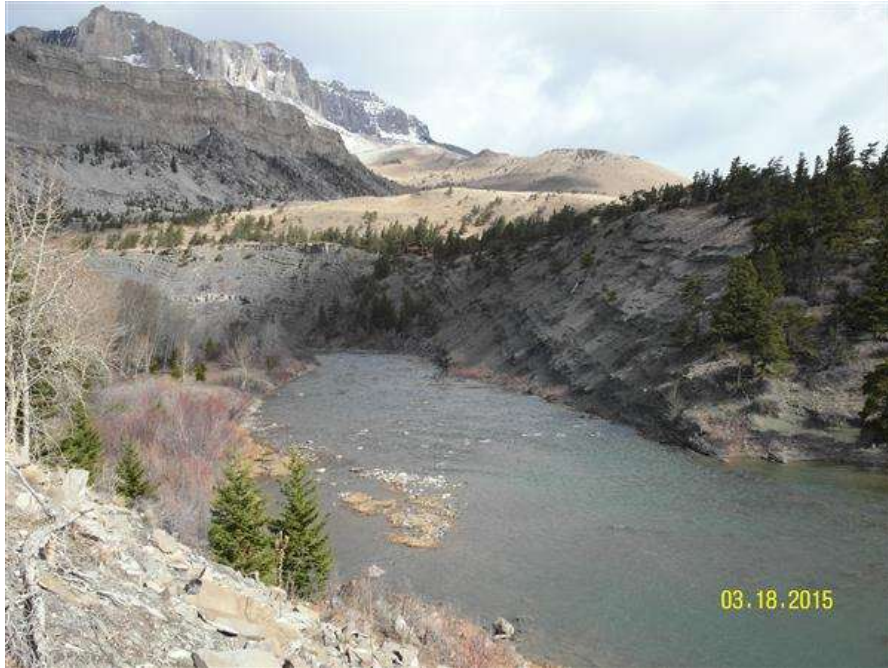
PHOTO #15 MTA-SR-001, SUN RIVER BRIDGE, PHOTO BY GARY GRASSEL. THIS IS A VIEW FROM THE BRIDGE DECK  
LOOKING UPSTREAM. (03/18/2015)
