Federal Highway Administration
Every Day Counts
Innovation Initiative

Safety Edge_{SM}
Demonstration Project
Seaford, Delaware

Field Report
January 30, 2011

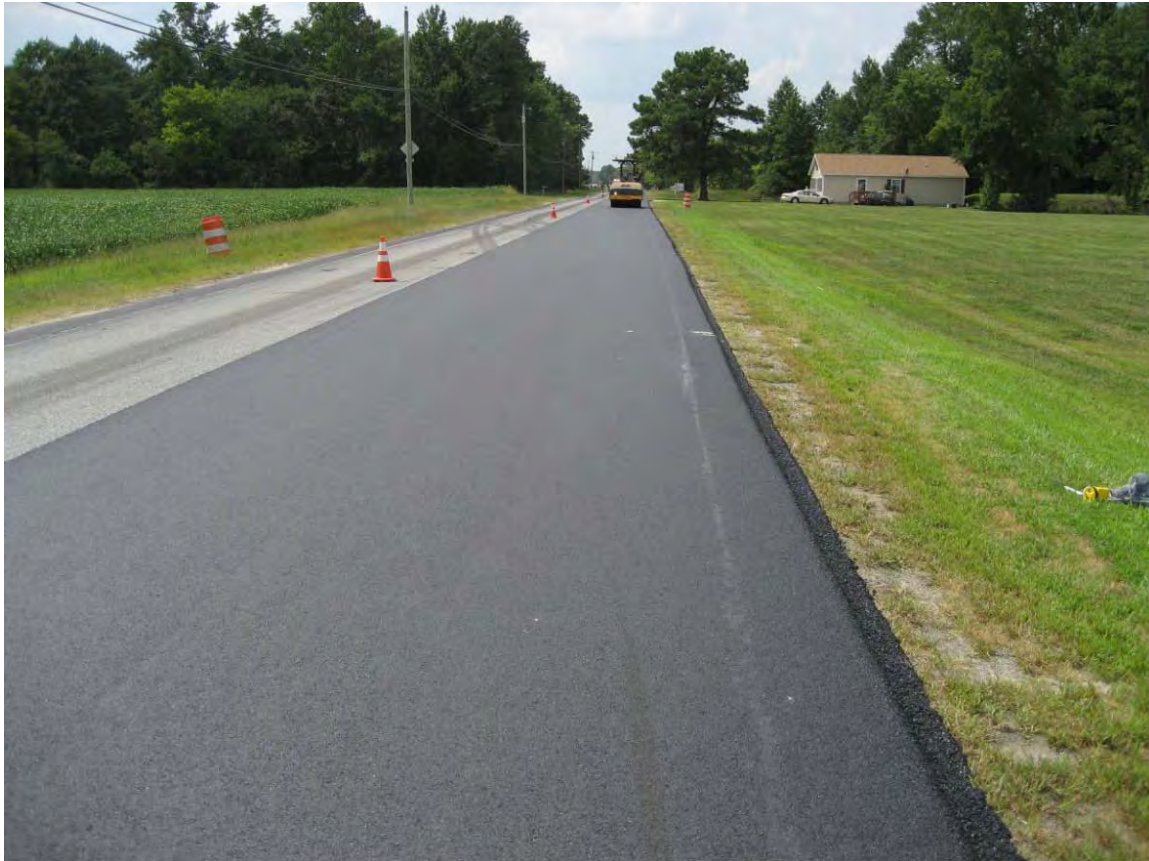
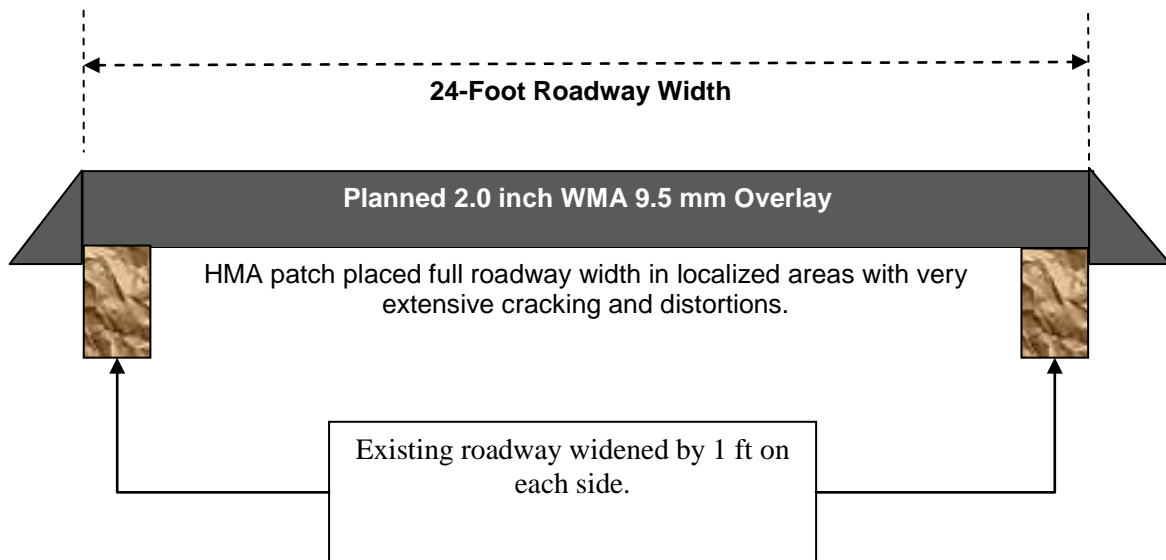
Figure 3. WMA overlay placed in the westbound lane.

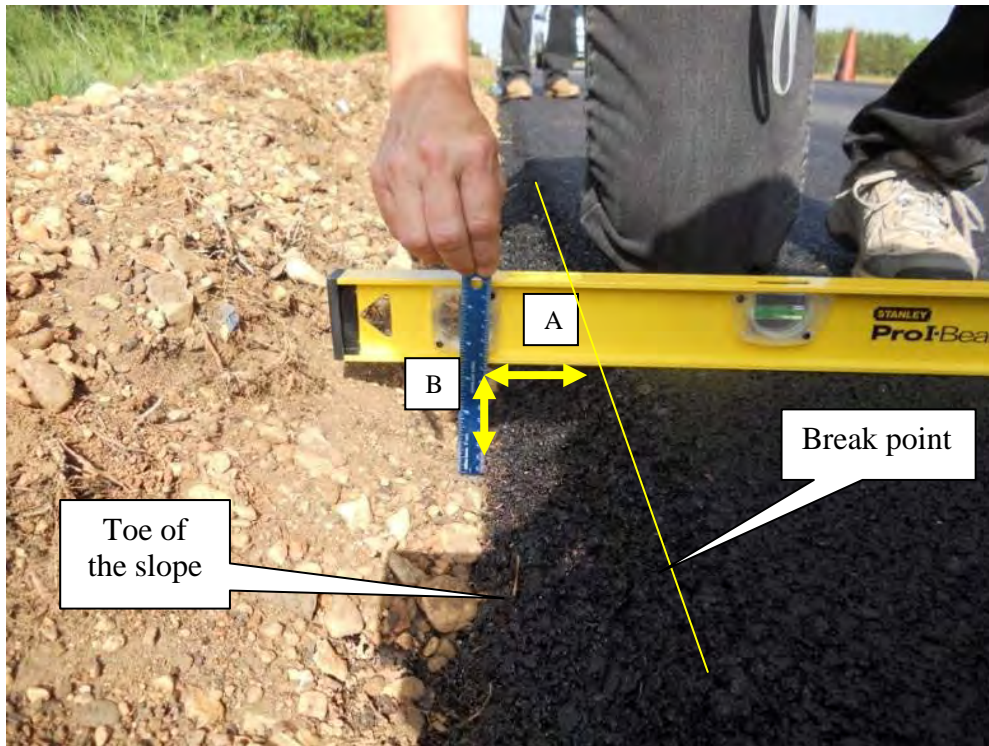
Figure 7. Safety Edge_{SM} angle measurement.

The slope of the Safety Edge_{SM} prior to rolling the unconfined edge was 34.1°. The average slope for the Safety Edge_{SM} created with the TransTech device after final rolling was about the same as prior to rolling, while the slope for Advant-Edger section was much steeper after final rolling. The Safety Edge_{SM} created with the TransTech device was placed on August 19 or 20, and the Safety Edge_{SM} created with the Advant-Edger device was placed on August 25 and 26. The WMA mixture was observed to shove and “push out” under the steel wheel vibratory roller for the paving on August 26. The reason for the difference in Safety Edge_{SM} slopes between the two devices is unknown, but it was reported that the mixture did change and corrections to production had to be made between the two paving dates. In fact, the production plant was shut down on August 26 to make adjustments to the WMA mixture.

Other slope measurements were made at random along the Safety Edge_{SM} in other areas of the project and the results were the same as for the specific Safety Edge_{SM} sections established for future performance reviews. Thus, the slope of the Safety Edge_{SM} was found to be steeper than what was planned.

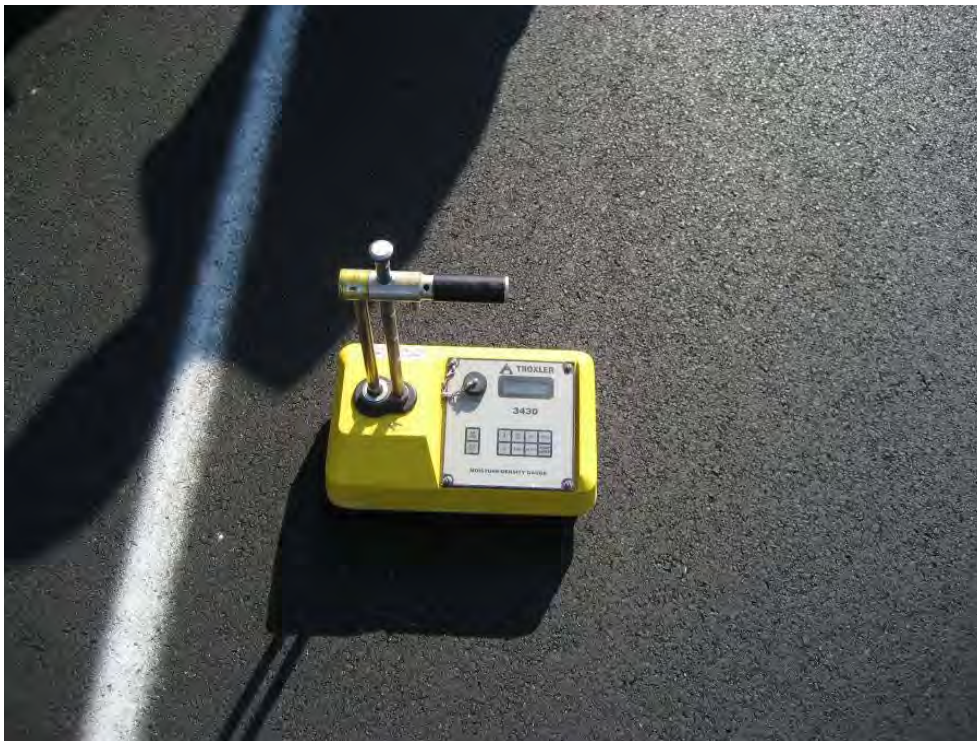
Figure 8. Troxler 3430 nuclear density gauge used to measure WMA density.

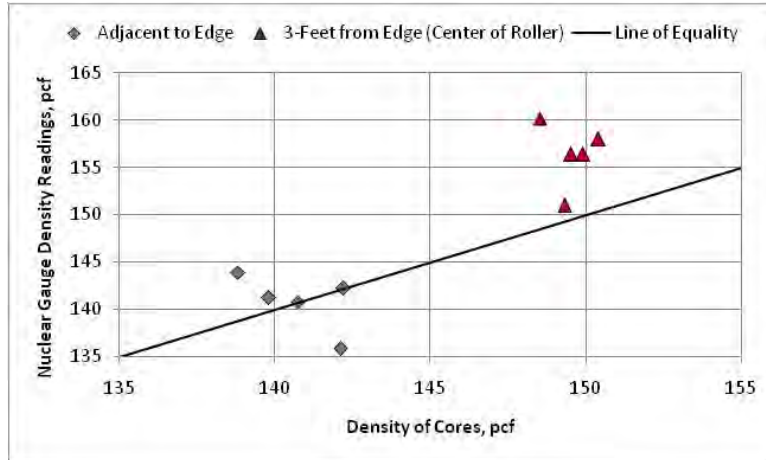
Nuclear density gauge readings were taken before drilling each core. Figure 12 is a comparison of the nuclear gauge readings and densities measured on the cores. As shown, there is a positive bias for the readings taken adjacent to the edge of the mat. Adjustment factors were determined for the nuclear gauge readings taken at the edge of the mat and 3 ft from the edge. The adjustment factors are included in Table A-4 and the nuclear density gauge readings at each point are listed in Table A-5 and Table A-6 in Appendix A. The following summarizes the adjustment factors determined for this project.

Figure 12. Comparison of the nuclear gauge readings and densities measured on cores recovered from the WMA mat.

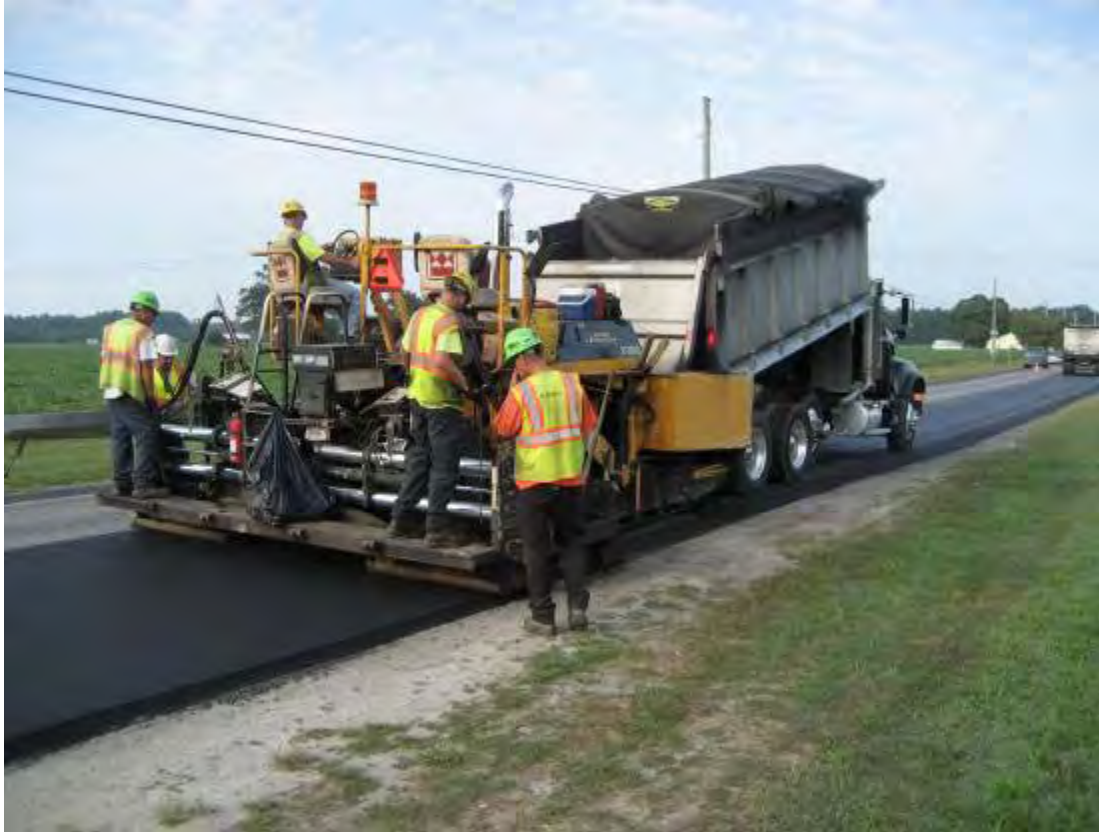
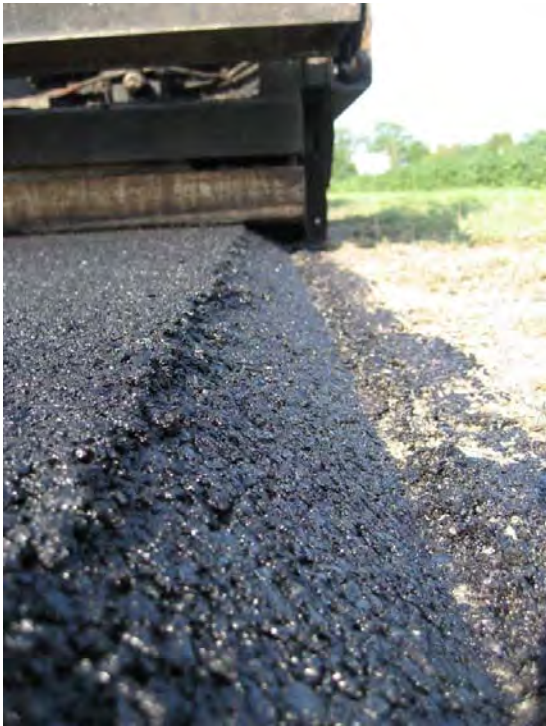
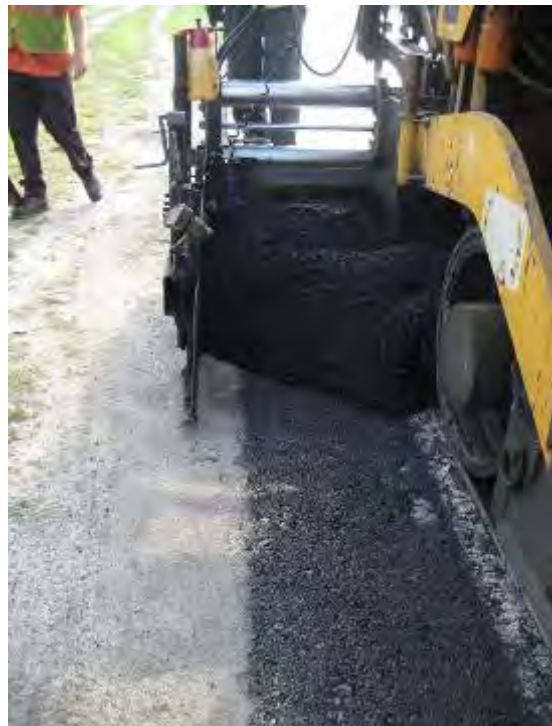
Figure 15 shows the equipment used to place the WMA overlay. The paving contractor operated the paver in the automatic longitudinal grade control mode and used non-contact sonic sensors for controlling the grade. The production plant was down for about 1.5 hours to make some WMA mixture revisions on August 26 to bring the mixture into specification. Free water was observed flowing from the back of a few truck beds. Excess water could explain some of the mixture tenderness characteristics observed during compaction (explained in the next section on *Compaction Operations*).

Figure 15. Equipment used to place the WMA overlay.

The distance between the end of the auger and screed end plate was approximately 24 inches (refer to Figure 15 and Figure 16). This distance should be less than 18 inches. The distance between the end of the auger and screed end plate was not believed to be a contributing factor to the steeper slope.

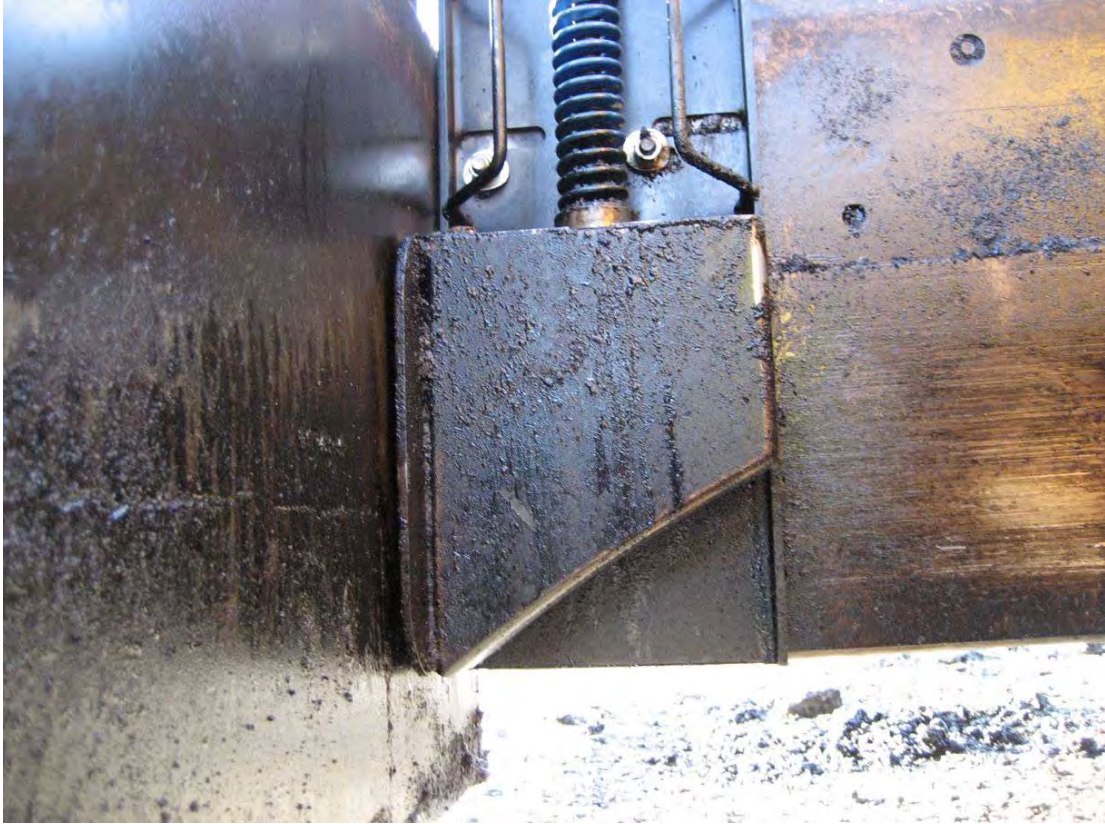
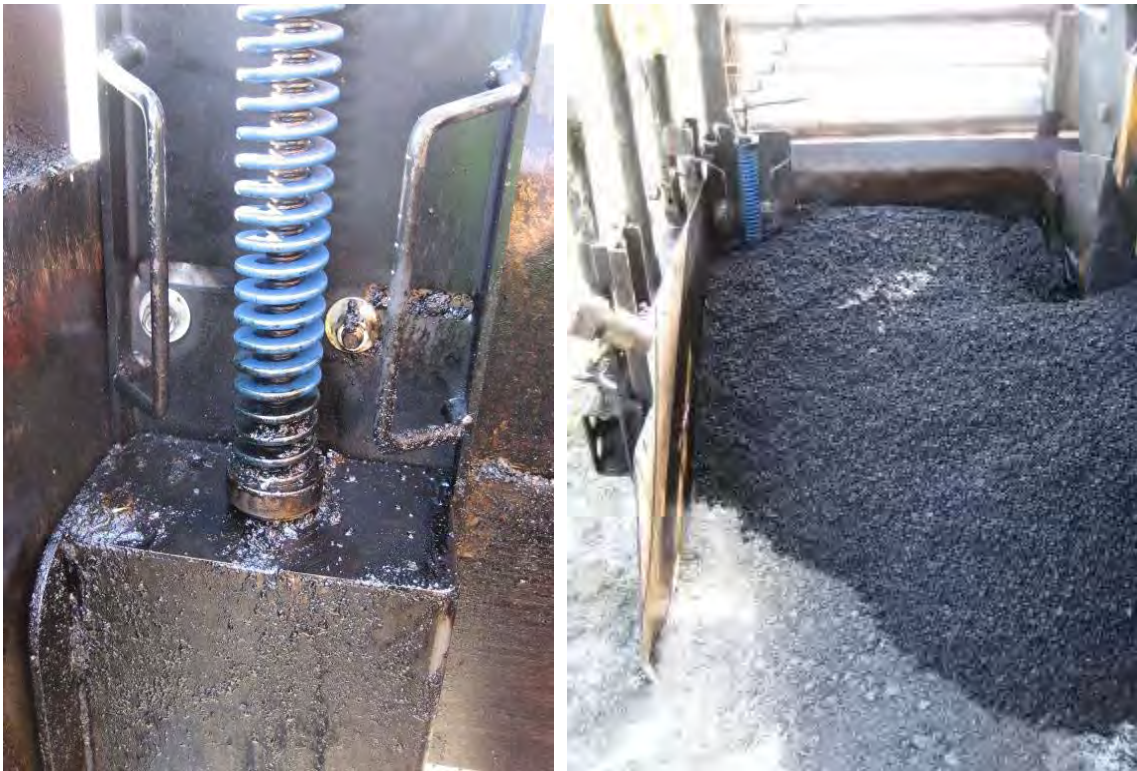
Figure 16 shows the Advant-Edger device attached to the screed. The project superintendent commented that there was no difference between the two devices, but the screed operator commented that the Advant-Edger seemed to work better than the TransTech device, resulting in a smoother edge condition. Figure 17 shows the slope and surface texture of the Safety Edge_{SM} prior to and after rolling.

Figure 16. Advant-Edger device attached to the screed.

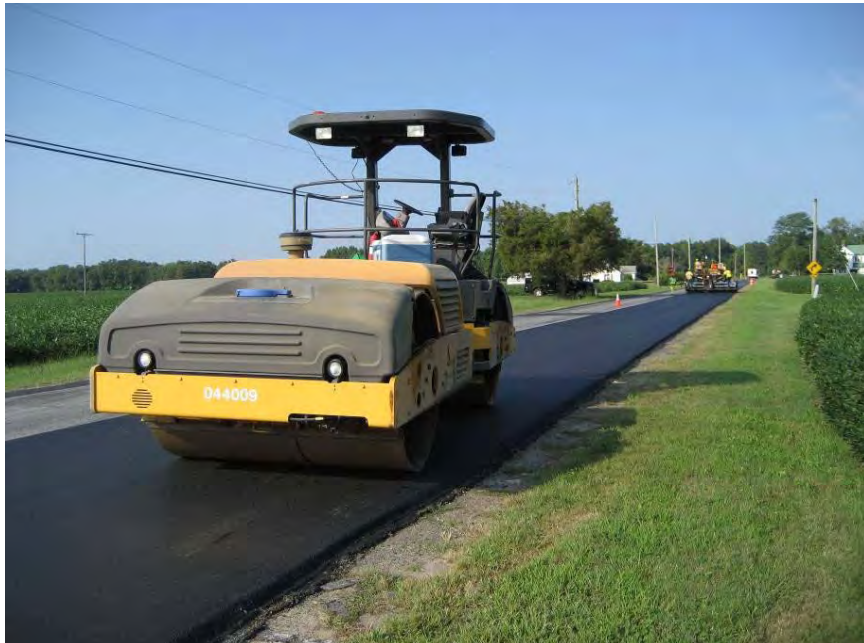
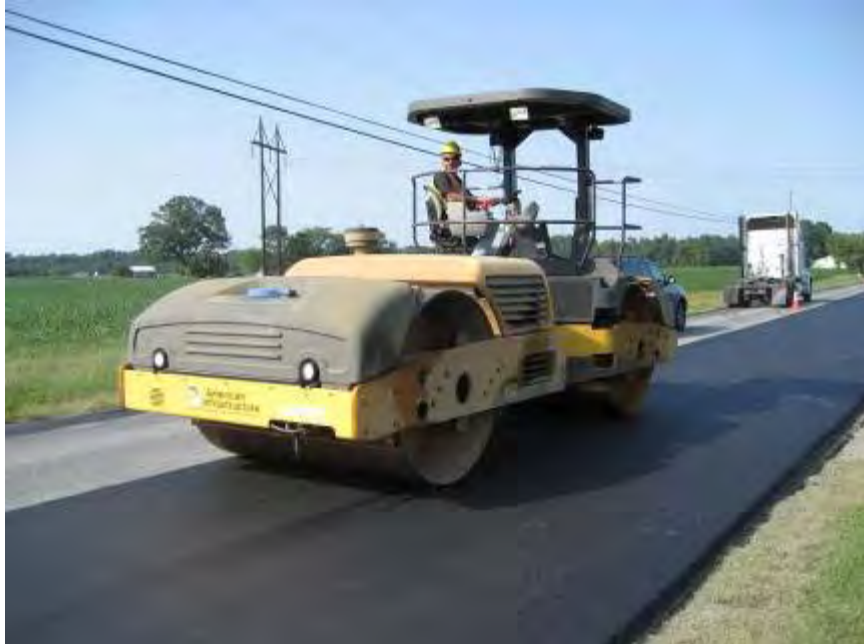
Figure 19. Rollers used for compacting the 9.5 mm WMA overlay mixture.

A control strip was not used to confirm that the roller pattern being used was achieving an adequate density of the mix. The Contractor used a Pavement Quality Indicator (PQI) non-nuclear density gauge to ensure that density was being met during paving. The non-nuclear and

nuclear density gauge readings and the densities of the cores suggest that adequate density was obtained for this mixture 3 ft from the edge, but the density was low near the edge.

Volvo double drum vibratory steel wheel roller used in breakdown or primary position for compacting the WMA overlay.

Volvo double drum vibratory steel wheel roller used in the vibratory and static mode that was used in the finish position for compacting the WMA overlay.
