Federal Highway Administration
Every Day Counts
Innovation Initiative

Safety Edge_{SM}
Demonstration Project
State Route 182
Columbus, Mississippi

Field Report
June 27, 2011

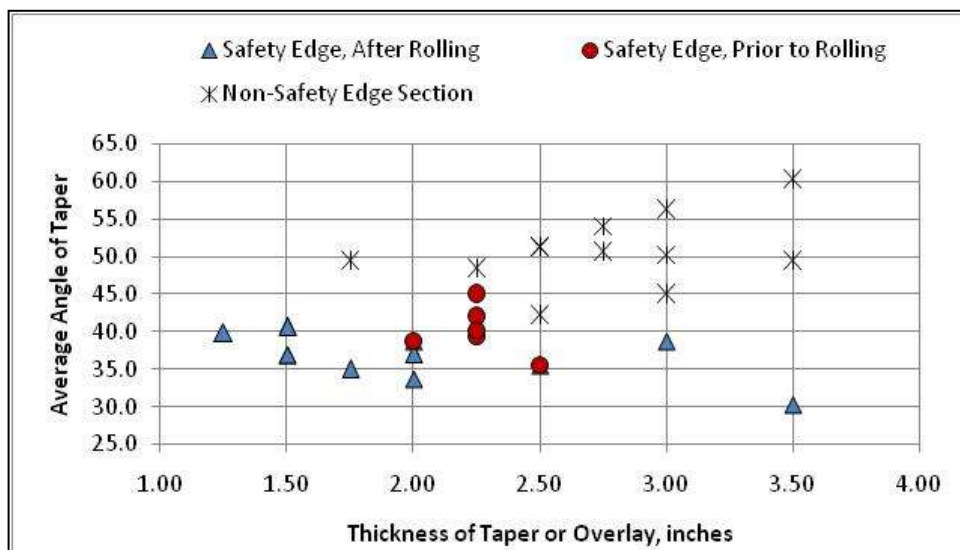
Figure 8. Comparison of the Safety Edge_{SM} slope and thickness of the HMA adjacent to the edge of the HMA overlay.

Slope measurements were taken using a straight-edge to measure the width and thickness of the taper of the Safety Edge_{SM} (refer to Figure 6). The average slope of the Safety Edge_{SM} was found to be 37°. All slope measurements are listed in Tables A-1 through A-3 in Appendix A. Only one of the measurements was about 30°. Figure 8 includes a comparison between the slope of the Safety Edge_{SM} after final rolling and thickness of the Safety Edge_{SM} for the two test sections. As shown, there appears to be no correspondence between thickness and the slope of the Safety Edge_{SM}.

Slope measurements were also made prior to rolling the Safety Edge_{SM}. These measurements are in Table A-2 in Appendix A and were compared to the values after final rolling; refer to Figure 8. As shown, the slopes prior to rolling are slightly steeper than after final rolling. These data sets were measured in different areas, so there is no direct correspondence between the individual point measurements. An observation from this comparison is that rolling did not steepen the slope, and suggests that rolling the Safety Edge_{SM} by overhanging the steel drum about 4 to 6 inches over the edge did not increase the slope. The rolling patterns used along the project are explained in the *Compaction Operations* section.

Slopes were also measured along the non-Safety Edge_{SM} section. These slope measurements are included in Table A-3 in Appendix A and shown in Figure 8. As expected, the slopes without use of the Safety Edge_{SM} are greater than when using the Safety Edge_{SM} device.

Other slope measurements were made at random along the Safety Edge_{SM} in other areas of the project, and the results were the same as for the specific Safety Edge_{SM} sections established for future performance reviews. Thus, the slope of the Safety Edge_{SM} was found to be steeper than what was planned.

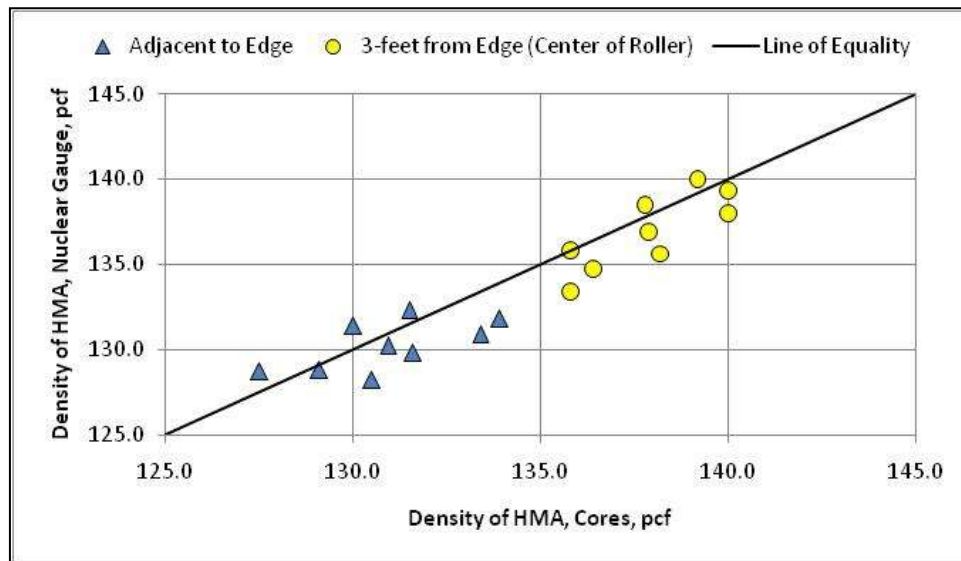
Figure 11. Comparison of the nuclear density readings and densities measured on the cores recovered from the mat.

Nuclear density readings were taken before drilling each core. Figure 11 shows a comparison of the nuclear gauge readings and densities measured on the cores. As shown, there is close correspondence between the nuclear gauge readings and core densities. Adjustment factors were determined for the nuclear gauge readings taken at the Safety Edges_{SM} and near the center of the steel drum roller being used to compact the HMA mat. The adjustment factors are included in Table A-4 in Appendix A. The following lists the average factors determined for this project, which are near unity.

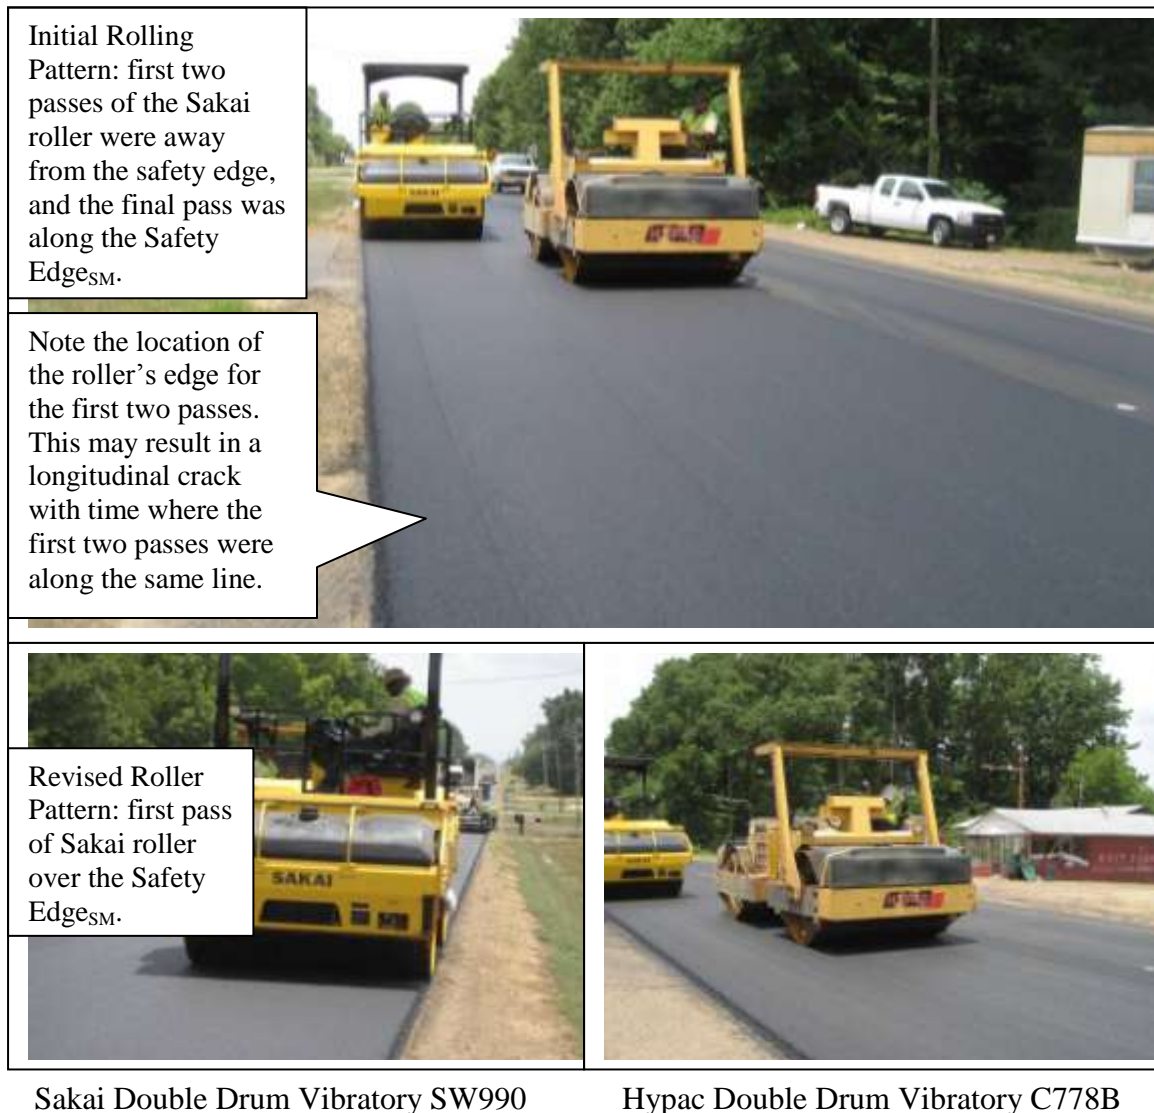
Figure 18. Two double drum vibratory steel wheel rollers were used in parallel in the breakdown position to compact the 9.5 mm HMA mix.

The Safety Edge_{SM} was rolled inconsistently along the project. The rolling pattern used along most of the project, however, was that the first pass of the Sakai breakdown roller was along the Safety Edge_{SM} with the roller extended over the edge of the HMA mat by about 4 to 6 inches (refer to Figures 18 and 20). As noted above, the Sakai roller operator did divert back to initially rolling the mat away from the edge and delayed rolling the edge until the last pass in different locations (refer to Figures 18 and 20). For the initial rolling pattern, the edge of the mat along the Safety Edge_{SM} received only one pass of the breakdown roller. The exact locations of the different rolling patterns were not identified along the project.

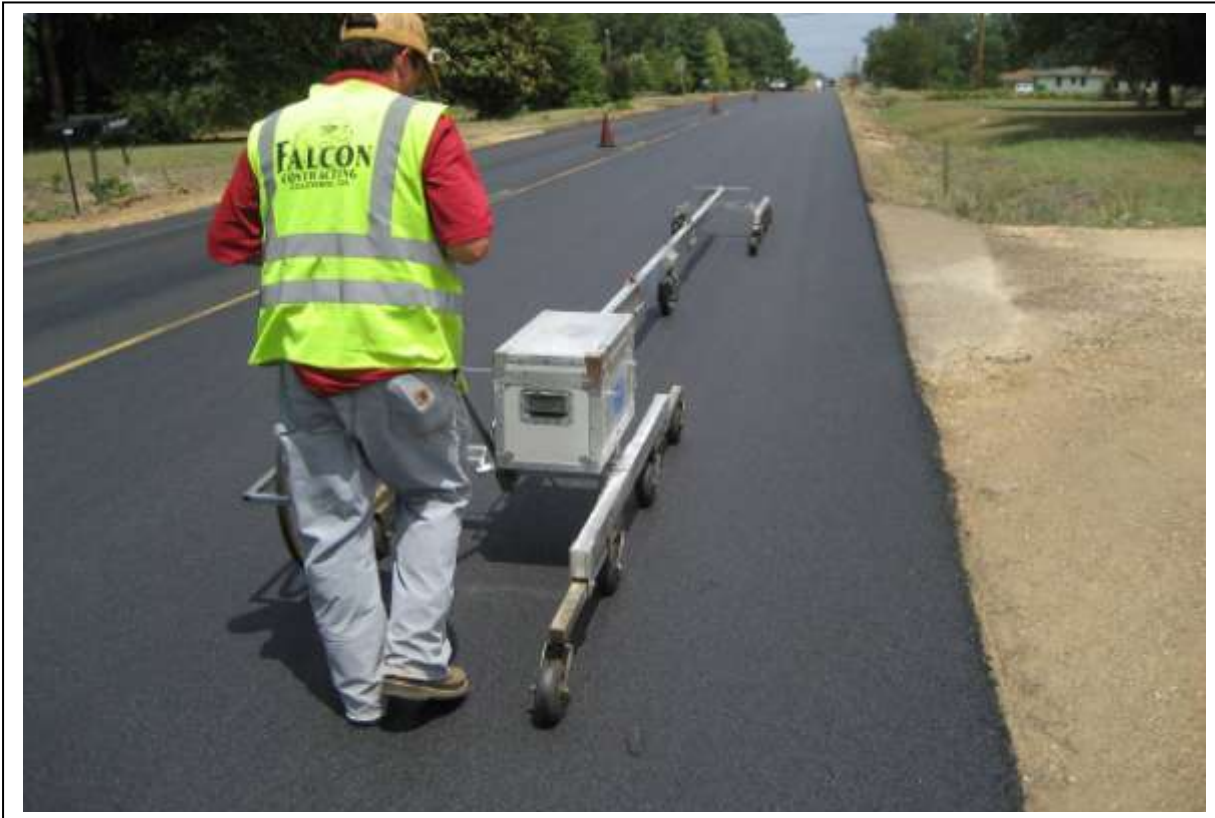
Figure 24. Longitudinal Profile Testing of Final Surface of Overlay

The other concern of the contractor was that the smoothness of the mat would decrease in those areas, and smoothness was a pay item (refer to Figure 24). The contractor requested that the Mississippi DOT permit the Safety Edge_{SM} device to be removed in those areas. It is unknown whether the Mississippi DOT permitted the contractor to remove the Safety Edge_{SM} device in those areas.
