Federal Highway Administration  
**Every Day Counts**  
Innovation Initiative

**Safety Edge<sub>SM</sub>**  
**Demonstration Project**  
**Kearney, Nebraska**

**Field Report**  
**May 24, 2011**

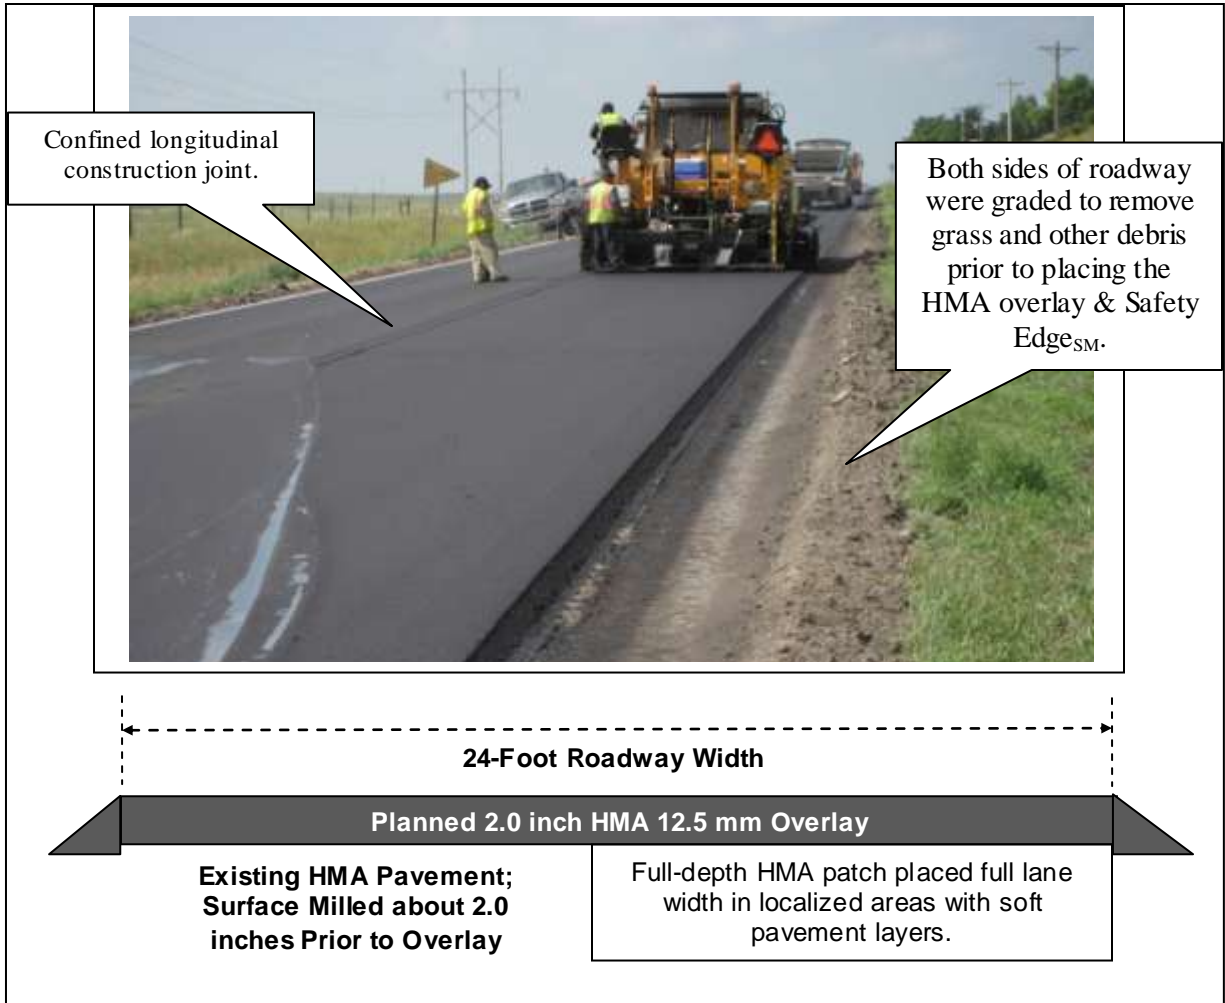
Figure 2. 12.5 mm HMA overlay being placed in one direction where the overlay in the opposite lane has already been placed.

The project consisted of milling the existing surface to a depth of about 2 inches (basically removing the existing wearing surface and some of the underlying layer) and placing a 2 inch lift of a 12.5 mm HMA mix over the existing HMA pavement. Figure 2 provides a general view of the 2 inch HMA overlay and typical cross section of the pavement. Figure 3 provides a general view of the roadway for this project. In preparation for the HMA overlay, the following activities and repairs were made.

- The existing shoulder was graded to remove grass and other debris; no other surface preparation along the shoulder was completed. Figures 2 and 4 show the shoulder that was graded prior to placement of the HMA overlay and Safety Edge<sub>SM</sub>.
- Full depth patches were placed in selected areas of the roadway where the subgrade or subsurface layer was found to be soft. Figure 5 shows a full-depth HMA patch that was used to repair the roadway prior to overlay placement, and shows depressions caused by the paver and belly-dump trucks delivering the 12.5 mm HMA mixture to the project site. The full-depth HMA patch was placed across the entire lane width.
- An emulsion tack coat was placed on the milled surface and patched areas.

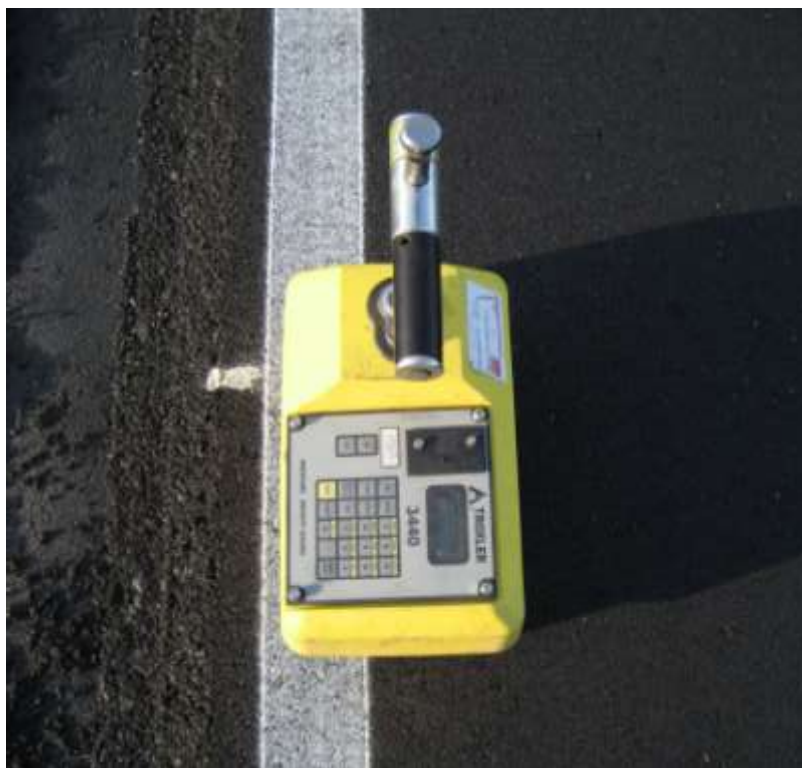
Figure 7. Troxler nuclear density gauge used to measure HMA density.

Field tests were conducted within each test section for measuring slope and HMA density. Slope measurements were taken using a 4-foot aluminum straight-edge and six inch ruler (refer to Figure 6), while density readings were taken adjacent to and 3-feet from the mat's edge using a Troxler 3440 nuclear density gauge (refer to Figure 7).

Density measurements were made with a Troxler 3440 gauge (refer to Figure 7). Two readings were recorded at each station or location; one reading was taken at a point adjacent to the Safety Edge<sub>SM</sub> and one near the center of the steel drum roller. The nuclear gauge was positioned parallel to the pavement edge (refer to Figure 7). The nuclear gauge readings at each point are listed in Table A-3 in Appendix A.

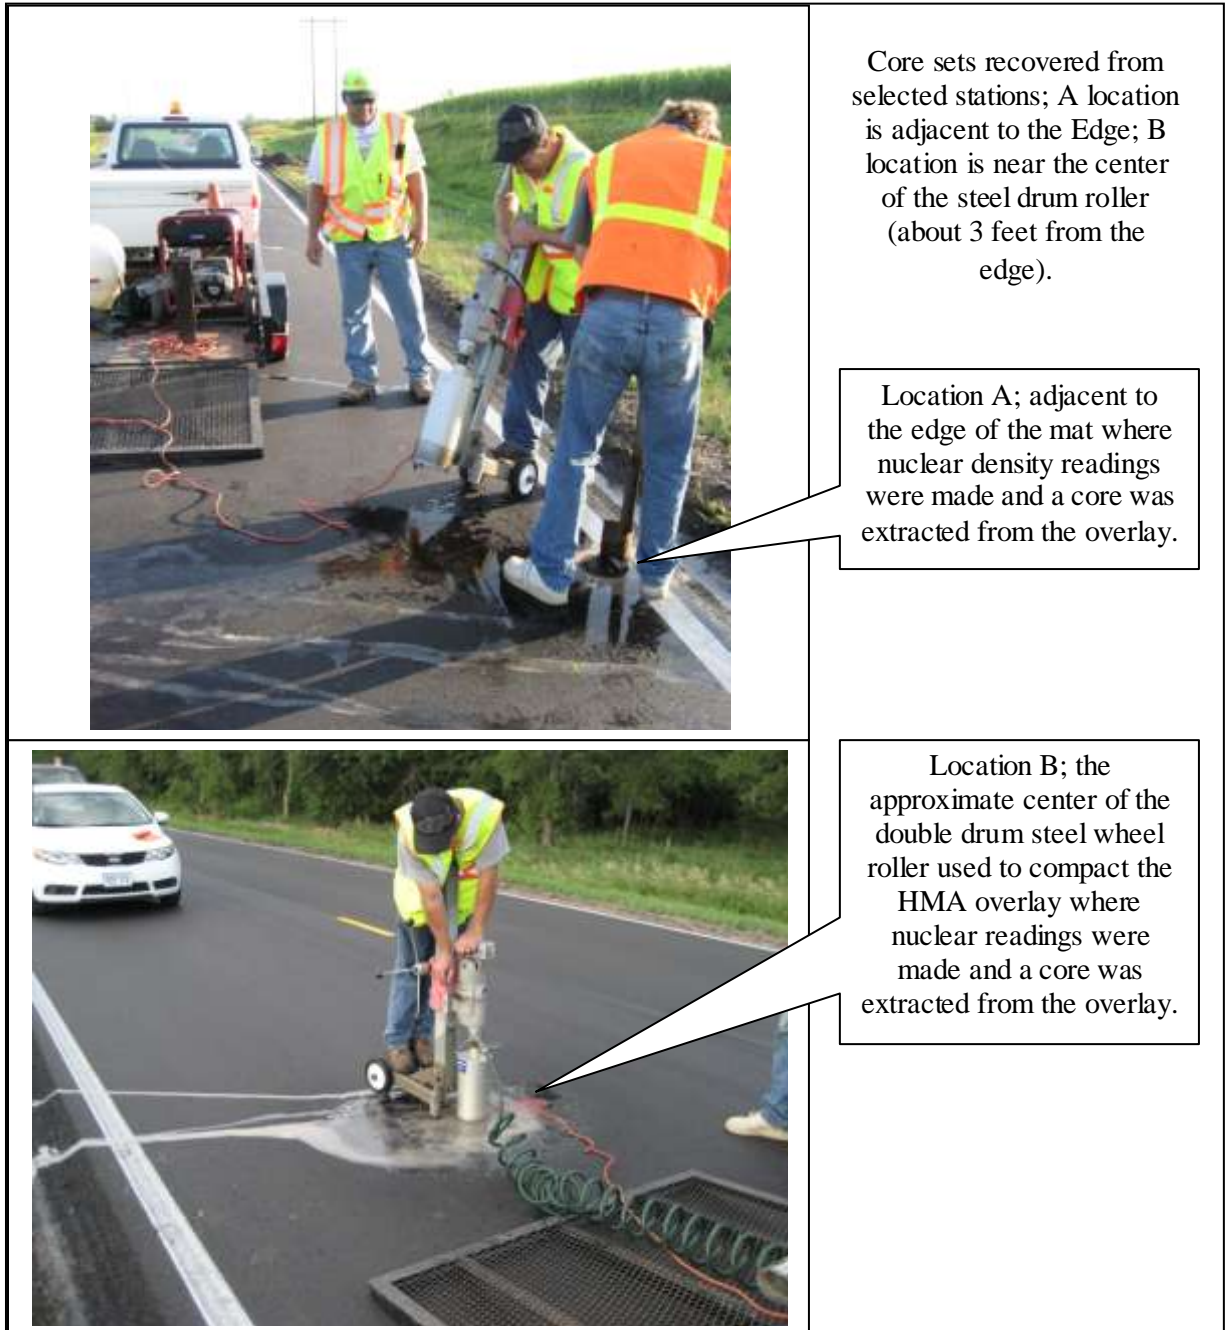
Figure 9. Photos show location of cores and nuclear density tests made with the Troxler gauge (nuclear density readings were taken and then the overlay was cored).

Ten cores were taken in the test sections established during the paving operation. The ten cores were obtained at five different locations (4 within the Safety Edge<sub>SM</sub> sections and 1 within the non- Safety Edge<sub>SM</sub> section). The cores were taken for calibration of the nuclear density gauge readings, and to observe the mix near the center of the mat and adjacent to the mat's edge. The longitudinal profile was not measured along this project because the 2.0 inch HMA overlay was considered a temporary repair to this roadway. Agency personnel noted that they expect this roadway to need additional strengthening and rehabilitation within 5 years.

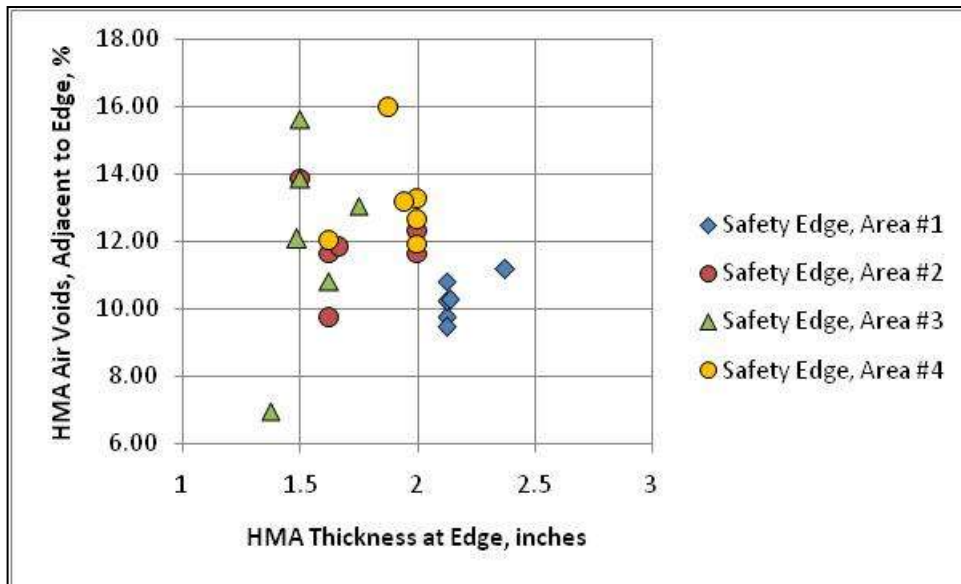
Figure 13. Comparison of HMA thickness at the edge of the mat and HMA air voids.

Figure 8 included a comparison between the HMA thickness (near the Safety Edge<sub>SM</sub>) and slope of the Safety Edge<sub>SM</sub>. The thickness of the HMA appears to have no effect or impact on the slope of the Safety Edge<sub>SM</sub>. Figure 13 shows a comparison of the density and HMA overlay thickness. As shown, there is also little correspondence between the overlay thickness and air voids or densities.

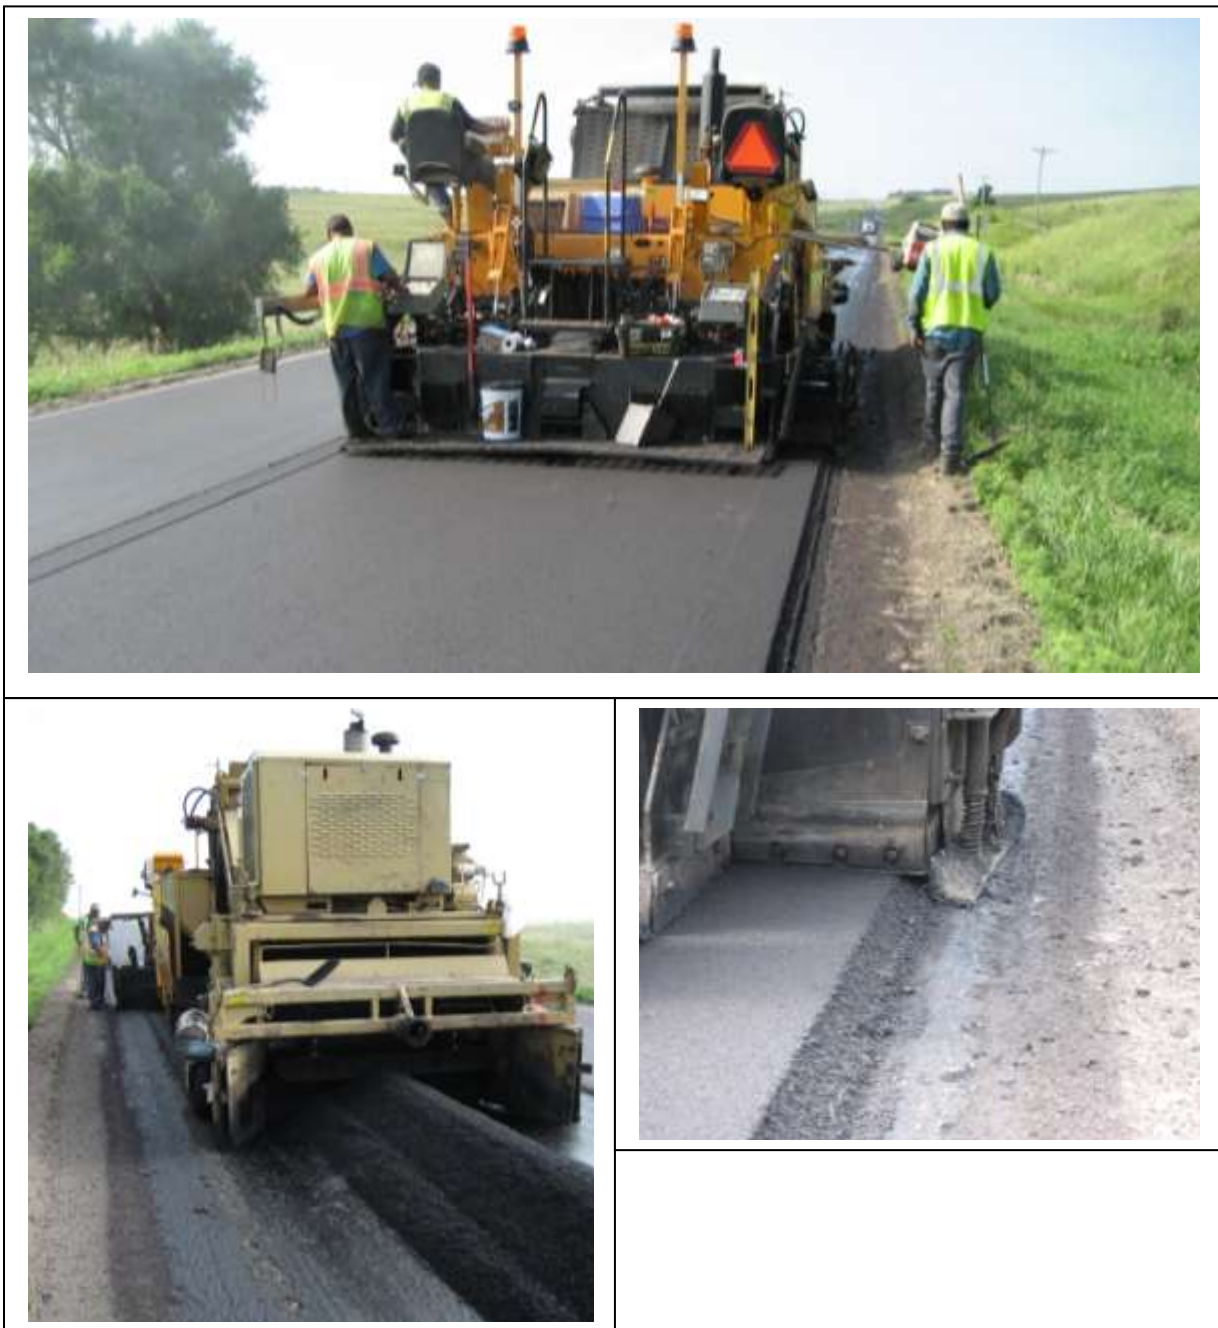
Figure 14. Equipment used to place the HMA overlay.

Figure 14 shows the equipment used to place the HMA overlay. The paving contractor operated the paver in the automatic longitudinal grade control mode and used non-contact sonic sensors for controlling the grade. Figure 15 shows the TransTech Shoulder Wedge

Figure 14 showed the HMA behind the screed and the Safety Edge<sub>SM</sub> slope prior to rolling. The slope of the Safety Edge<sub>SM</sub> prior to rolling was equal to or slightly steeper than the planned 30°. The distance between the end of the auger and screed end plate was about 18 inches (refer to Figure 15). This distance should be less than 18 inches. The temperature of the HMA being delivered to the project site was reported to be 310 to 318 °F. Mix temperature and the distance between the end of the auger and screed end plate are not believed to be contributing factors to the steeper slopes.

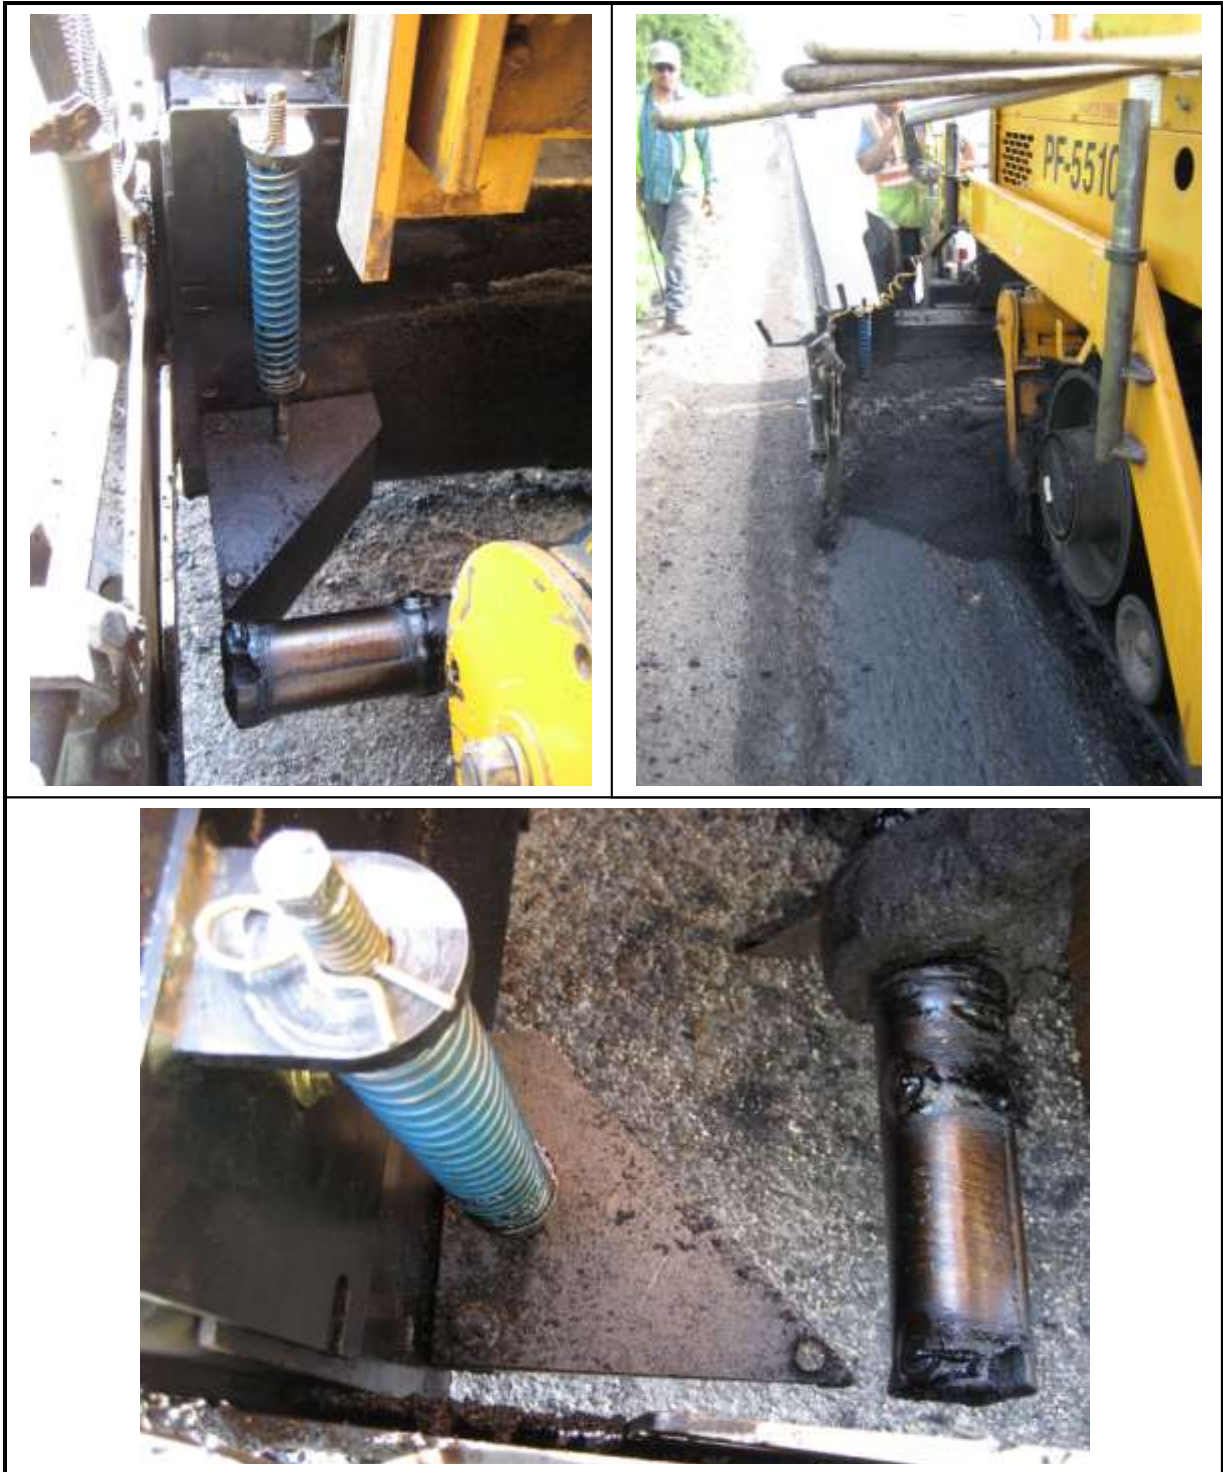
Figure 15. TransTech Shoulder Wedge Maker device attached to the screed.

- The Safety Edge<sub>SM</sub> was formed using the TransTech Shoulder Wedge Maker device, which was properly bolted to the screed. Construction personnel recommended that the Safety Edge<sub>SM</sub> device include an automated system for raising and lowering the device.
- Both contractor and agency personnel voiced a concern that the spring stiffness is too high and the travel length too short. In paving across intersections or in areas with higher longitudinal profile, the Safety Edge<sub>SM</sub> device may raise the screed relative to the profile set by the longitudinal ski.

Maker device attached to the screed. The HMA overlay was placed in windrows using belly-dump trucks. The use of windrows and associated paving equipment allowed the paver to place the HMA at a constant and uniform rate with few stops of the paver.

Figure 16 shows the slope and surface texture of the Safety Edge<sub>SM</sub>. The contractor superintendent/owner recommended that the Safety Edge<sub>SM</sub> device be an automated system rather than manually turning the screw to raise and lower the Safety Edge<sub>SM</sub> device.

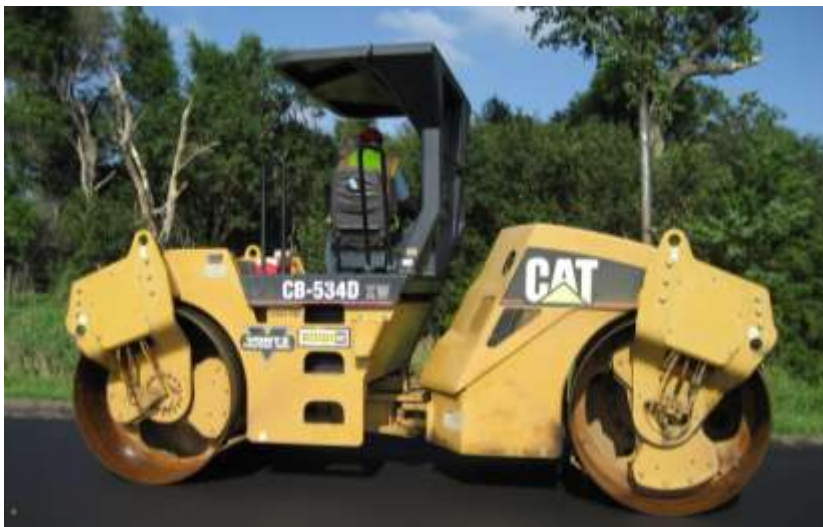
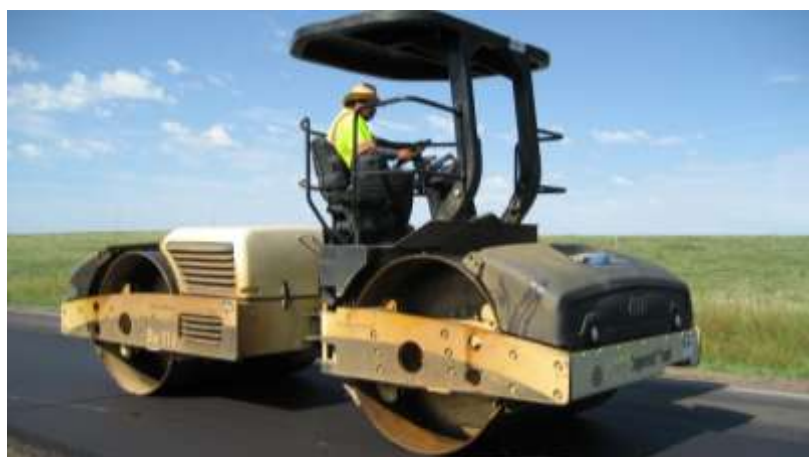
Figure 17. Rollers used for compacting the 12.5 mm HMA overlay mixture.

Figure 17 shows the two rollers that were used to compact the 12.5 mm HMA mixture. The primary or breakdown roller was a Caterpillar double drum vibratory (CB 534D), while the finish roller was an Ingersoll-Rand double drum vibratory (DD118 420HFA). The field evaluation forms identify the number of passes and coverage used by all rollers (a pass is defined as one movement of the roller in one direction, while coverage is defined as each point on the mat receiving a pass of the roller). In summary, each roller had 5 passes with 2 coverages, except for the area adjacent to (within 6 inches) and along the Safety Edge<sub>SM</sub>, which only received one pass of the breakdown roller.

A control strip was not used to confirm that the roller pattern being used was achieving an adequate density of the mix. The nuclear density gauge readings and the densities of the cores suggest that adequate density was obtained for this mixture away from the edge, but the density was low near the edge.

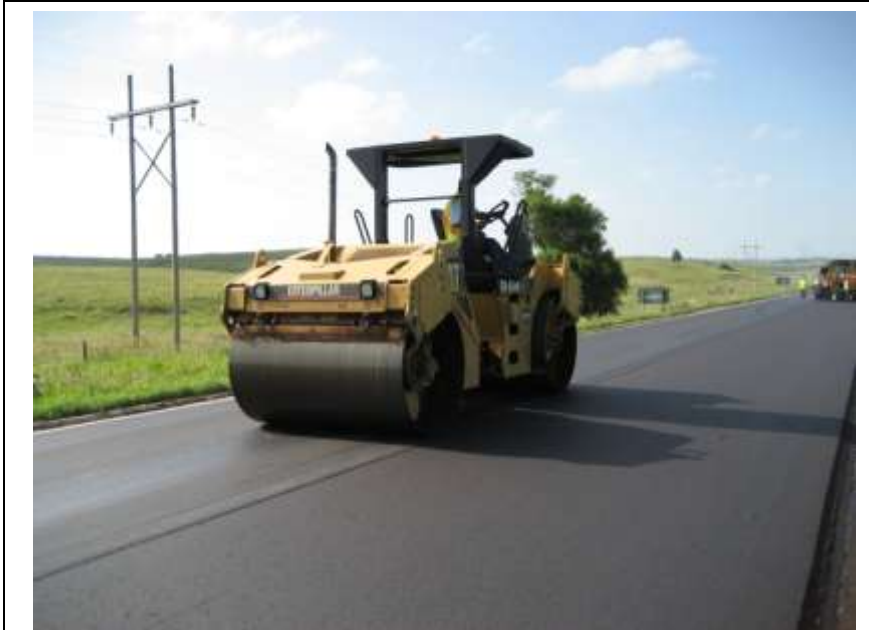
- First pass was along the longitudinal centerline joint in the static position along the cold side of the joint (refer to Figure 19.a; cold-side-pinch).

(a) First pass of Caterpillar breakdown roller in static mode along the cold-side of the longitudinal joint.

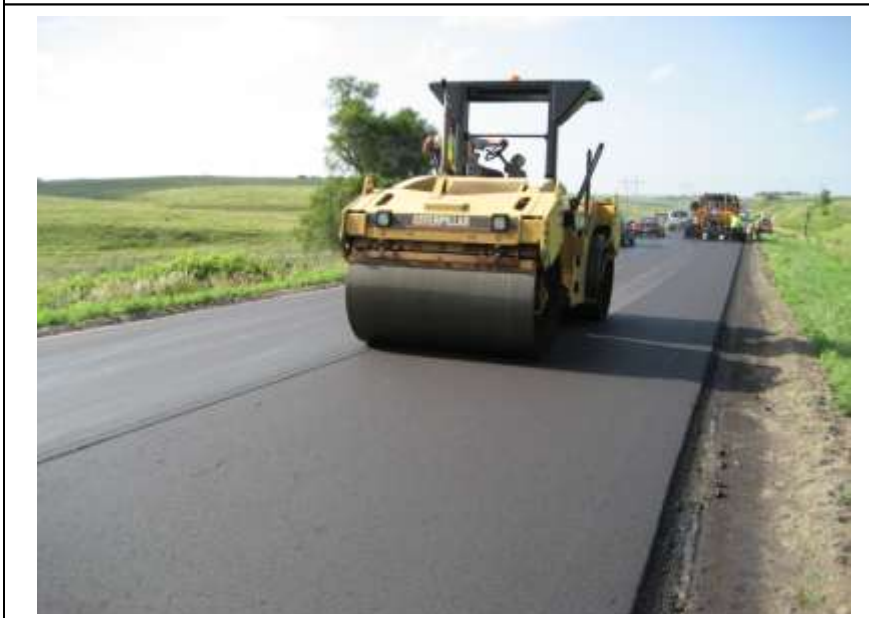
- Second pass was along the longitudinal centerline joint but on the hot side of the joint in the vibratory mode (low frequency, low amplitude [refer to Figure 19.b]).

(b) Second pass of Caterpillar breakdown roller in vibratory mode along the hot-side of the longitudinal joint.
