Federal Highway Administration
Every Day Counts
Innovation Initiative

Safety Edge_{SM}
Demonstration Project
Elizabethtown,
Pennsylvania

Field Report
May 24, 2011

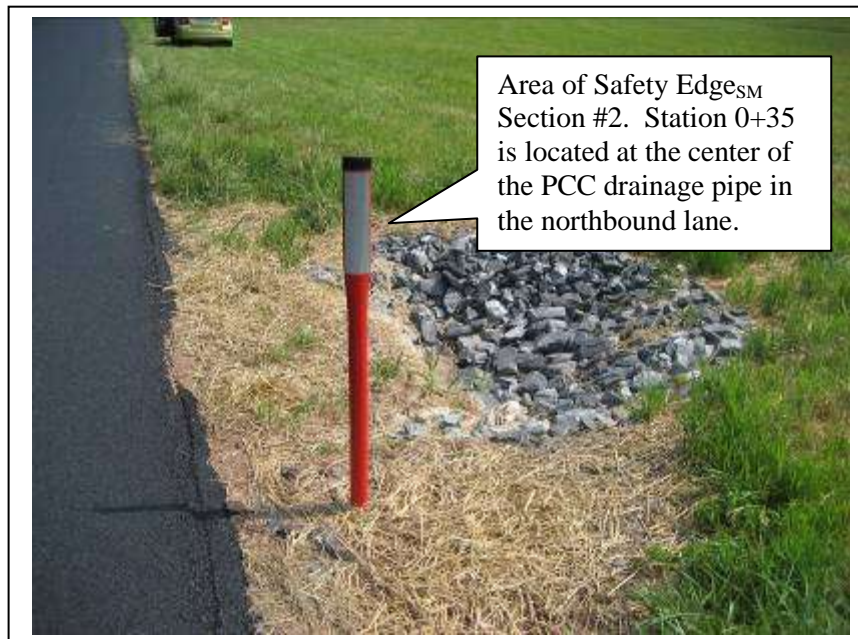
Figure 7. Reference marker for Safety Edge_{SM} Section #2.

2. Non- Safety Edge_{SM} Control Section; north bound lane on the opposite side of the roadway from the Safety Edge_{SM} Section #1.
3. Safety Edge_{SM} Section #2; northbound lane, north of the intersection between Bellaire Road and Maple Dale Road – just north of 365 Bellaire Road. Station 0+35 for this section is located at the center of the culvert and PCC drainage pipe (refer to Figure 7). This section was selected because the Safety Edge_{SM} device was visually observed being used and this area is subject to erosion and future lane-shoulder drop-off.

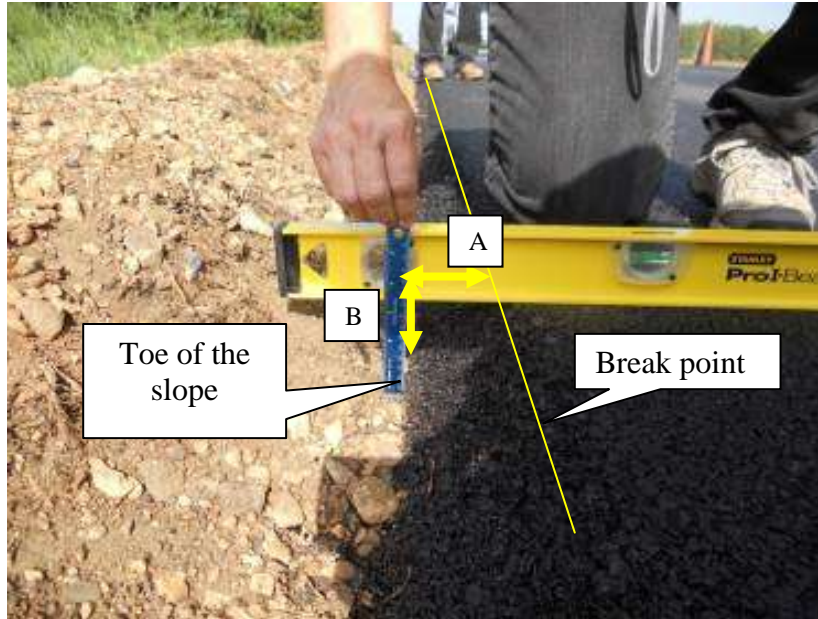
Figure 8. Measurement of the Safety Edges_{SM} angle.

Slope measurements were taken using a straight-edge to measure the width and thickness of the taper of the Safety Edge_{SM} (refer to Figure 8). The average slope of the Safety Edge_{SM} was 48°. Table A-1 in Appendix A contains slope measurements recorded at each individual measurement location. Only one of the measurements was less than 40°. Figure 9 includes a comparison between the slope of the Safety Edge_{SM} and mat thickness at the Safety Edge_{SM} for the two test sections. As shown, there appears to be no correspondence between mat thickness and the slope of the Safety Edge_{SM}.

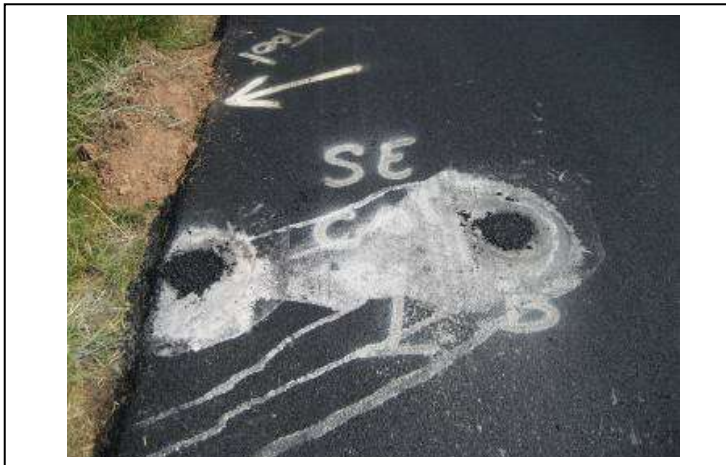
Core #1; Safety Edge_{SM} section (A location is adjacent to the Edge; B location is near the center of the steel drum roller (about 3 feet from edge).

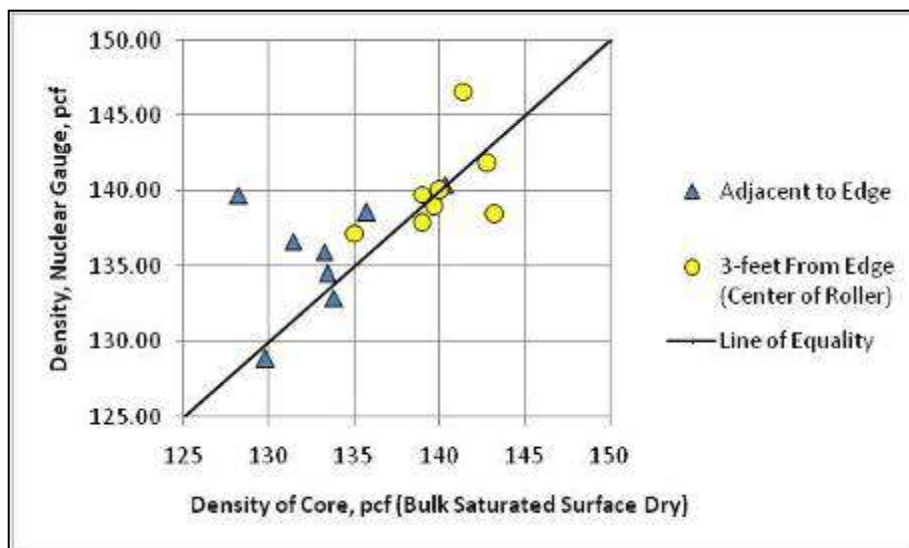
Figure 12. Comparison of the nuclear density readings and densities measured on cores recovered from the HMA overlay.

Nuclear density readings were taken at each core. Figure 12 shows a comparison of the nuclear densities and densities measured on the cores. As shown, there is close correspondence between the nuclear and core densities. Adjustment factors were determined for the nuclear density readings taken at the Safety Edge_{SM} and near the center of the steel drum roller being used to compact the HMA mat. The adjustment factors are included in Table A-3 in Appendix A and are summarized as follows:

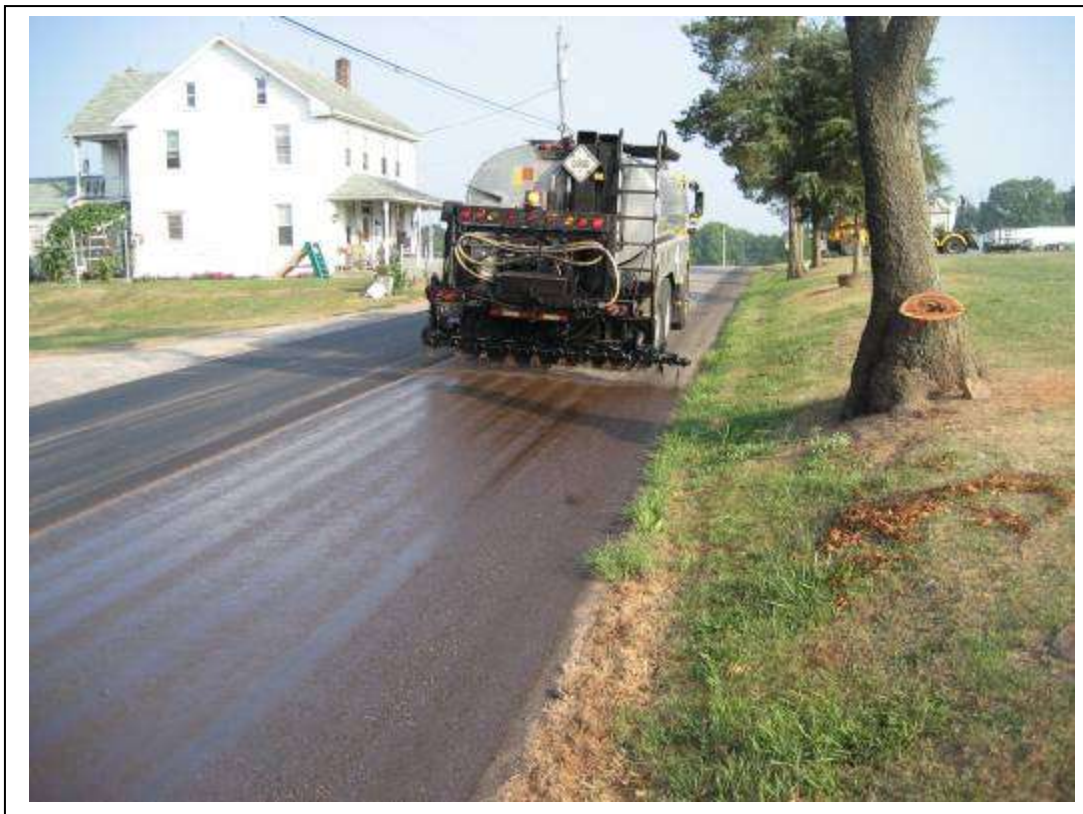
Figure 15. An emulsion was used as a tack coat prior to HMA placement (note the material that was added to the edge of the pavement to widen the roadway).

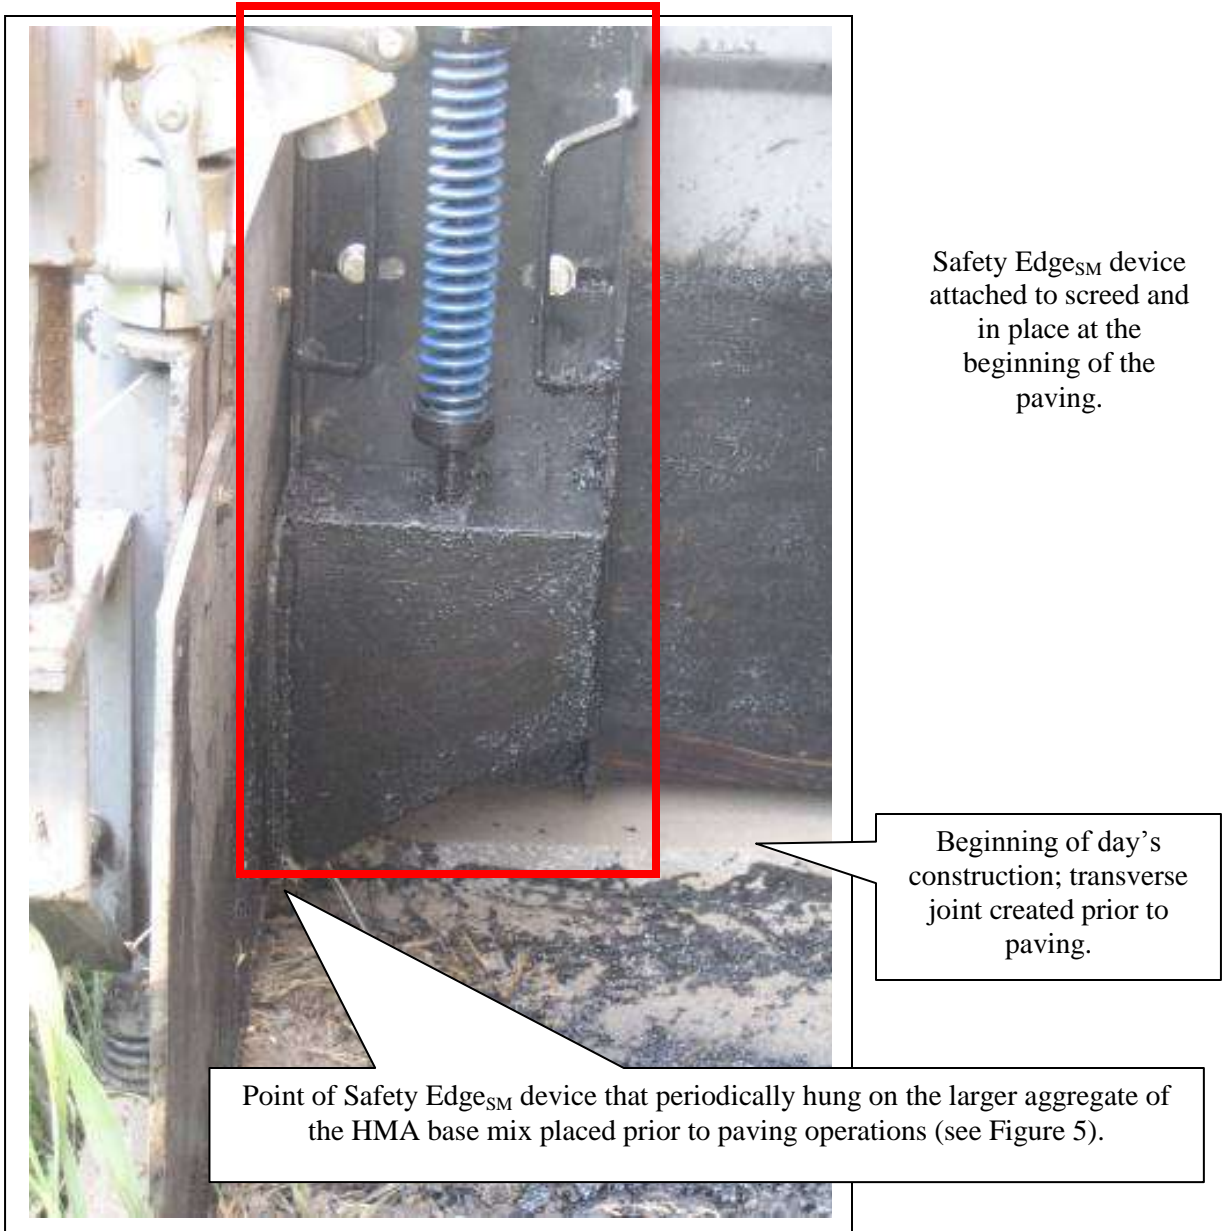
Figure 17. Safety Edge_{SM} device attached to the screed.

- The screed operator's opinion was that it was difficult to control the height of the screed, screed end plate, screed extension, and Safety Edge_{SM}. It was recommended that the Safety Edge_{SM} device be automated rather than operated by manually turning the screw.
- One major issue that was observed during the paving operation was that the bottom part of the Safety Edge_{SM} device or shoe would periodically get caught on the coarse aggregate of the HMA base mix used to widen the roadway. This caused a sudden jerk in the screed when the coarse aggregate-broke loose or the Safety Edge_{SM} device/screed rose above the aggregate. The screed operator forced the Safety

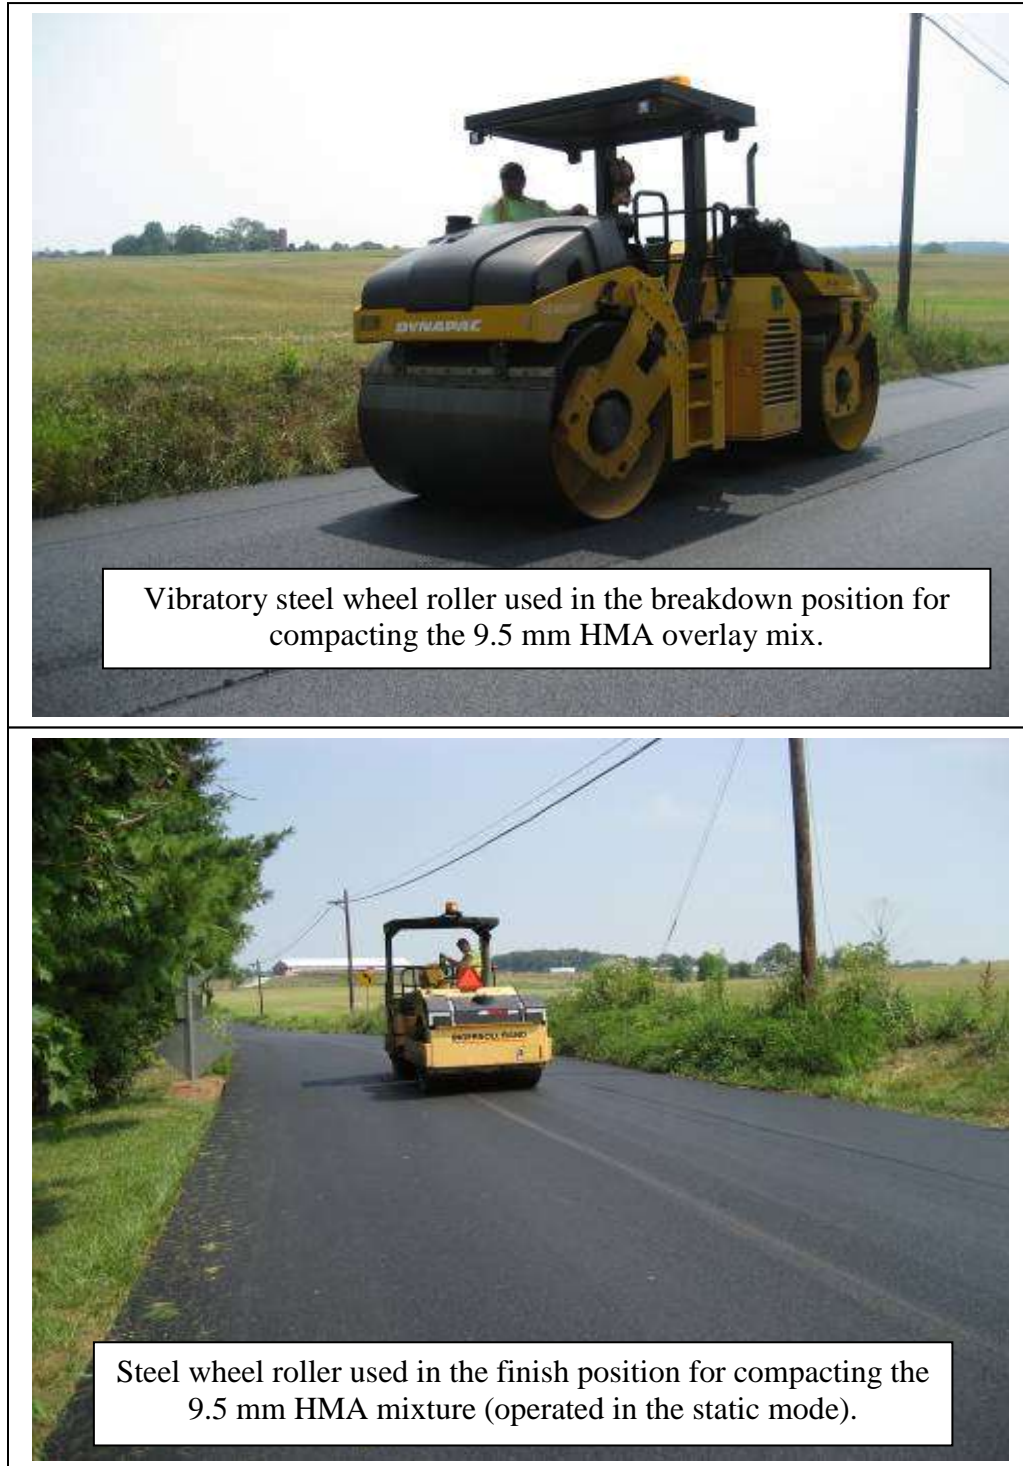
Figure 21. Two steel wheel rollers used to compact the 9.5 mm HMA mix.

Figure 21 shows the two rollers that were used to compact the HMA 9.5 mm mixture. The breakdown roller was a Dynapac CC422VHF and the finish roller was an Ingersoll-Rand DD90.
