Hillsborough Street (NC-54) Horne Street to Gorman/Faircloth Street

**Pedestrian Road Safety Assessment
Raleigh, North Carolina
April 21 – 22, 2009**

**Dan Nabors and Frank Gross
Vanasse Hangen Brustlin (VHB), Inc**

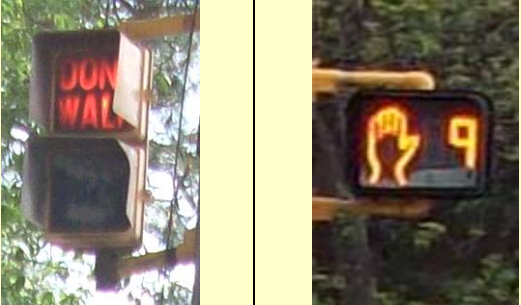
<p>5. Issues with Traffic Control Devices</p>		
<p>Lack of guidance for pedestrians crossing side streets—pedestrian signals are provided at signalized intersections to cross Hillsborough St., but not for the side street crossings. Pedestrians crossing the side street would typically use the traffic signal as an indication, but the traffic signals are mounted on span wires, which make it difficult for pedestrians to see the signal indication.</p>	<p><i>Long-term</i> – Install pedestrian signals on side streets at signalized intersections.</p> <p>Install post-mounted LED traffic signals as part of Hillsborough Redesign Project.</p>	
<p>Inconsistent use of pedestrian signals—pedestrian signals are provided at signalized intersections for those crosswalks across Hillsborough St., but not all are countdown heads.</p>	<p><i>Intermediate</i> – Upgrade to countdown signals when pedestrian signals are replaced during future stages of the Hillsborough Redesign Project.</p>

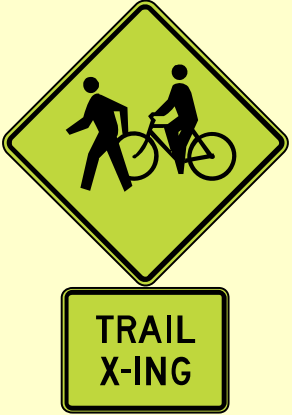
<p>Example of trail crossing sign to alert drivers to the presence of pedestrians and bicyclists.</p>

<p>pedestrians and bicyclists.</p> <ul style="list-style-type: none"> - Install trail crossing warning signs (see photo, top right) for northbound and southbound drivers at the crosswalk on the north approach. For the southbound approach, an additional sign should be installed at the north end of the median island for those bicyclists traveling from Clark St toward to the trail. - Consider restriping the right-turn lane along Faircloth St (at Clark St) as a bicycle lane to provide access from the crosswalk to the designated bike route on Clark St. This will likely help to keep bicyclists from riding on the sidewalk along Faircloth St. This option should only be considered if right-turn volumes do not warrant the right-turn lane. <p><i>Intermediate</i> – Consider widening the median and providing a cut-through for bicyclists. The median should be wide enough to provide refuge for a bicyclist. If this option is implemented, the trail crossing signs should be moved to the location of the median cut-through. This option would provide a direct path across Faircloth St. from Clark St. to the trail. If this option is pursued, consider adding an extension to the trail from the existing trail to Faircloth St., aligning with the median cut-through to Clark St.</p>

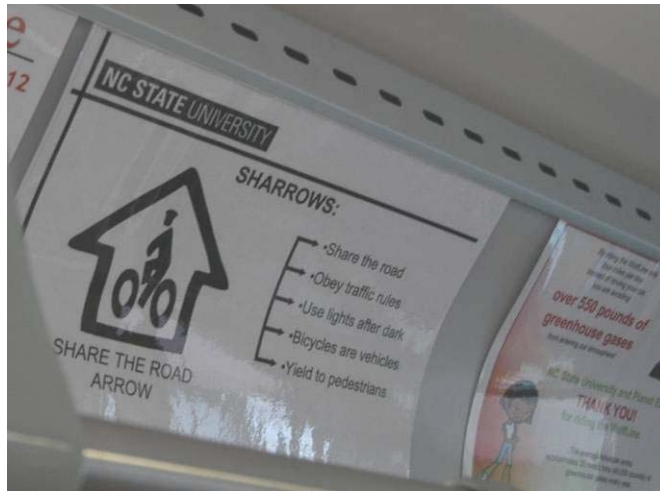
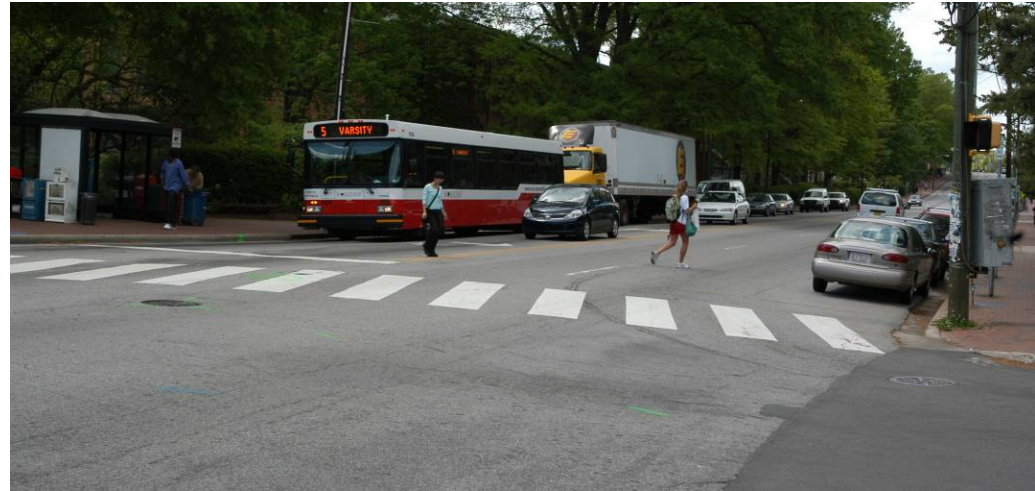
There is also an opportunity to educate the bus drivers. The RSA team observed several buses blocking crosswalks along Hillsborough St when stopping at far side bus stops. The drivers should pull forward so as not to block the crosswalks.

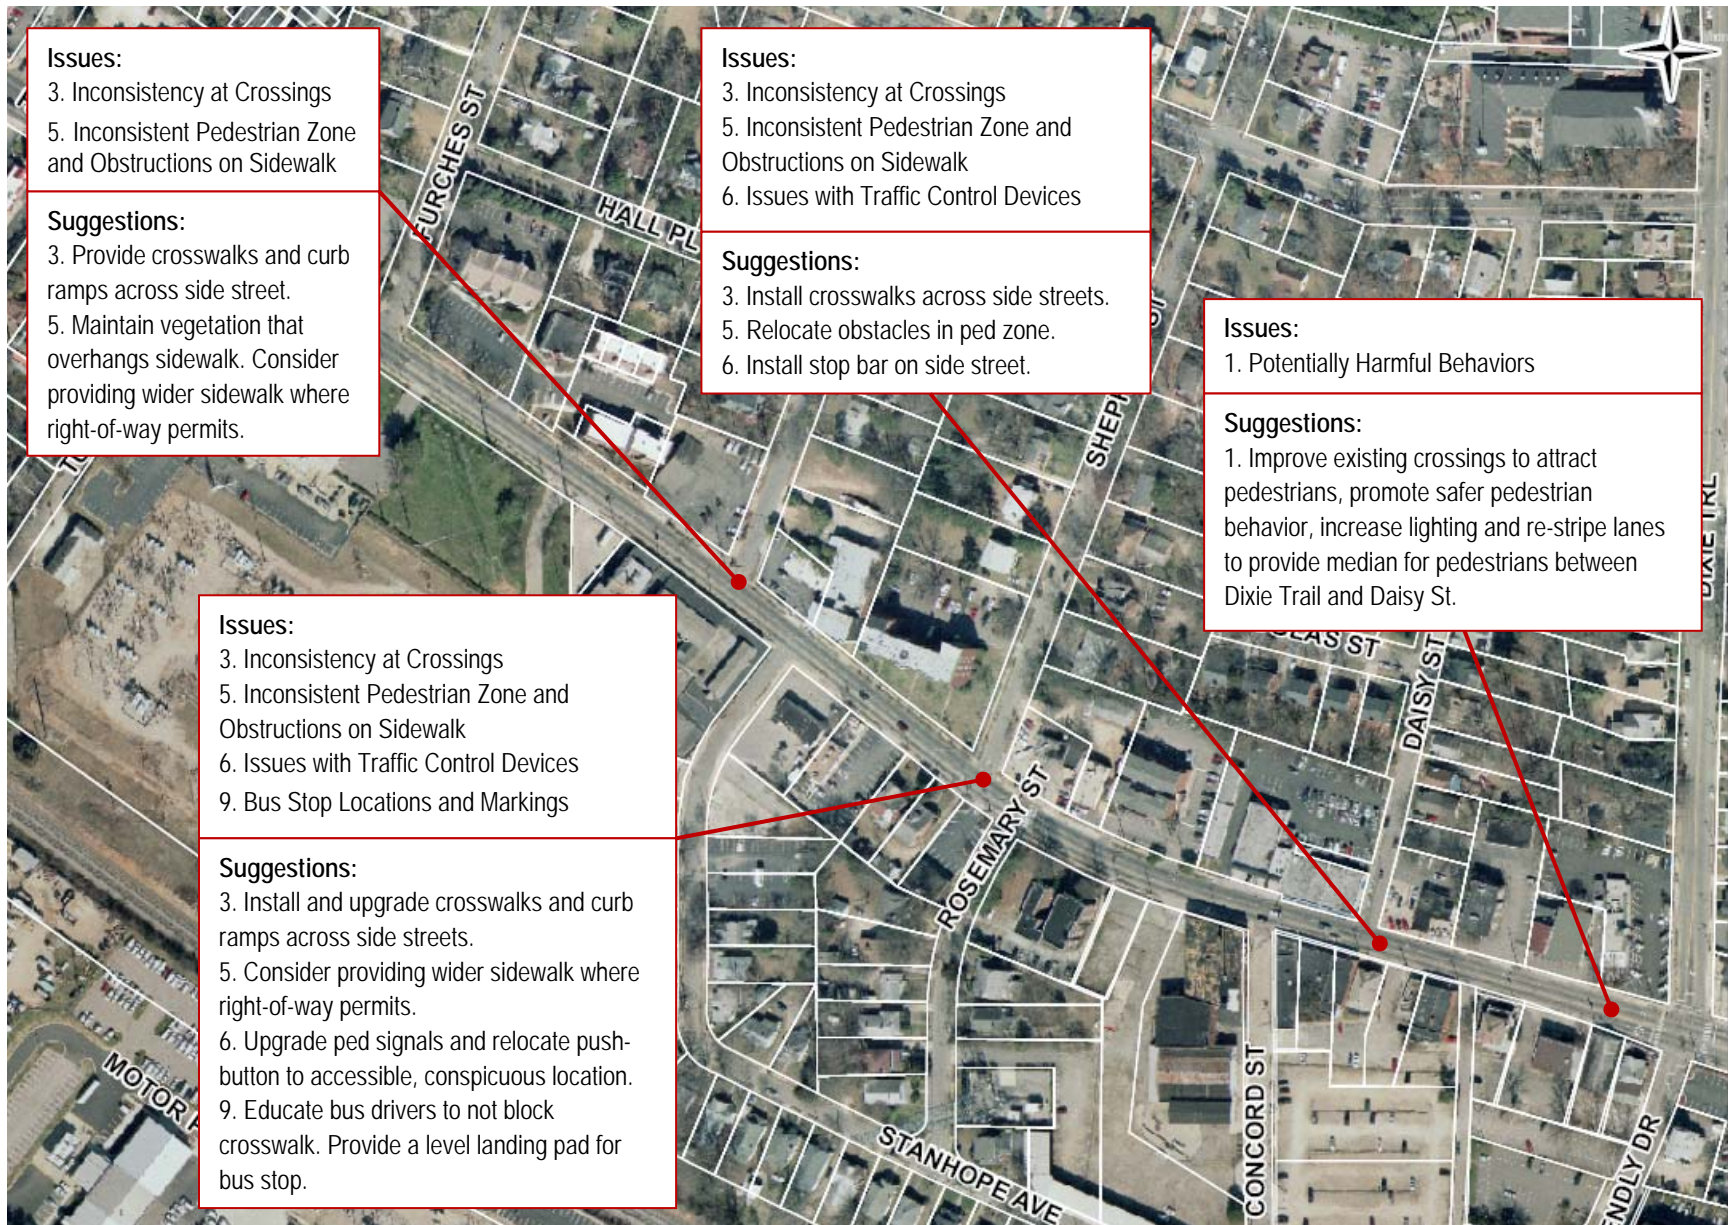
Issues:

- 3. Inconsistency at Crossings
- 5. Inconsistent Pedestrian Zone and Obstructions on Sidewalk

Suggestions:

- 3. Install and upgrade crosswalks and curb ramps across side streets.
- 5. Consider providing wider sidewalk where right-of-way permits.
- 6. Upgrade ped signals and relocate push-button to accessible, conspicuous location.
- 9. Educate bus drivers to not block crosswalk. Provide a level landing pad for bus stop.

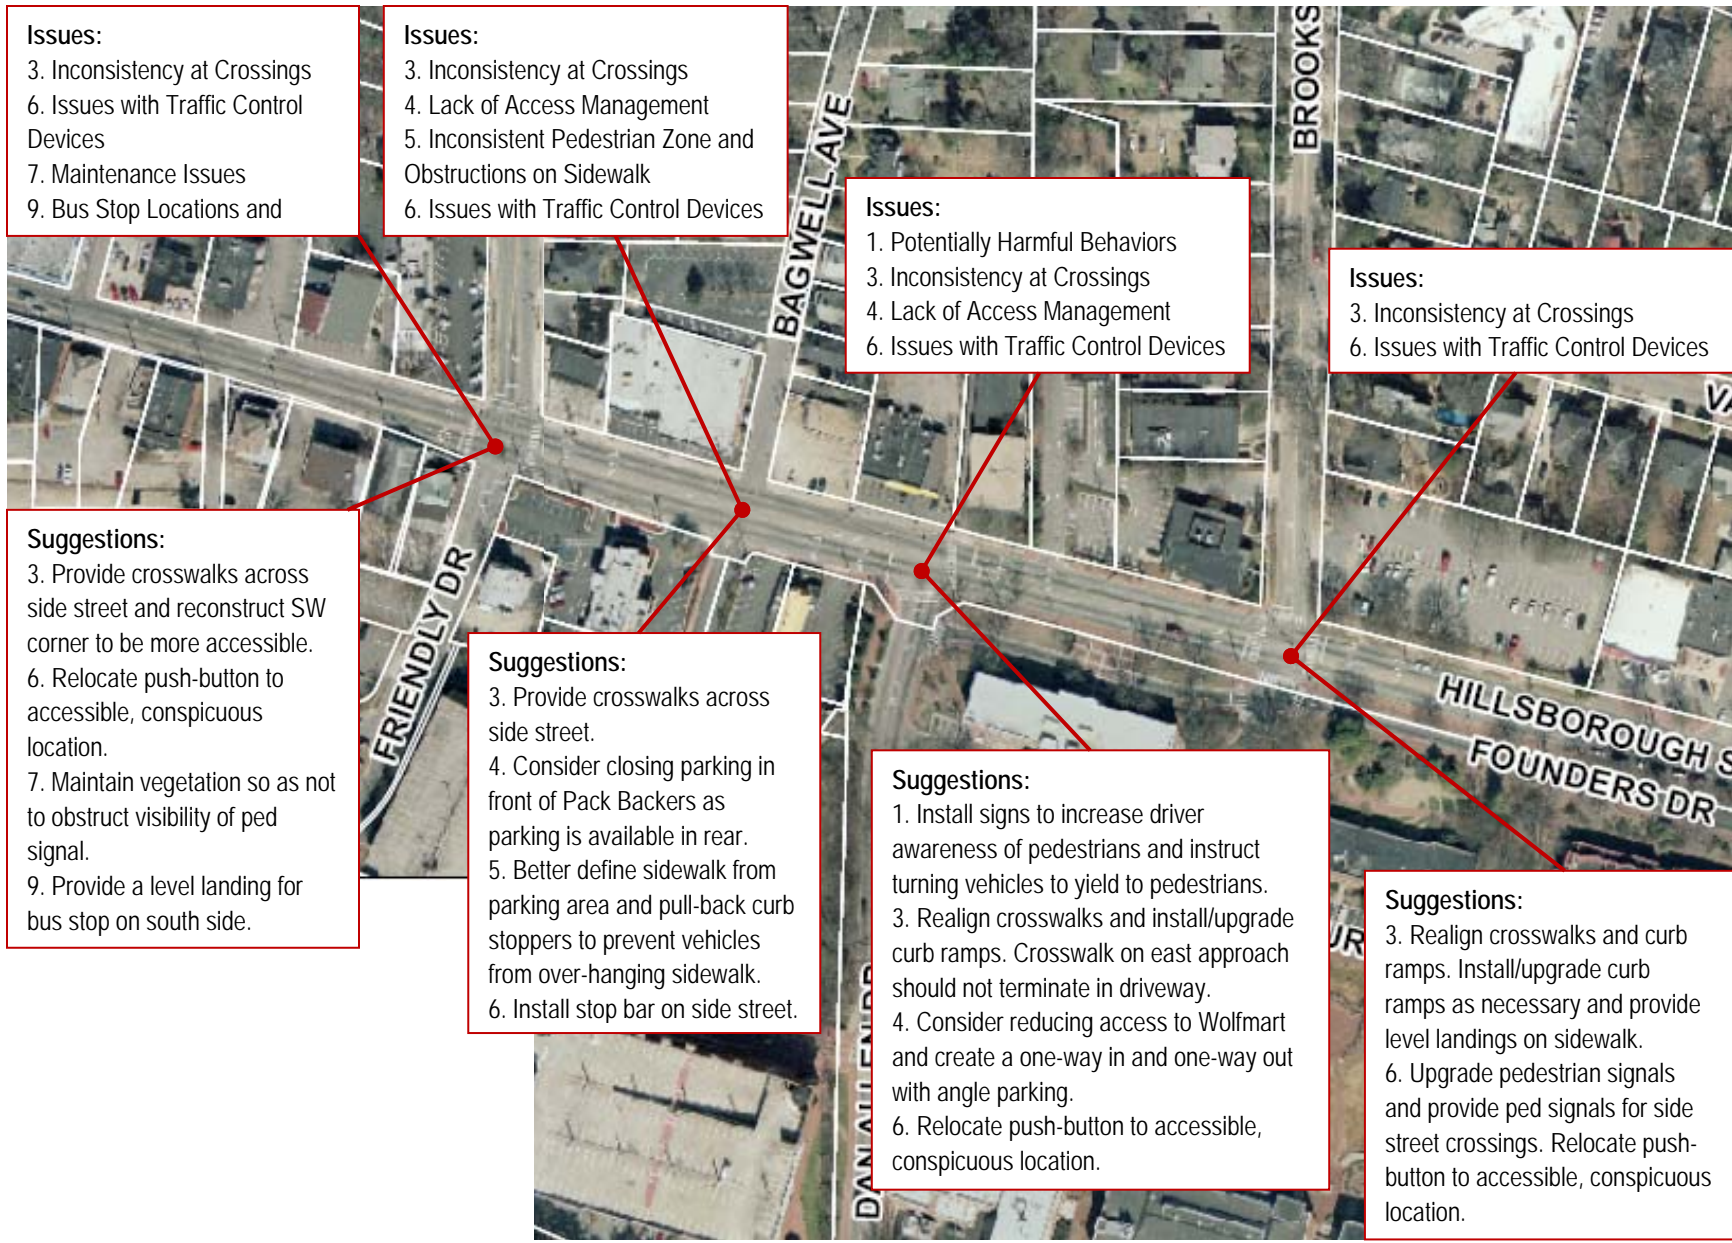
Issues:

- 3. Inconsistency at Crossings
- 6. Issues with Traffic Control Devices
- 7. Maintenance Issues
- 9. Bus Stop Locations and

Suggestions:

- 3. Realign crosswalks and curb ramps. Install/upgrade curb ramps as necessary and provide level landings on sidewalk.
- 6. Upgrade pedestrian signals and provide ped signals for side street crossings. Relocate push-button to accessible, conspicuous location.

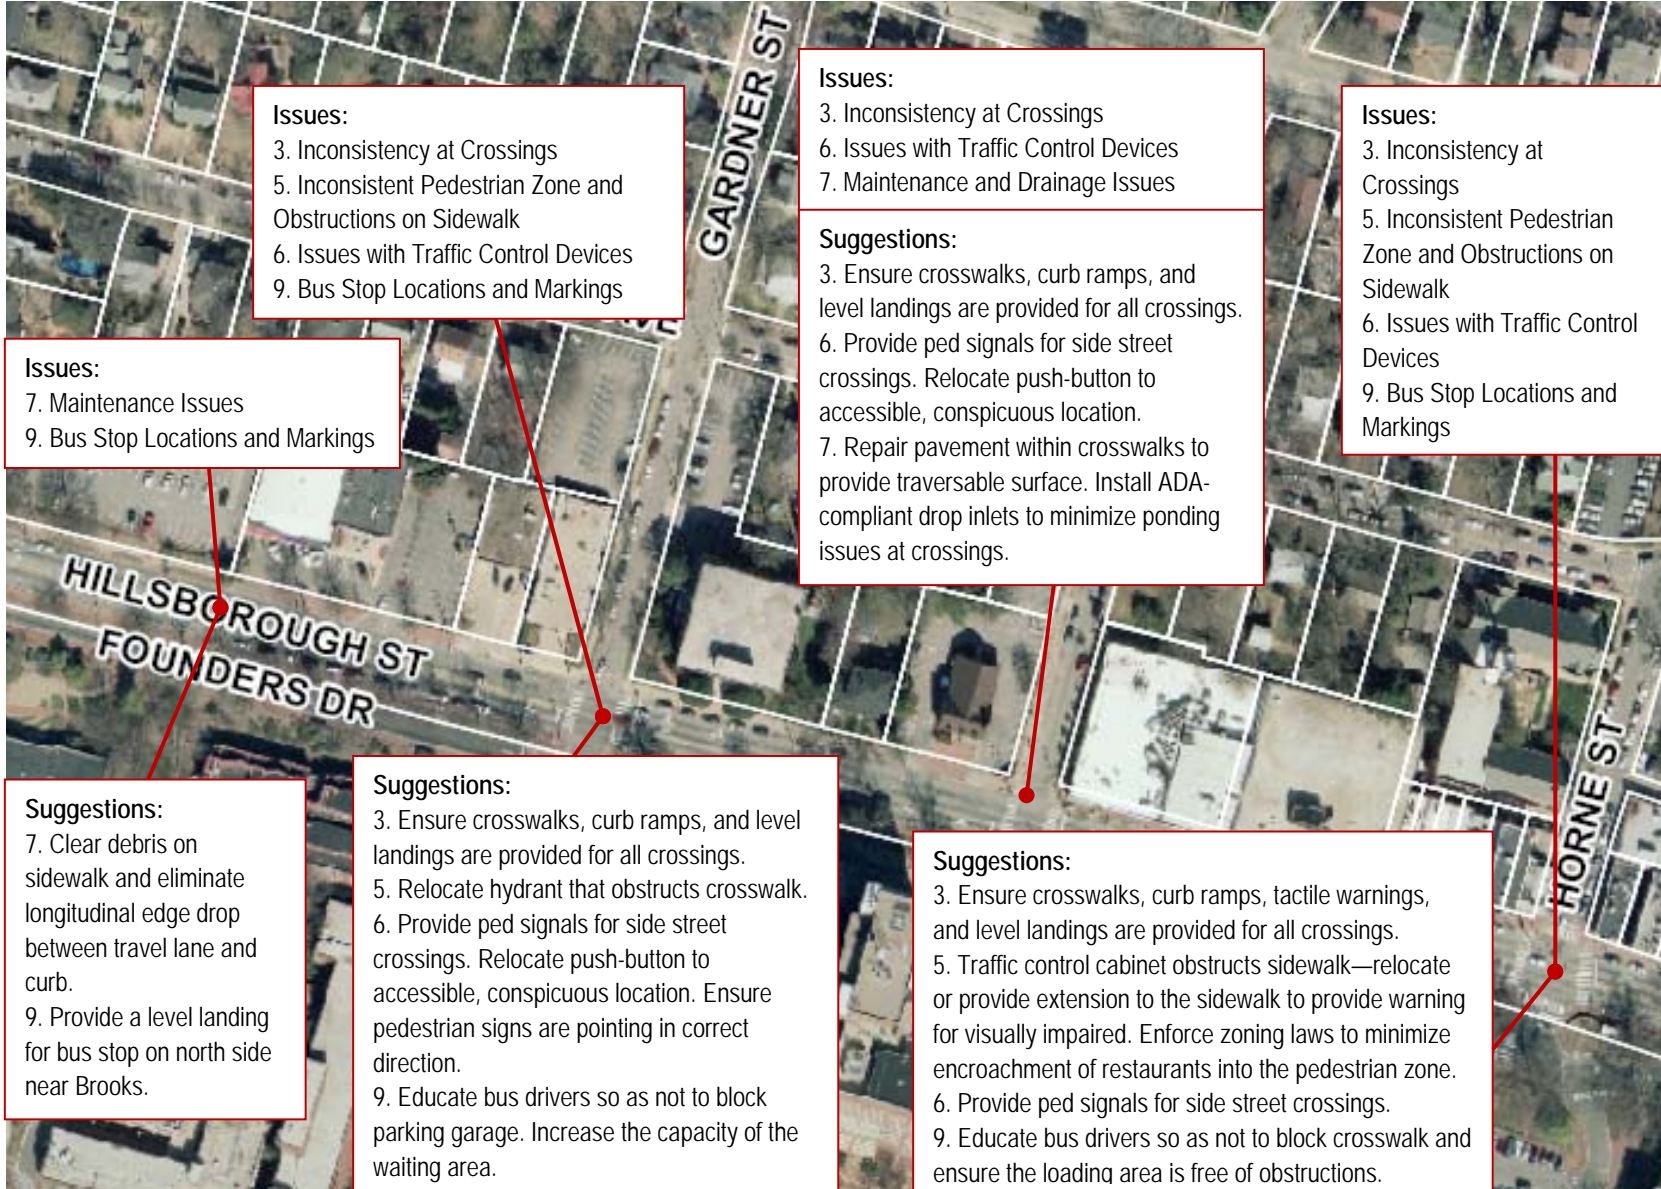
Issues:

- 3. Inconsistency at Crossings
- 5. Inconsistent Pedestrian Zone and Obstructions on Sidewalk
- 6. Issues with Traffic Control Devices
- 9. Bus Stop Locations and Markings

- 3. Ensure crosswalks, curb ramps, and level landings are provided for all crossings.
- 6. Provide ped signals for side street crossings. Relocate push-button to accessible, conspicuous location.
- 7. Repair pavement within crosswalks to provide traversable surface. Install ADA-compliant drop inlets to minimize ponding issues at crossings.
