BRIDGE INSPECTION REPORT

INSPECTION TYPE: ROUTINE

SUN RIVER BRIDGE

STRUCTURE NO. MTA-SR-001

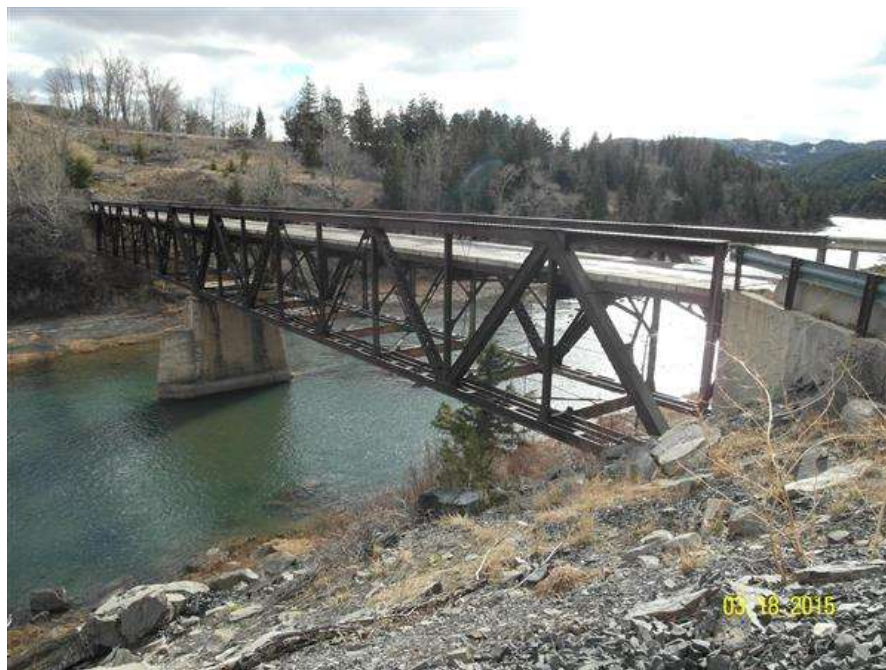
PHOTO #1 MTA-SR-001, SUN RIVER BRIDGE, PHOTO BY GARY GRASSEL. VIEW LOOKING AT THE UPSTREAM SIDE OF THE BRIDGE. (03/18/2015)

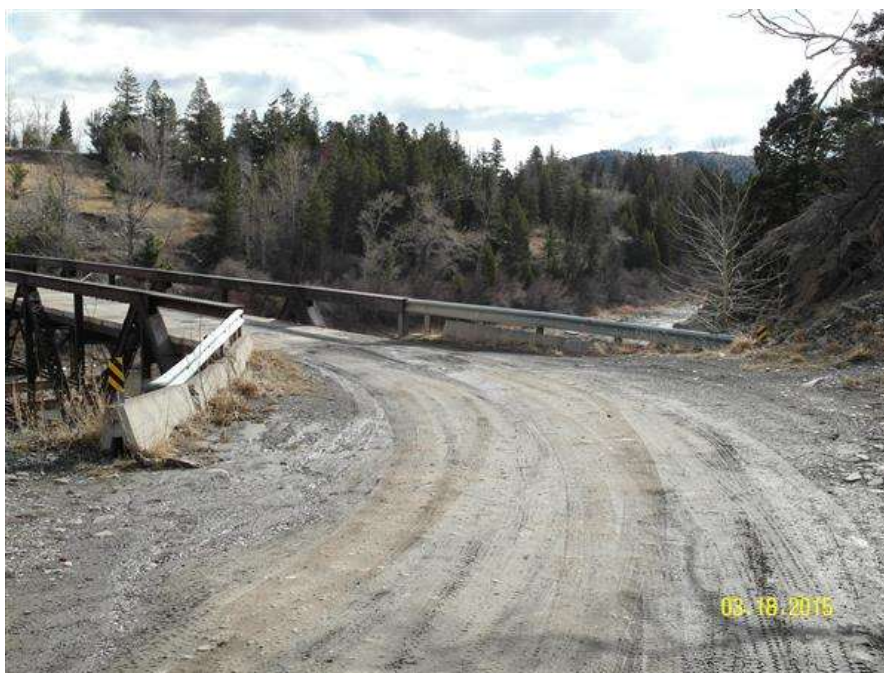
PHOTO #6 MTA-SR-001, SUN RIVER BRIDGE, PHOTO BY GARY GRASSEL. THIS IS A VIEW OF THE RIGHT APPROACH TO THE BRIDGE. (03/18/2015)

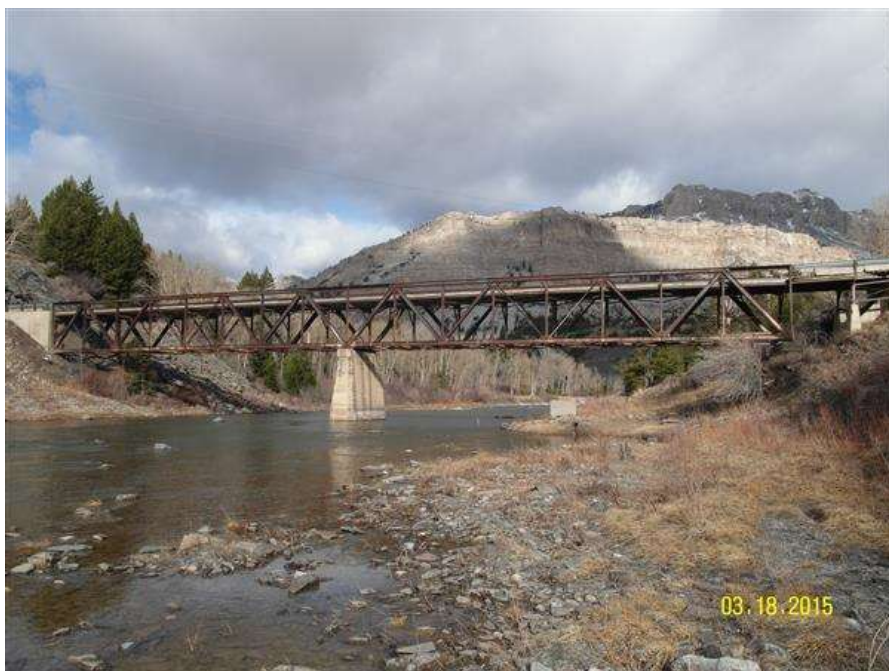
PHOTO #14 MTA-SR-001, SUN RIVER BRIDGE, PHOTO BY GARY GRASSEL. THIS IS A VIEW LOOKING AT THE DOWNSTREAM SIDE OF THE BRIDGE. (03/18/2015)

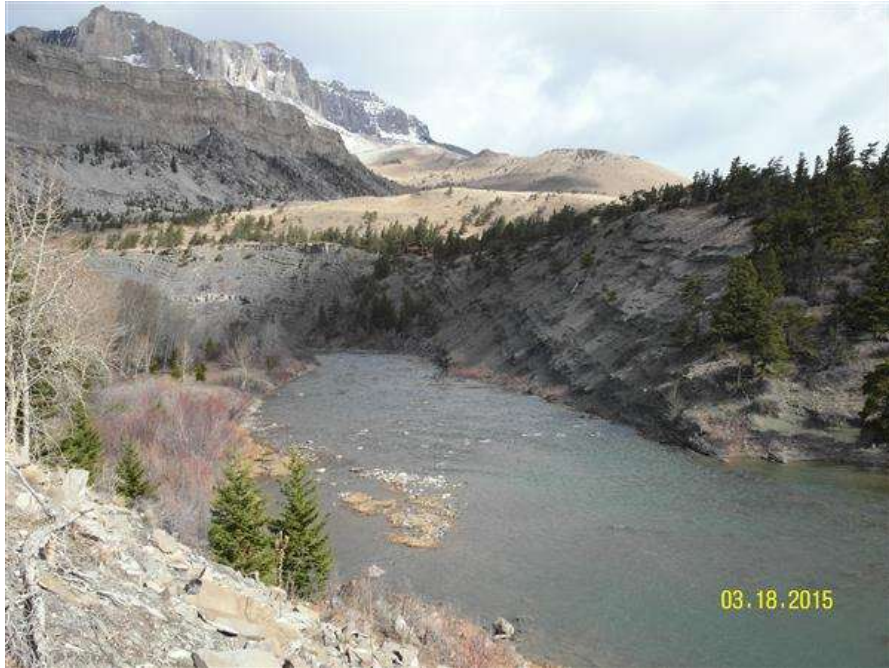
PHOTO #15 MTA-SR-001, SUN RIVER BRIDGE, PHOTO BY GARY GRASSEL. THIS IS A VIEW FROM THE BRIDGE DECK
LOOKING UPSTREAM. (03/18/2015)
