Performance of Transportation Infrastructure During Kumamoto Earthquakes of April 14 and 16, 2016— A Reconnaissance Report

PUBLICATION NO. FHWA-HRT-22-110

MARCH 2023

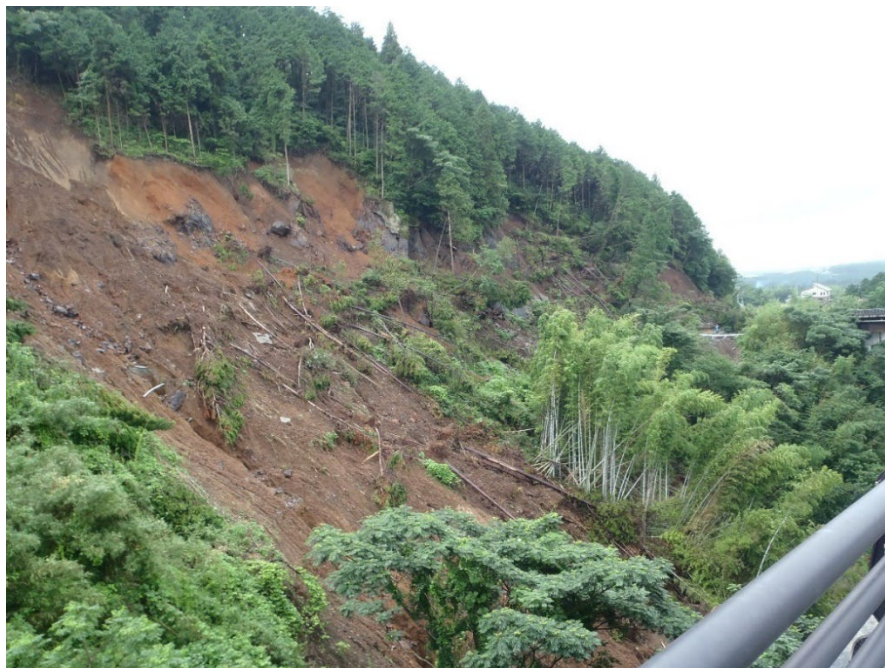
Figure 17. Photo. Slope on the south side of the bridge after the earthquake.

The surrounding area sustained a significant number of slope failures, which damaged a number of retaining walls. A landslide occurred at the location of the bridge, which totally destroyed the adjacent old road (figure 14, figure 16, and figure 17). Only a few retaining walls survived, as shown in figure 18.

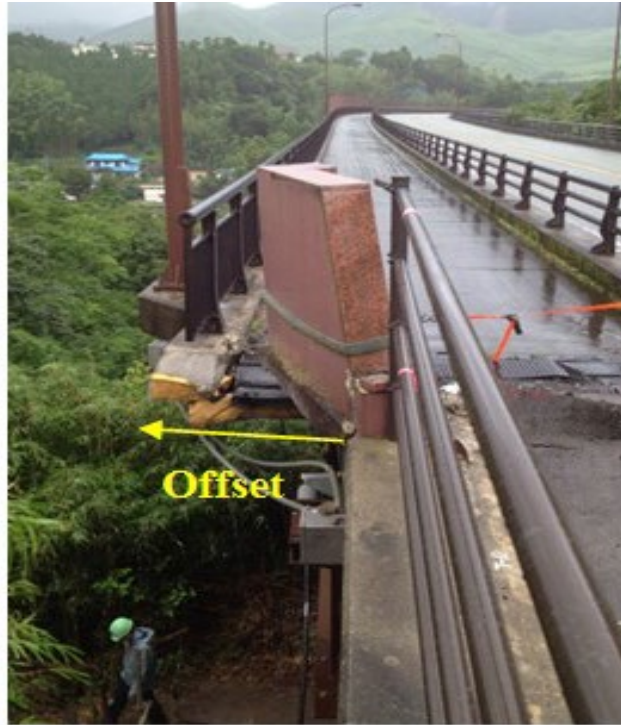
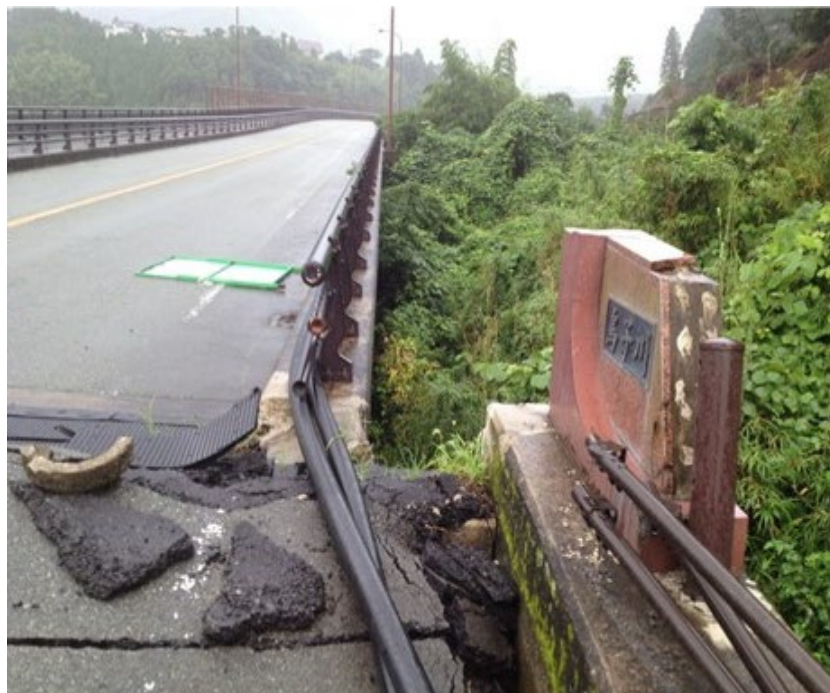
Figure 19. Photos. Offset of the superstructure at abutment A1.

In addition to the damage in the surrounding area, the earthquake had significant effects on the bridge superstructure and substructure. As shown in figure 19 and figure 20, the superstructure had a large offset toward the north at both abutments, which was approximately 40 inches (1.0 m). This offset was accompanied by extensive failure of the elastomeric bearings. At abutment A1, the bearings below all five girders were ruptured close to either the top plate or the bottom, as shown in figure 21. At the same abutment, some of the longitudinal restrainers failed due to excessive movements of the superstructure (figure 22) from south to north, or due to the combination of lateral and longitudinal displacements that characterize the complex response of a curved bridge. The complexity of the curved bridge response is expected to have been increased by the fact that abutment A2 is skewed. Abrasion on the back wall indicates that pounding of the superstructure on the abutment occurred during shaking (figure 23), which may have led to buckling in the web stiffener under a partial height diaphragm at this abutment (figure 24).

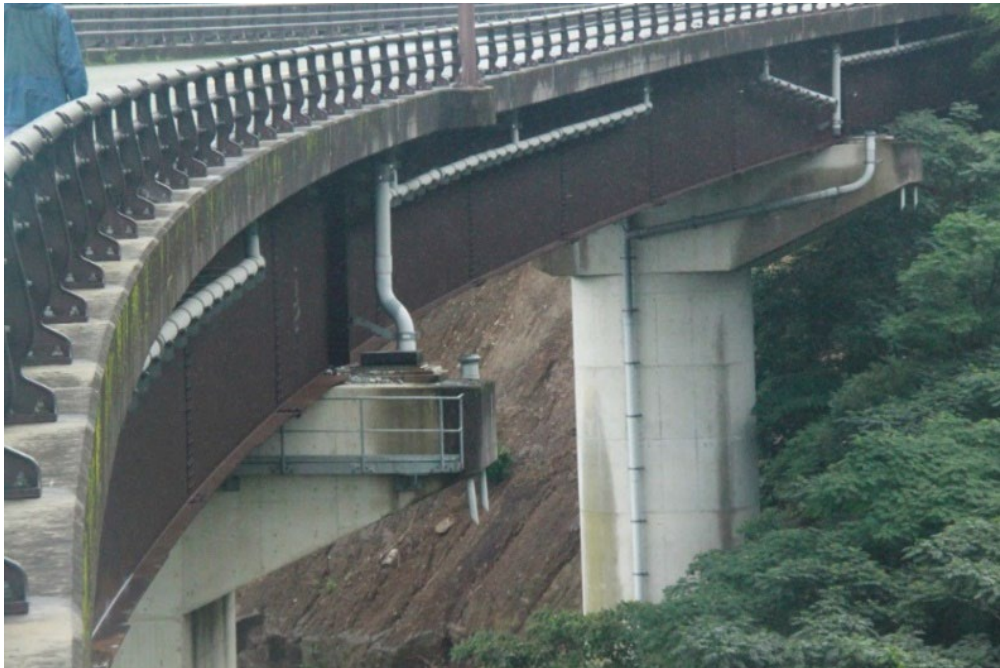
Figure 25. Photo. Offset of superstructure at piers P3 and P4.

Apart from the offset of the superstructure at the abutments, significant offsets were also observed at interior piers (figure 25). These offsets were associated with the failure of the connections of the deck to the piers. However, as shown in figure 26 and figure 27, the elastomeric bearings at these locations did not rupture as did those at abutment A1 but, instead, the bolts connecting the top plates to the bearings failed. Pier P2 also had cracking close to the base of the column just above the foundation, indicating the existence of large moments during the shaking (figure 28).

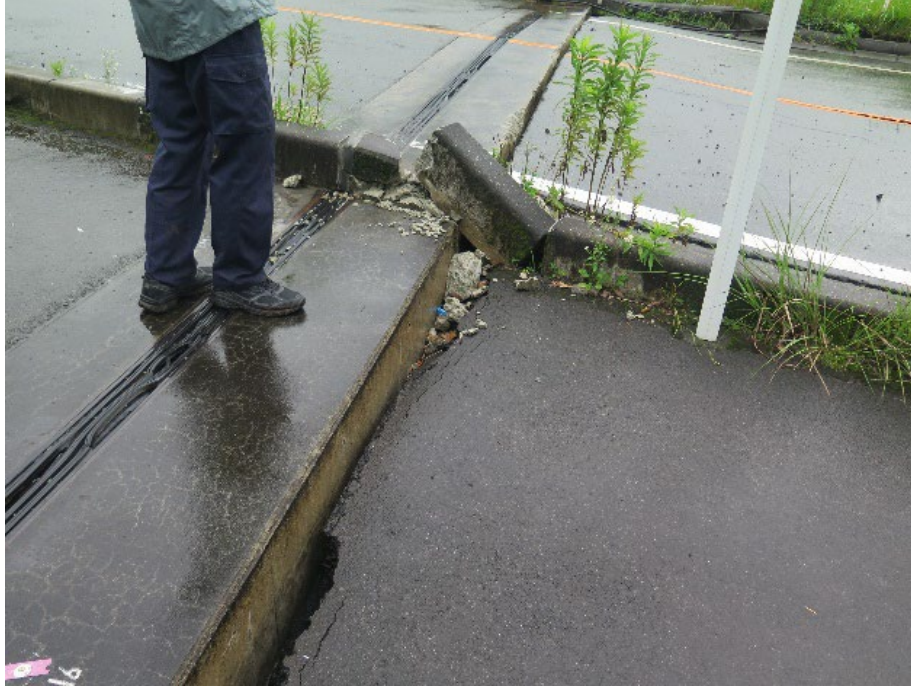
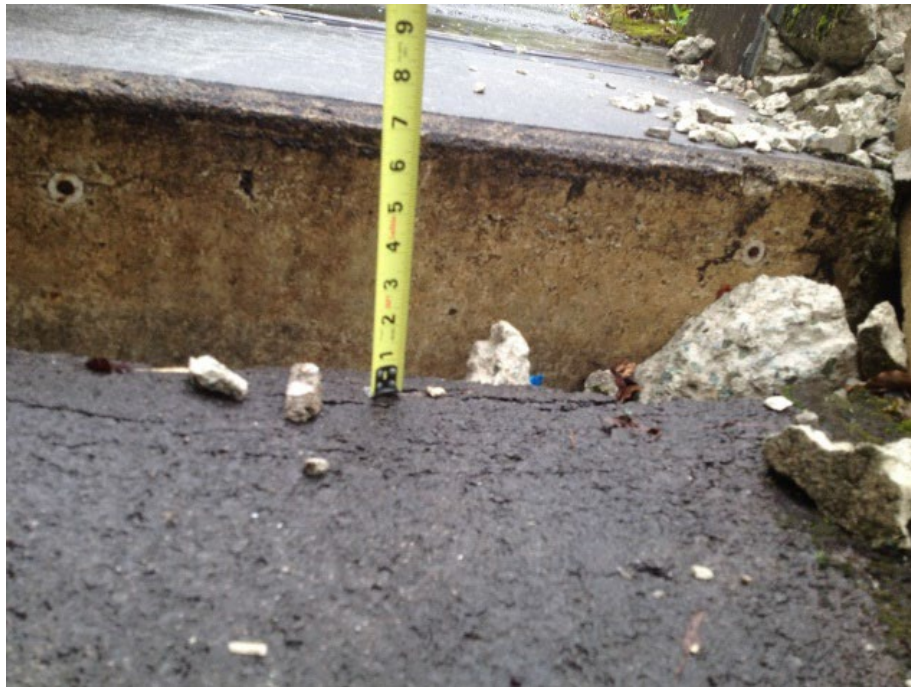
The Ookirihata Dam bridge is a single-span bridge constructed in 1998 with a span of 114.8 ft (35 m). It is a prestressed concrete T-girder bridge on a deep pile foundation with pile diameter of 8.2 ft (2.5 m) and length of 44.3 ft (13.5 m) (figure 32 and figure 33). The ground around the bridge experienced substantial movement, which led to permanent bridge displacement (figure 34 and figure 35).

B. Measurement of the settlement.

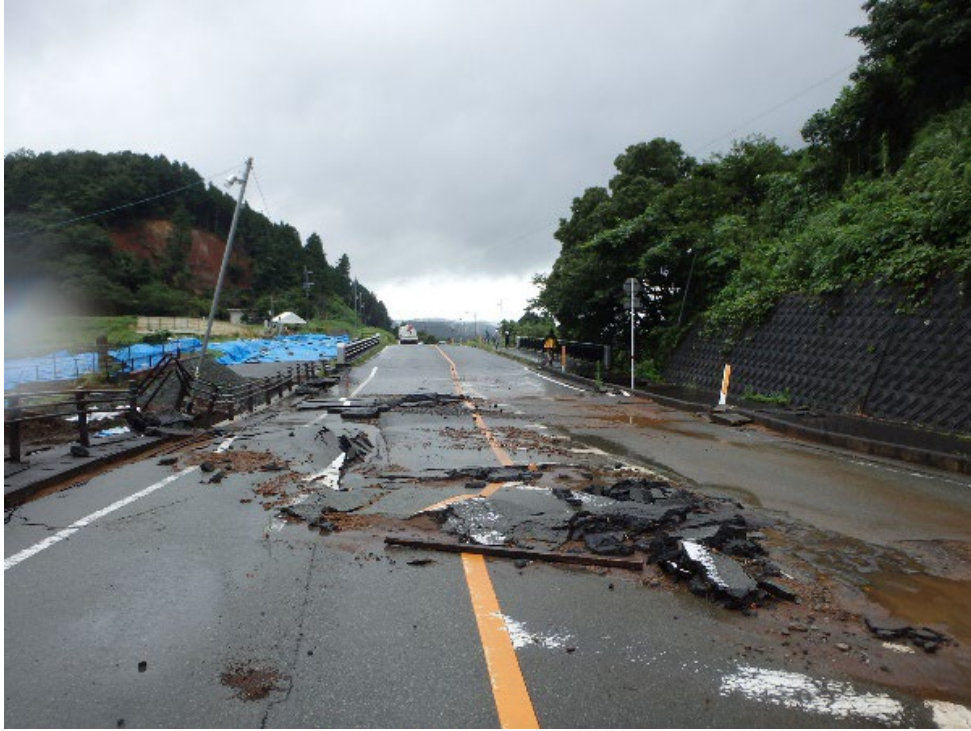
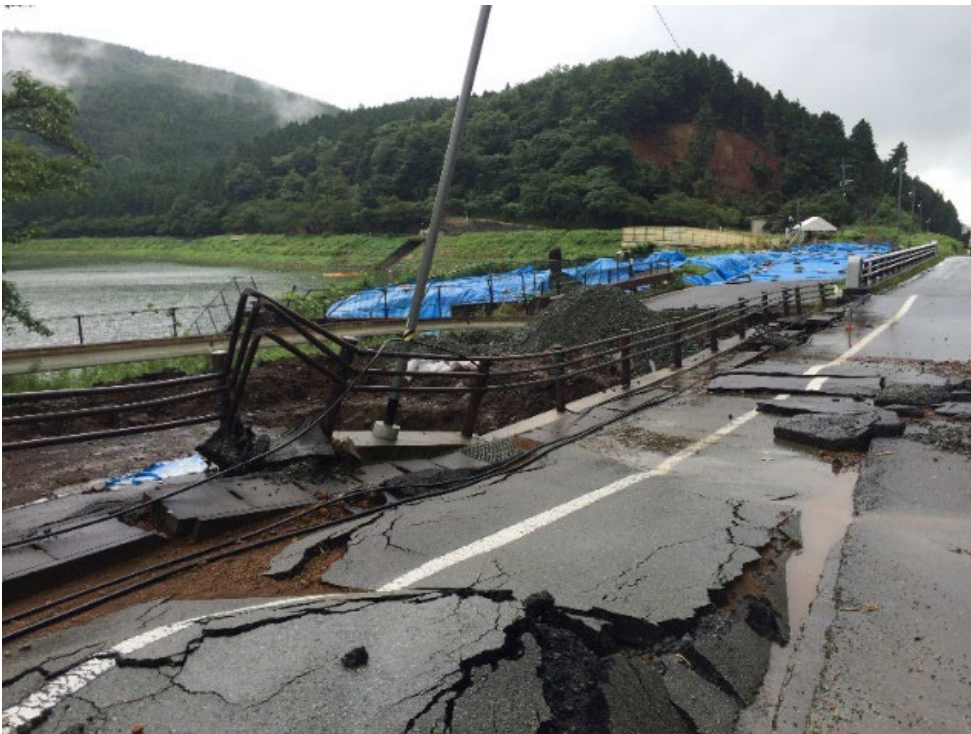
Figure 34. Photos. Approach fill movement at the abutment.

A. Overview.

B. Deformed railing indicating the amount of ground deformation.

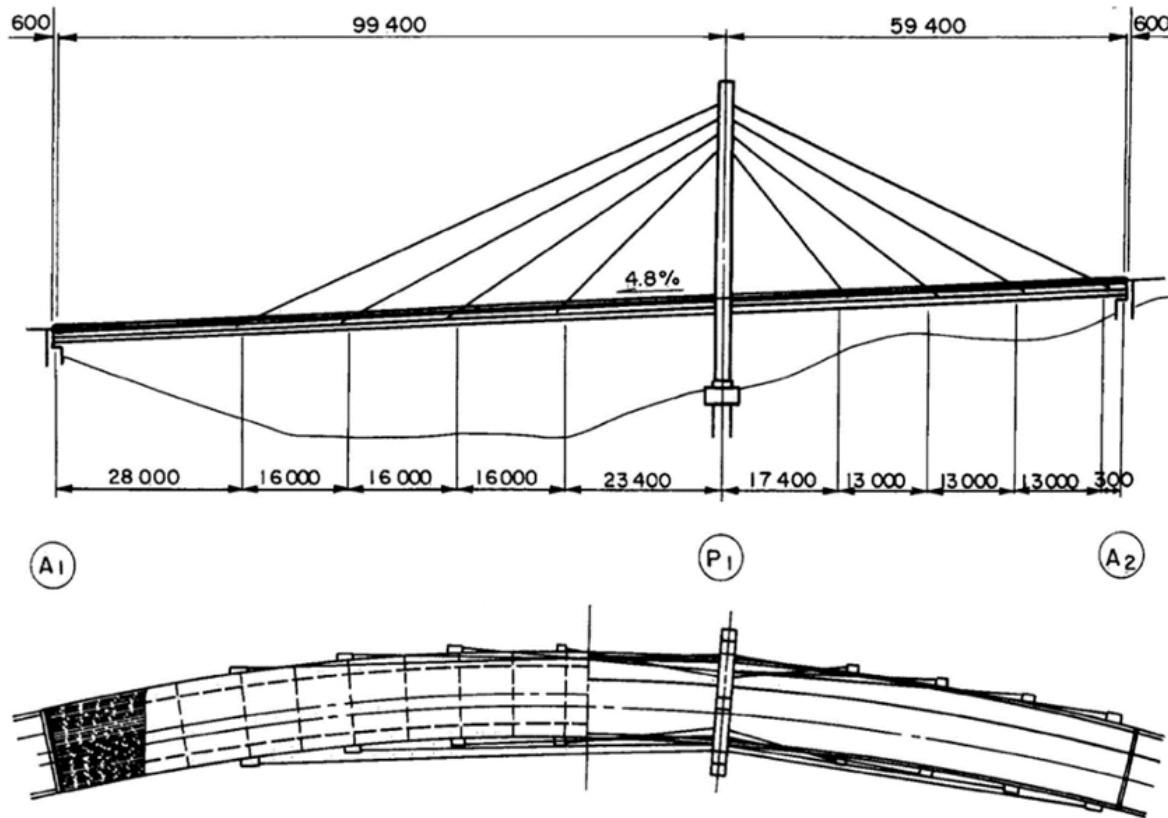
Figure 36. Drawing. Elevation and plan of Kuwazuru Oh-hashii bridge.⁵

The Kuwazuru Oh-hashii bridge was designed in 1994 and constructed in 1997 following the then-current JRA specifications (figure 36 and figure 37). It was retrofitted based on the specification revisions that occurred following the 1995 Great Hanshin earthquake (Kobe) earthquake. The bridge is oriented south to north, with abutment A1 south and A2 north. It is a cable-stayed bridge with a single central pier consisting of two steel towers that form an “X” in the plane perpendicular to the bridge. The two spans of the bridge are unequal in length. The long span off abutment A1 is 325 ft (99 m), and the short span off abutment A2 is 194 ft (59 m). The short span is 60 percent of the longer span’s length. The total structure length is 525 ft (160 m). The superstructure deck has two main steel tub-shaped girders, for the full length, connected by transverse diaphragms. The deck has a 4.8 percent grade, resulting in abutment A2 being 25.3 ft (7.7 m) higher in elevation than abutment A1. The deck has two undivided traffic lanes, one for each direction, with modest shoulders and a multiuse path on one side.

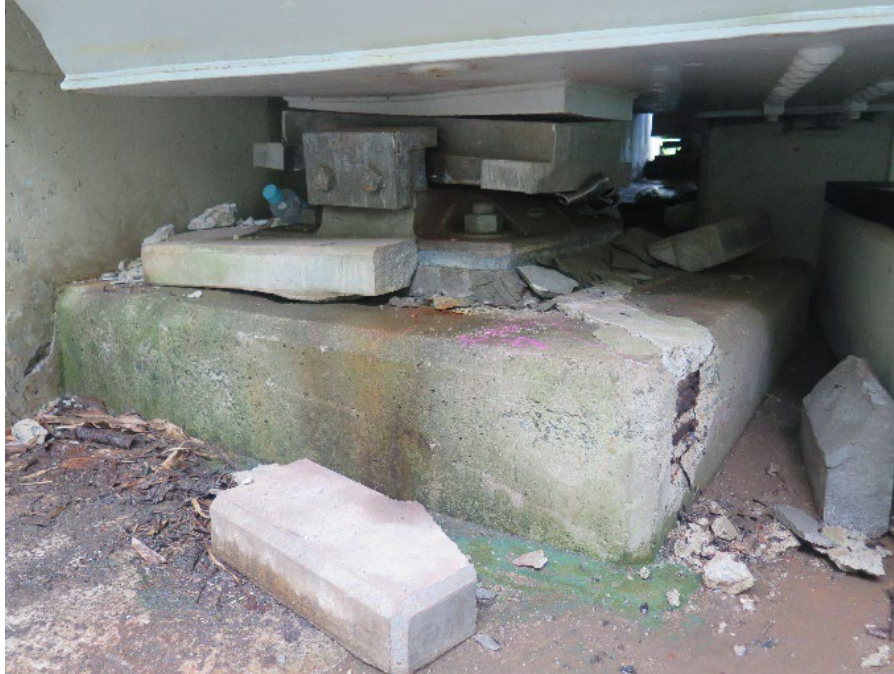
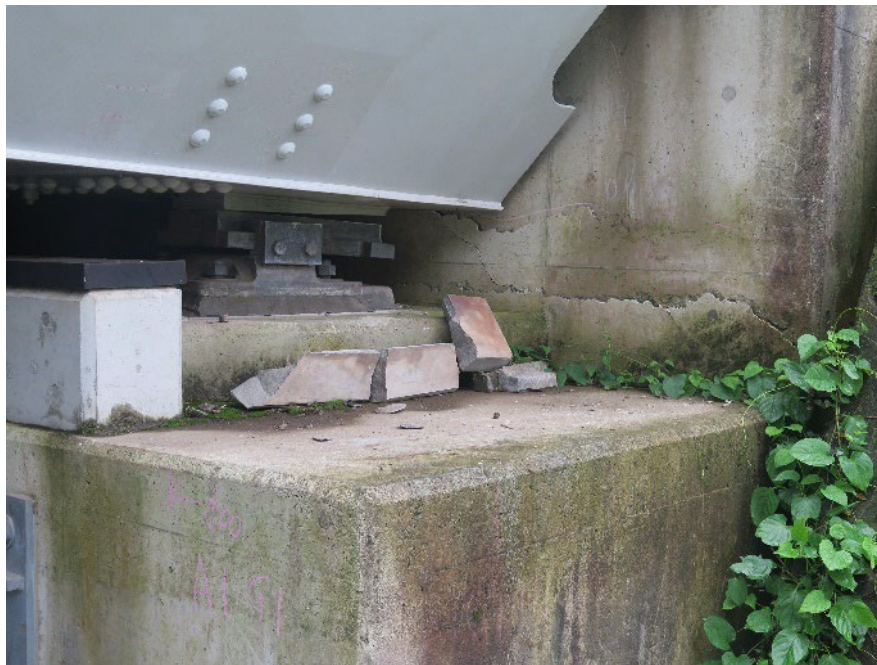
Figure 38. Photos. Damage to steel bearings at abutment A1.

There was substantial damage at the abutments. The damage observed at abutment A1 was mainly to the steel bearings and unseating prevention devices (figure 38 and figure 39). The expansion joint at this abutment showed little displacement (figure 40). Abutment A2, which supports the short north span, experienced more damage than abutment A1. The short north span required vertical tension restrainers to maintain its position. These restrainers failed, allowing the superstructure to move upward and lift off the abutment seat. At the same time, the superstructure moved to the right when looking at abutment A2 under the structure. A large arcuate gouge was present in the abutment wall that was lower in elevation than the current girder position, suggesting the gouge occurred on restrainer failure. The steel girder also impacted the stop block and crushed it (figure 41).

A. East bearing.

B. West bearing.

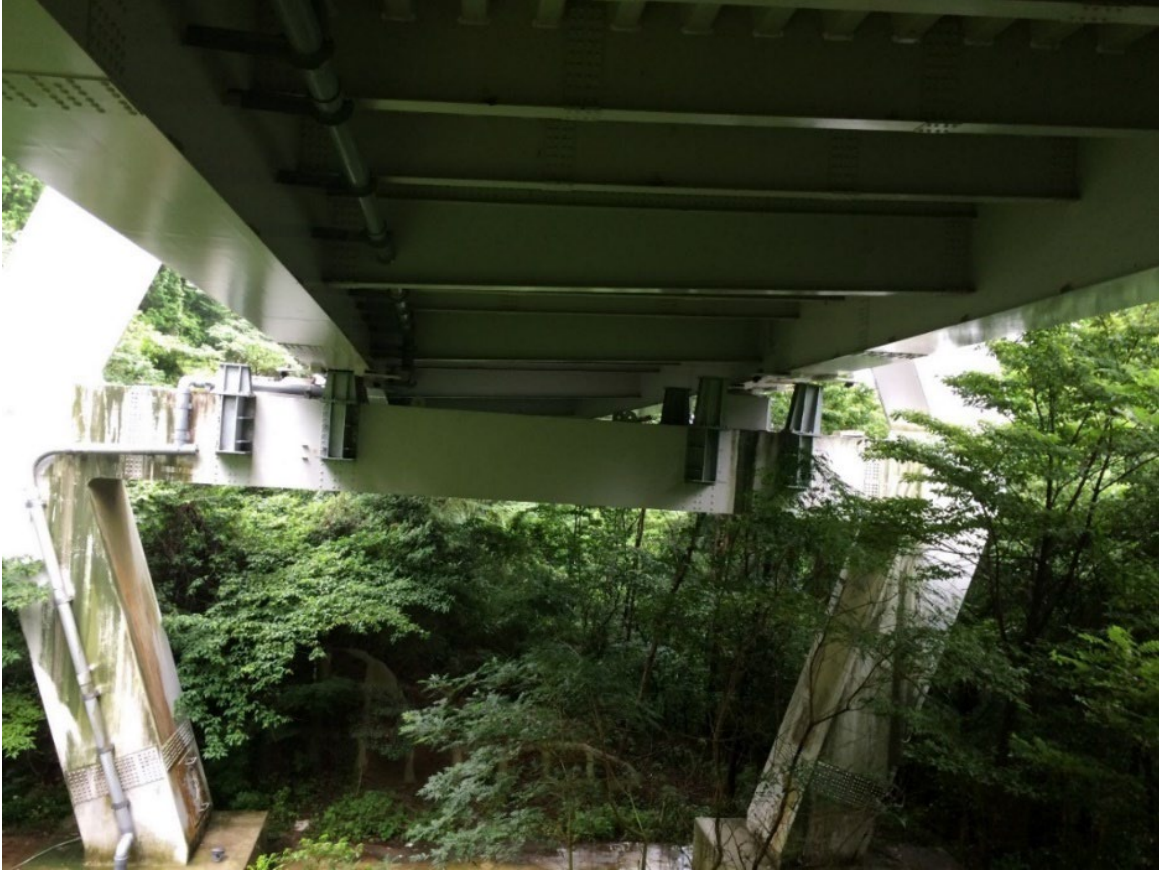
At the center pier, the bridge deck was displaced to the west by about 2 ft (0.6 m). Figure 42 shows the superstructure displaced to the west (right side of photo). On the east side of the bridge, the distance to the tower leg is 7.2 ft (2.2 m) at the railing elevation (figure 43). On the west side of the bridge, the distance to the tower leg is 9 inches (23 cm) at the railing elevation (figure 44). The deck was not centered between the tower legs before the earthquake, but the offset is now more severe. Figure 45 shows the damage and permanent displacement of the center pier.

Figure 42. Photo. Center pier of Kuwazuru Oh-hashii bridge.

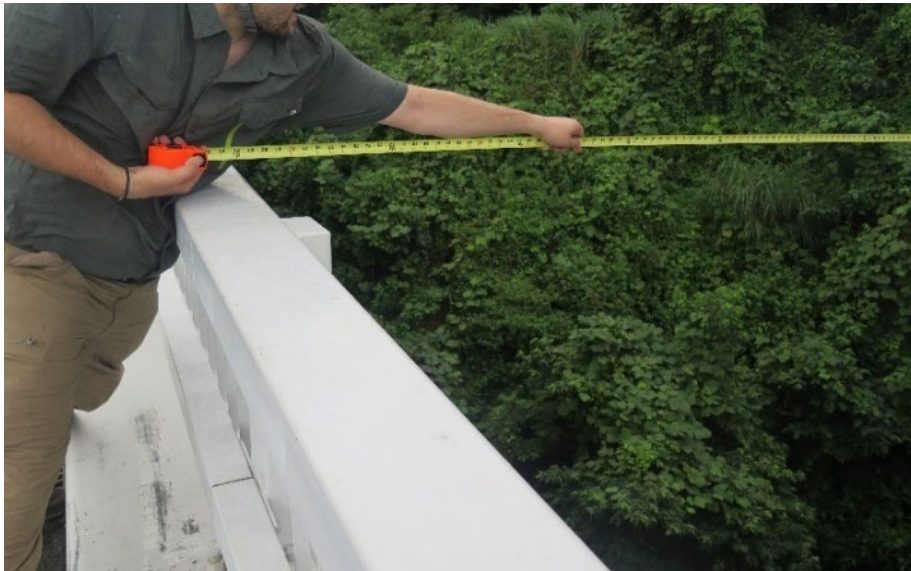
Figure 43. Photo. Distance from the bridge rail to the east tower leg.

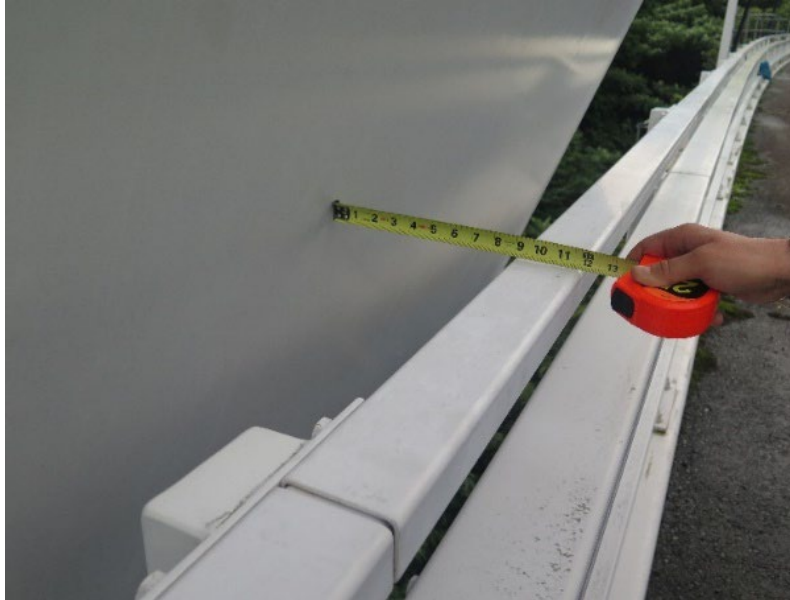
Figure 44. Photo. Distance from the bridge rail to the west tower leg.

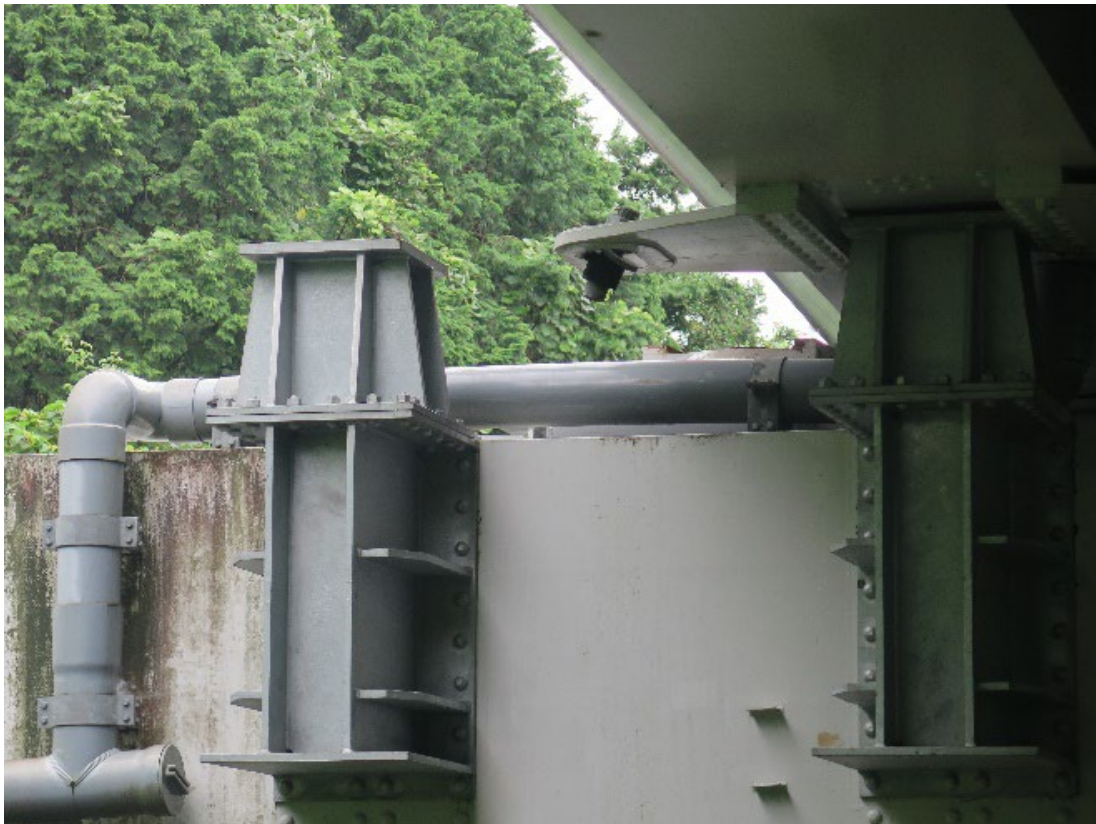
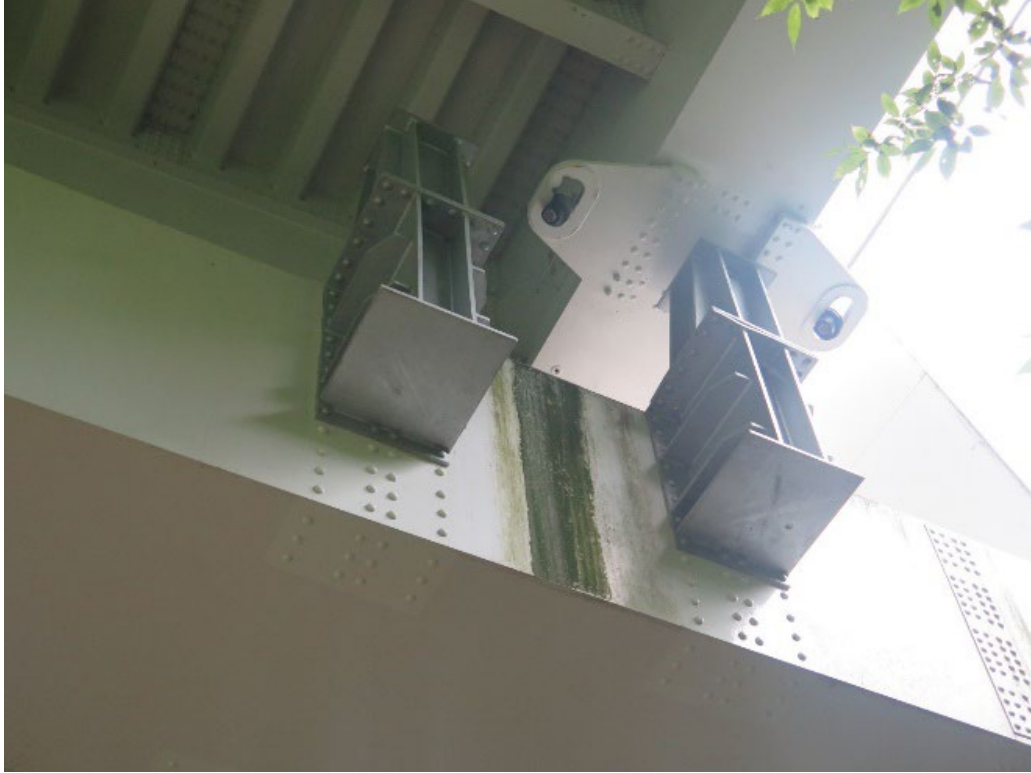
Figure 45. Photos. Damage to the east side and west side support blocks at the center pier.

A. East side.

B. West side.

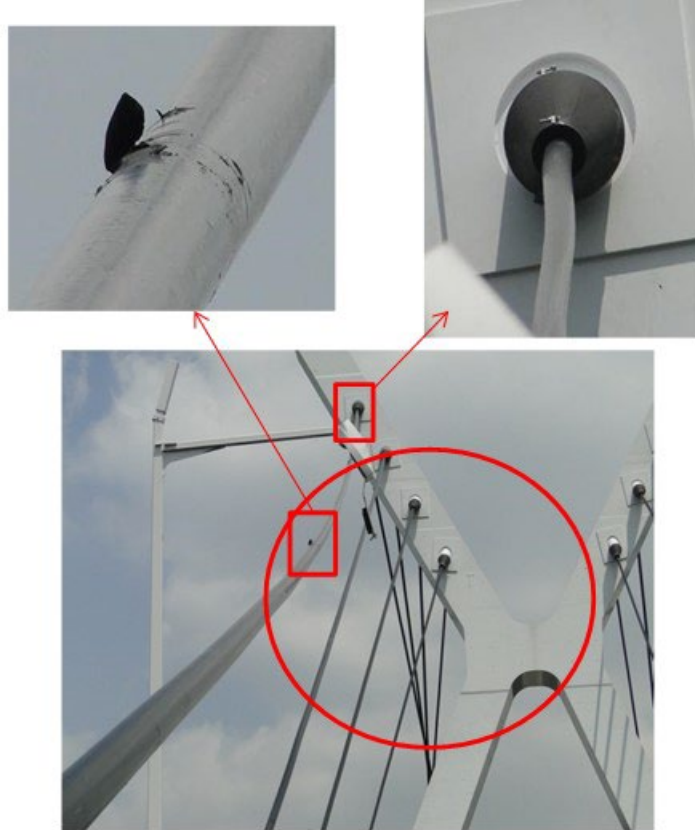
Damage to the cables also occurred (figure 46 and figure 47). On the west side of the long span, a gouge occurred in the high-density polyethylene sheathing on a cable where it appeared to have made contact with a luminaire. The current separation between the luminaire arm and cable appeared to be 3 ft (0.9 m). At least two cables failed, both on the west side of the bridge, one in each span. The failure does not appear to be a complete rupture of the cable and is likely associated with movement of the wedges and anchor plate. This opinion is based on the observed extension in the corrosion protection shielding.

Figure 46. Photo. Cable damage.

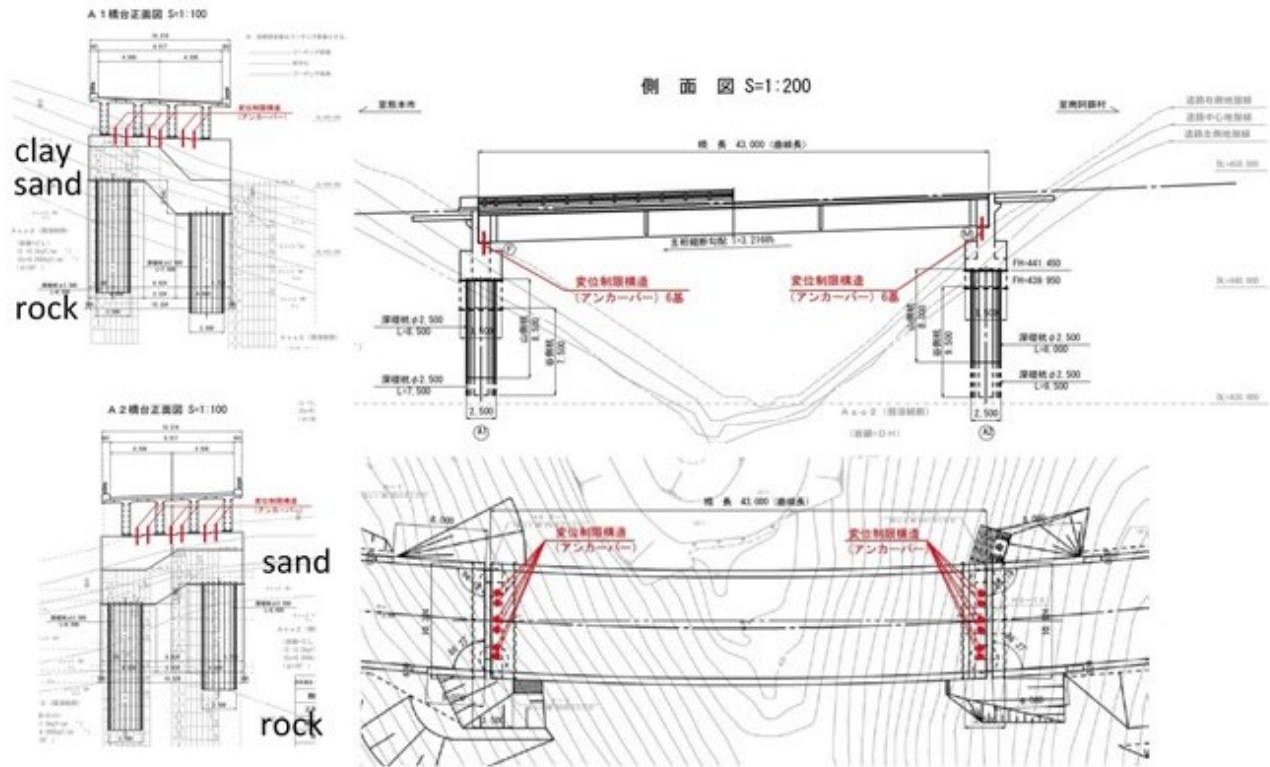
Figure 49. Drawing. Elevation, plan, and cross sections of Susukinohara bridge.⁷

The Susukinohara bridge is oriented EW on Route 28 (figure 48). It was constructed in 1999 and is a 141 ft (43 m), single-span, concrete T-beam bridge. The substructure sits on deep pile foundations bearing on bedrock that is 25–31 ft (7.5–9.5 m) in length. Plan layout and elevation views are shown in figure 49 and figure 50. Although damaged, the bridge survived the earthquake but was closed to traffic.

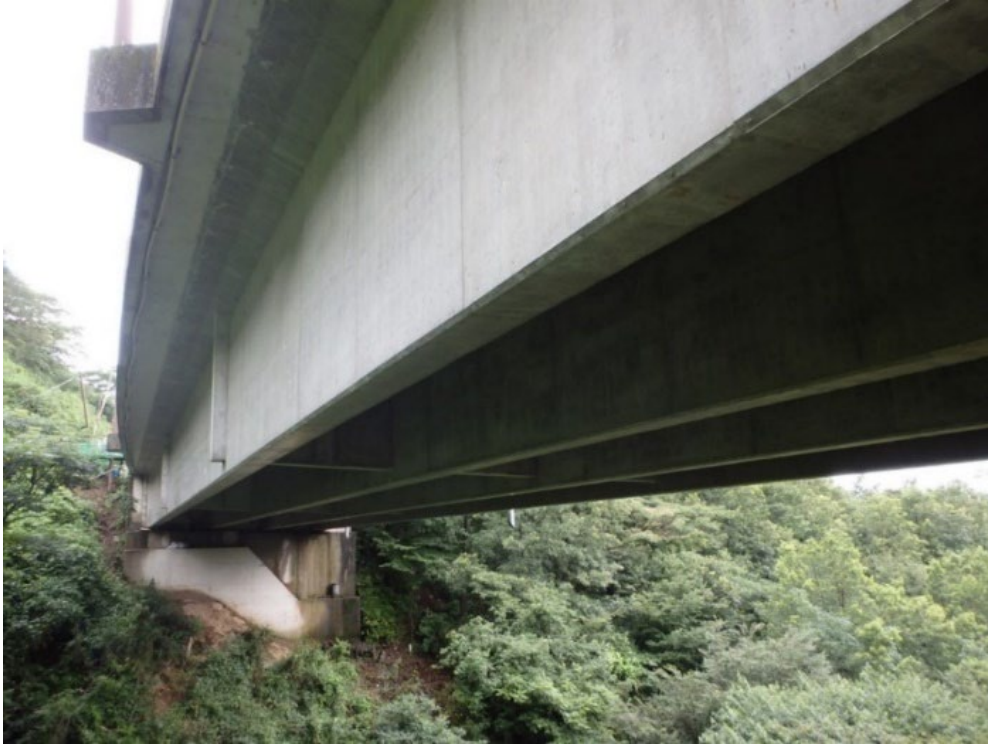
Figure 50. Photo. Susukinohara bridge showing concrete T-girder superstructure with diaphragms.⁸

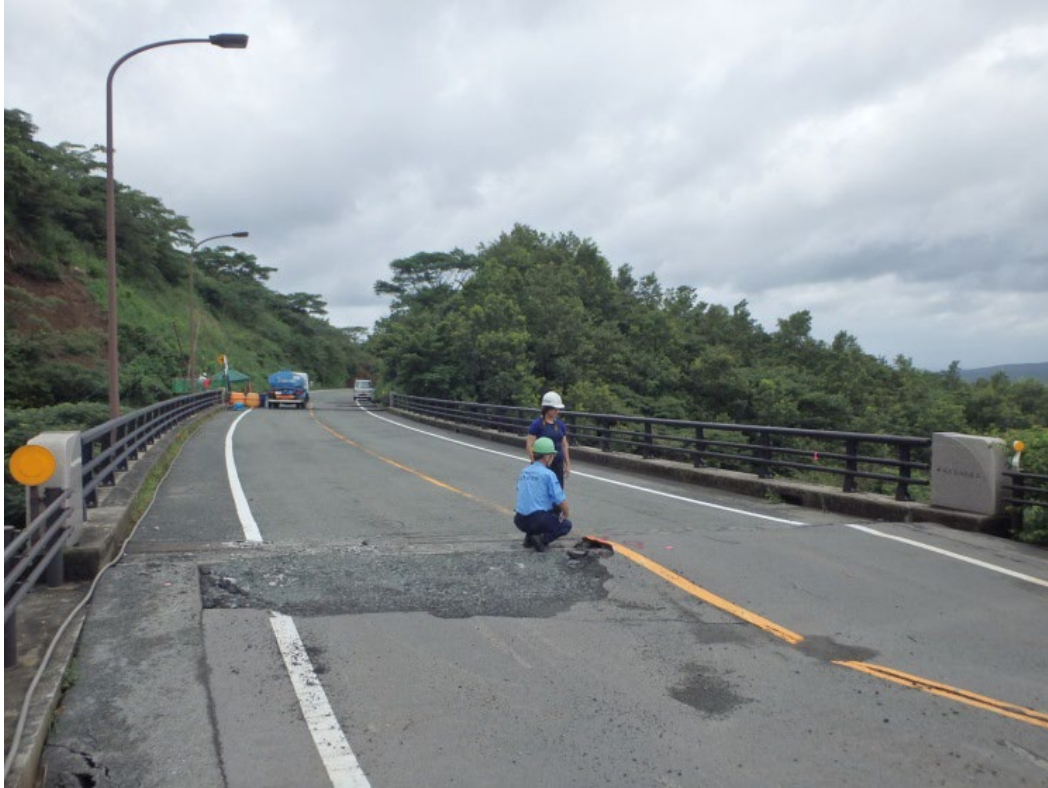
The damage observed is shown in figure 51, which includes settlement of the bridge relative to the roadway and damage to the end diaphragm at the east abutment due to lateral movement and possible pounding of the girders. No visible cracks were observed on the girders, and, for the most part, there was little damage to the bridge girders or the deck.

Figure 51. Photo. Distant view of damaged approach at the west abutment.⁹

Figure 51 and figure 52 show damage to the approach slab, which had folded up. This damage was at the west abutment. At the east abutment, a large gap appeared between the end of the bridge and the approach (figure 53). This damage indicates the bridge had moved longitudinally toward the west. The amount of permanent lateral movement can be judged from the misalignment of the roadway stripe.

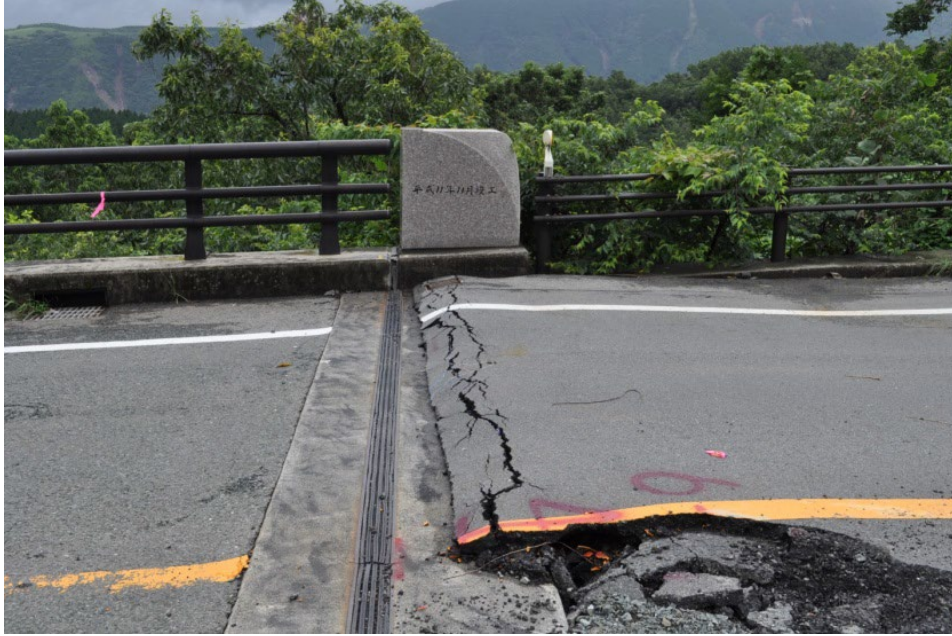
Figure 52. Photo. Close-up view of damaged approach at the west abutment.

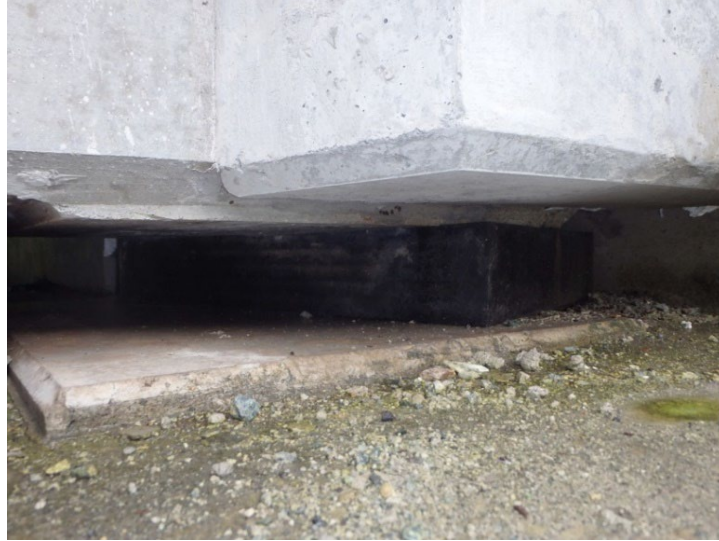
Figure 54 shows the rotation of the elastomeric bearing about a vertical axis. However, none of the girders had fallen off the bearings or the abutments. Figure 55 shows timber blocking that is currently being used for additional support.

Figure 54. Photo. Rotation of an elastomeric bearing.¹⁰

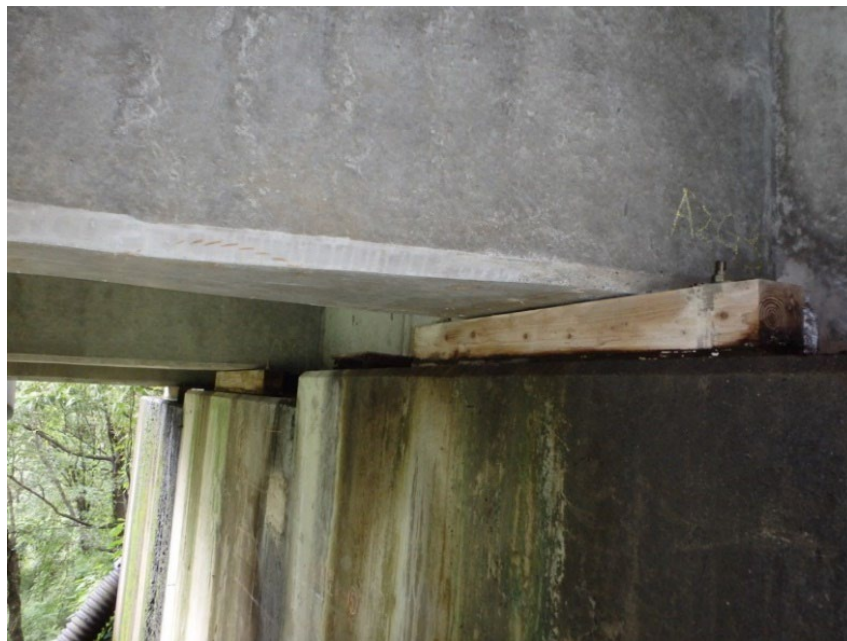
Figure 55. Photo. Timber blocks being used for additional support of girders at abutment seats.¹¹

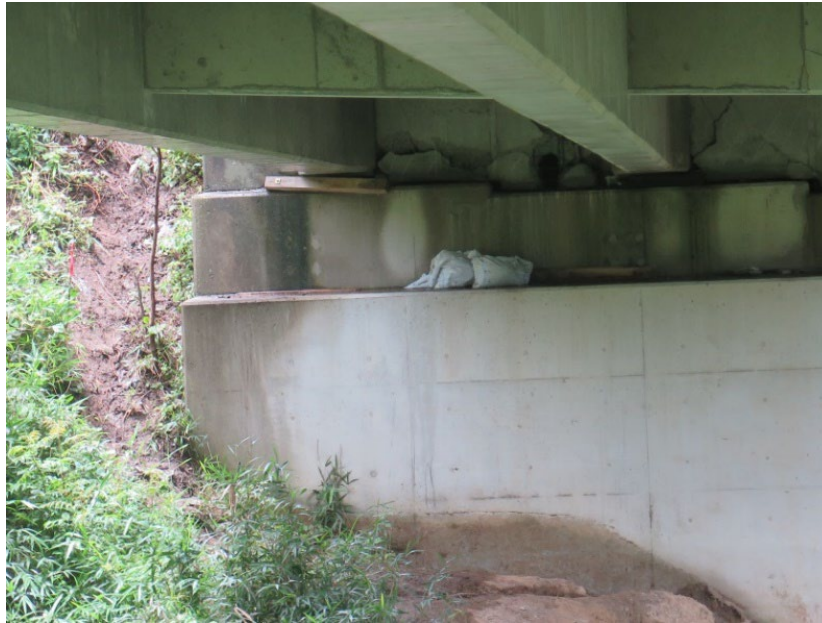
The most severe damage observed in this bridge was the failure of the end diaphragm at the east abutment (figure 56 and figure 57). The longitudinal and lateral movements of the bridge toward the abutment resulted in the failure of the diaphragm.

Figure 56. Photo. Damaged end diaphragm at the east abutment and dislodged timber block from under the second girder from the left.

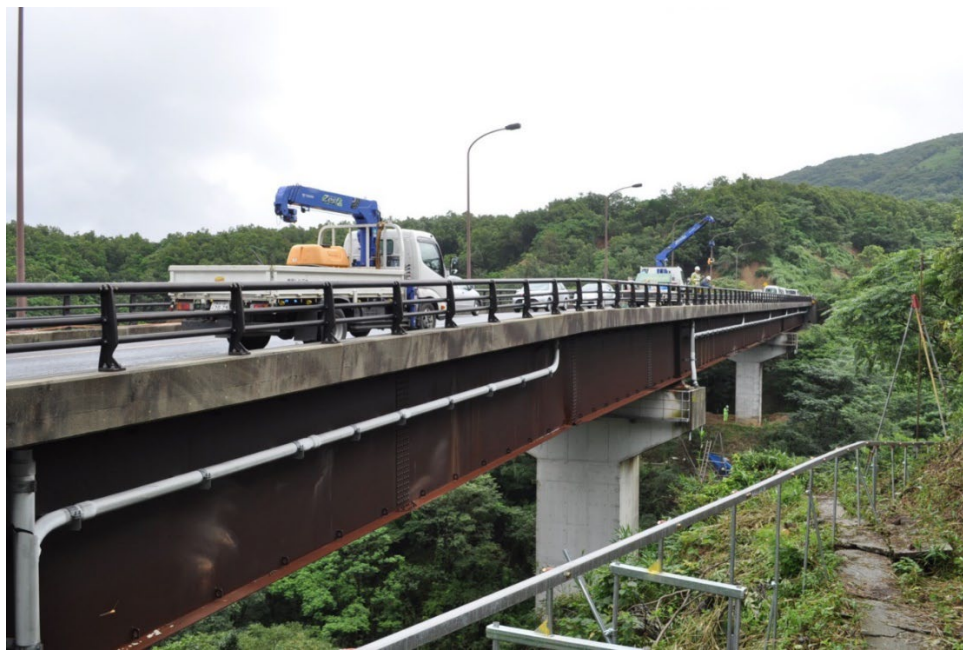
Figure 60. Photo. Tawarayama Oh-hashii bridge looking east.

The observed damage included girder and cross-frame buckling, bearing distortion, lateral and longitudinal movement of the girders, ground and abutment movement, lateral and vertical movement of finger joints, settlement of approaches, span unseating, shear key failures, and cable restrainer failure. At the road level, settlement of the superstructure and deformation of the railings could be observed. Elastomeric bearings were damaged at several supports.

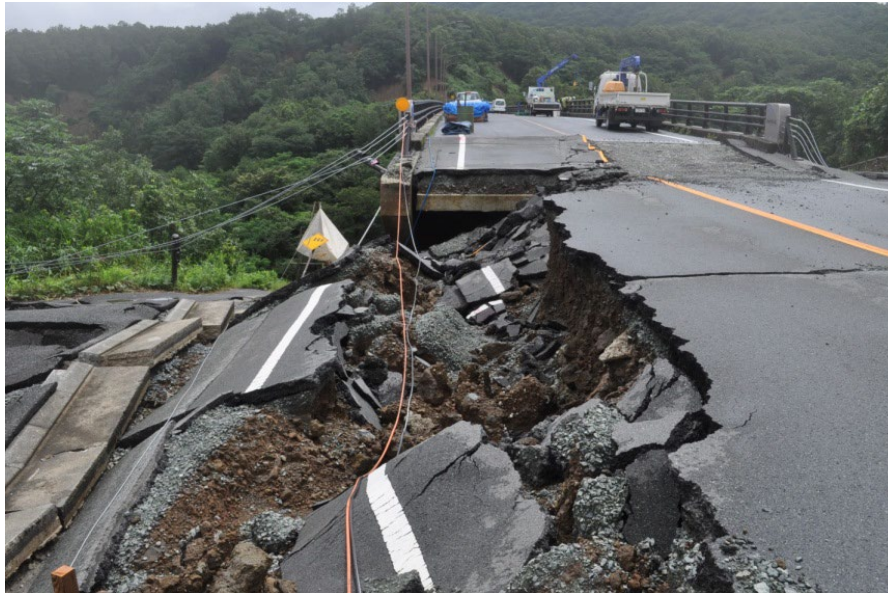
At the west end, damage was predominantly due to ground movement, leading to failure of the approach roadway, abutment rotation, pounding of girders, and bearing distortion (figure 61, figure 62, and figure 63).

Figure 61. Photo. Failure of the west approach.

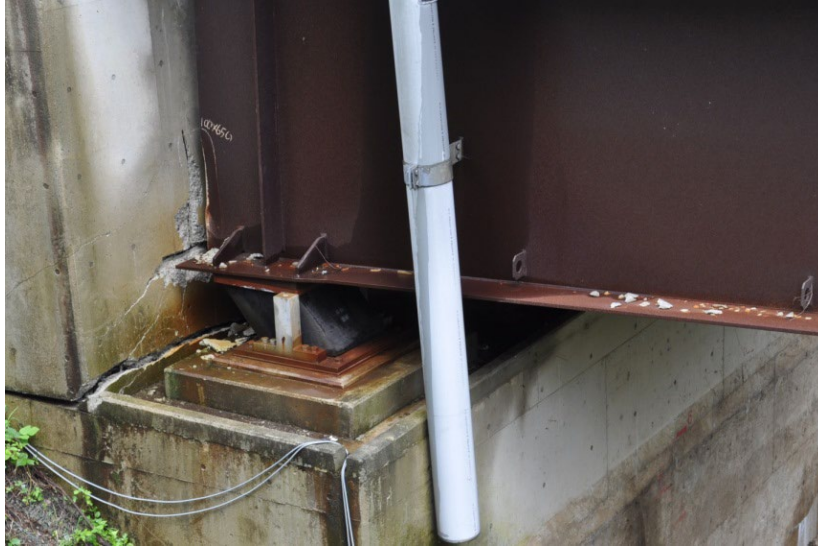
Figure 63. Photo. Pounding at the west abutment and permanent bearing deformation.

Abutment rotation can be visualized in figure 62 from the greater separation distance between the top of the girder and abutment back wall compared with that at the bottom of the girder. Additionally, figure 62 and figure 63 show substantial residual displacement in the bearing. Large permanent displacements in elastomeric bearings were observed on a number of bridges due to residual displacements in their superstructures and/or substructures. Rupture of the drain pipe can also be seen. Furthermore, the back wall was crushed during pounding by the girders, and there was slight distortion of the girders at this location.

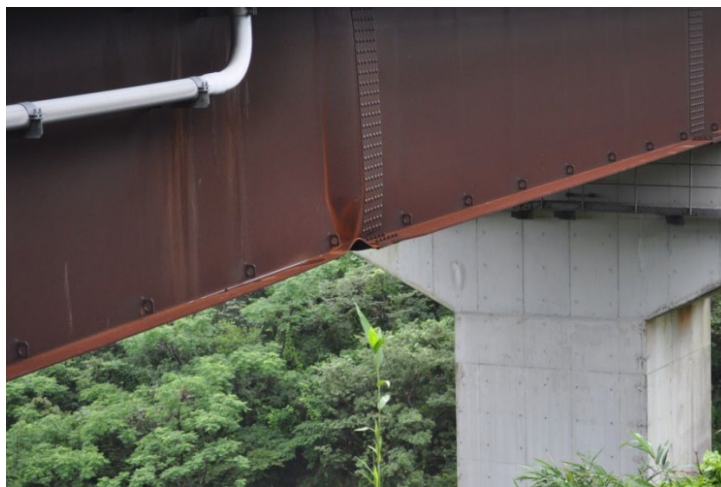
In addition to girder distortion at the abutment, buckling was observed in the web and lower flange of the outside girder in the same span (figure 64). This type of buckling failure was not seen in other girders.

Figure 64. Photo. Buckled girder flange and web.

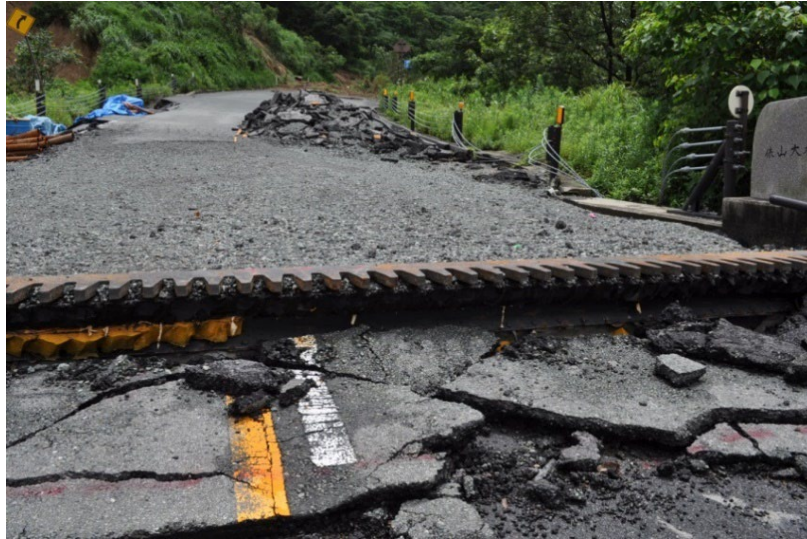
Figure 65 and figure 66 show the condition at the east abutment. As seen in figure 65, the bridge separated from the finger joint and settled about 12 inches (30 cm). Directly below the deck level, figure 66 shows the condition of the elastomeric bearings and the girder. The bearing and the girder moved laterally and longitudinally together and buckled the flange and web as the bridge hit the back wall. This movement resulted in failure of the steel stopper, which was designed to prevent the girder from moving laterally (figure 67).

Figure 65. Photo. Vertical offset at the east abutment between the bridge and approach pavement.

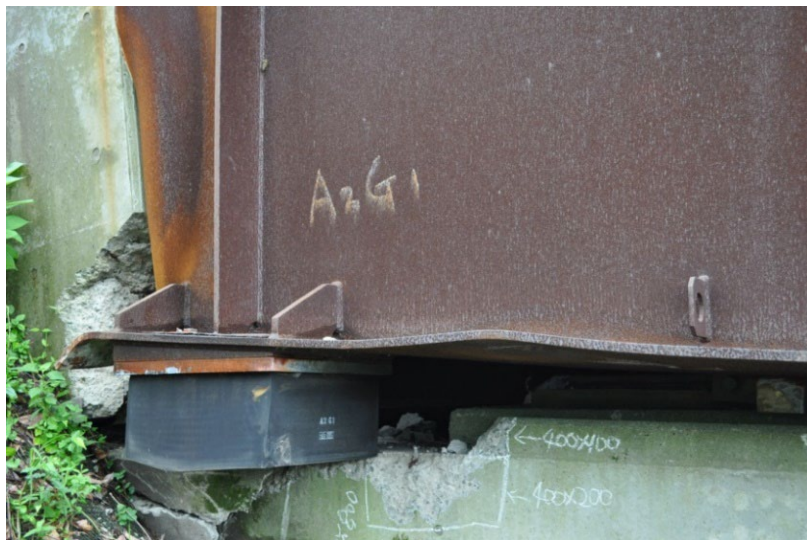
Figure 66. Photo. Lateral movement of a girder and bearing at the east abutment.¹⁵

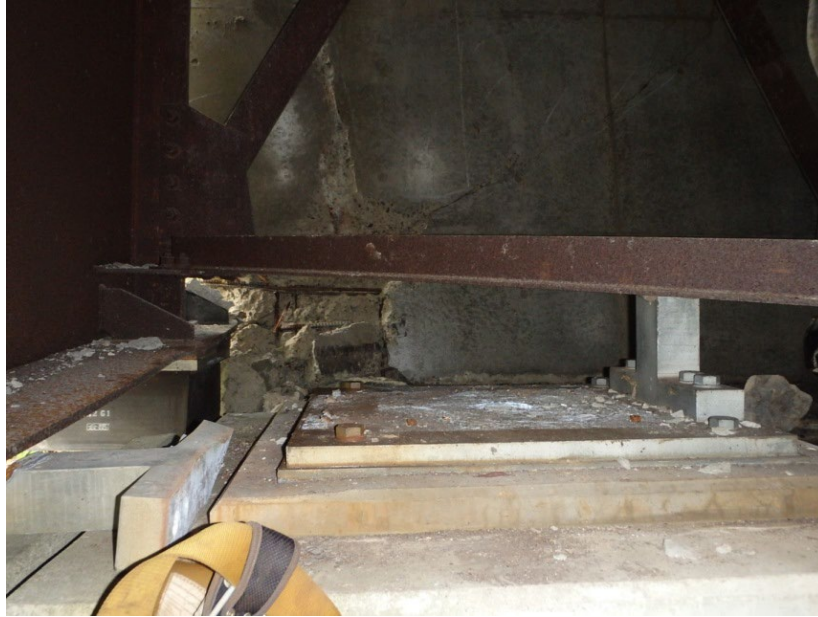
Figure 67. Photo. Failure of a bearing stopper at the east abutment.¹⁶

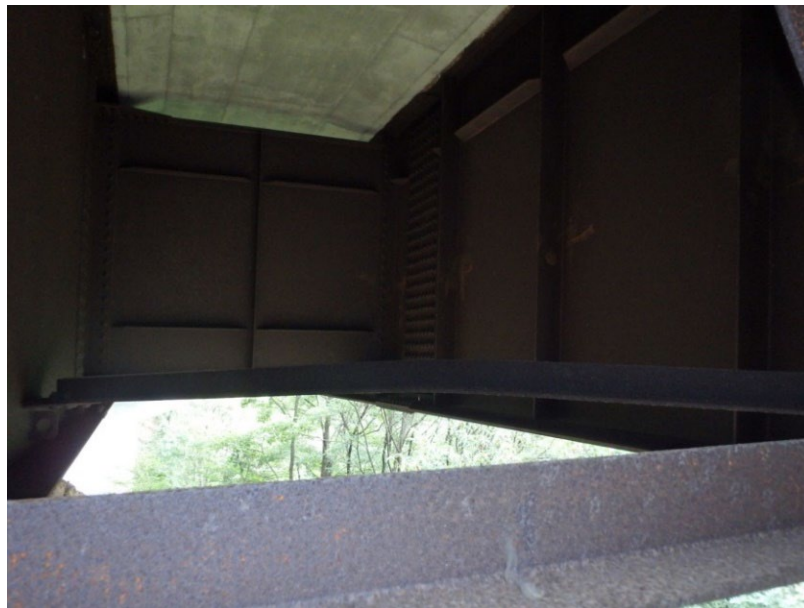
Additionally, buckling occurred in the lower chord braces (figure 68 and figure 69).

Figure 68. Photo. Out-of-plane buckling of the lower chord brace.¹⁷
