Performance of Transportation Infrastructure During Kumamoto Earthquakes of April 14 and 16, 2016— A Reconnaissance Report

PUBLICATION NO. FHWA-HRT-22-110

MARCH 2023

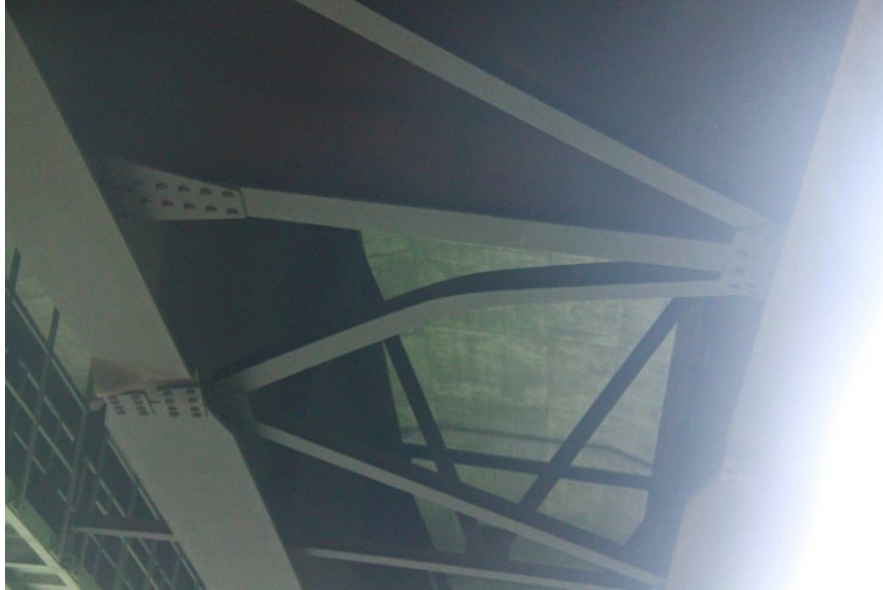
Additionally, buckling occurred in the lower chord braces (figure 68 and figure 69).

Figure 69. Photo. In-plane buckling of lower chord braces.

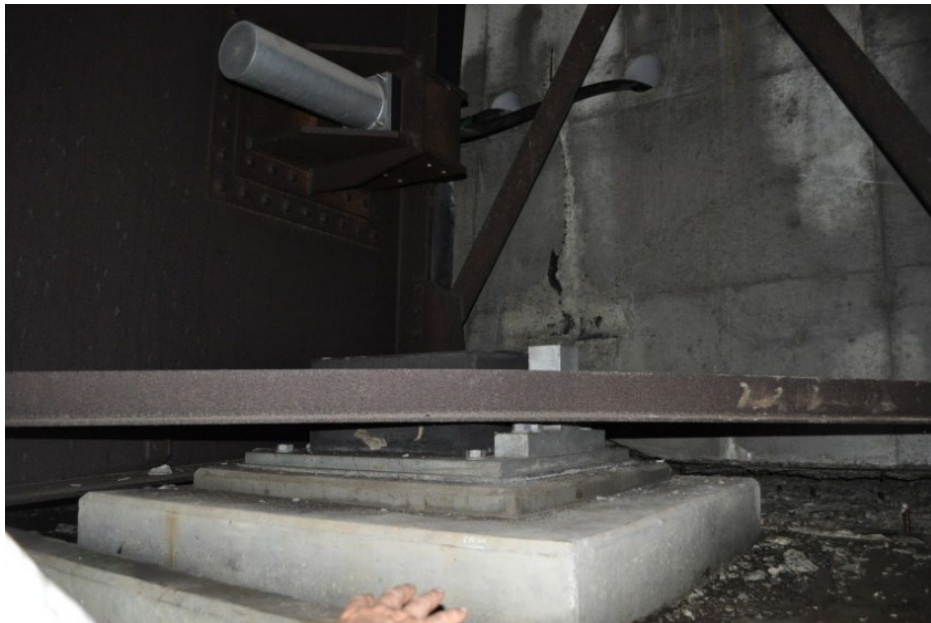
Figure 70 shows a typical restraining cable system used to prevent girders from unseating longitudinally. However, as seen in this figure, these cables were not able to prevent lateral movement, as might be expected. Although this restrainer was still attached, the girder moved laterally off the bearing but remained vertical.

Figure 70. Photo. Longitudinal restrainer unable to prevent girder unseating transversely, as might be expected.

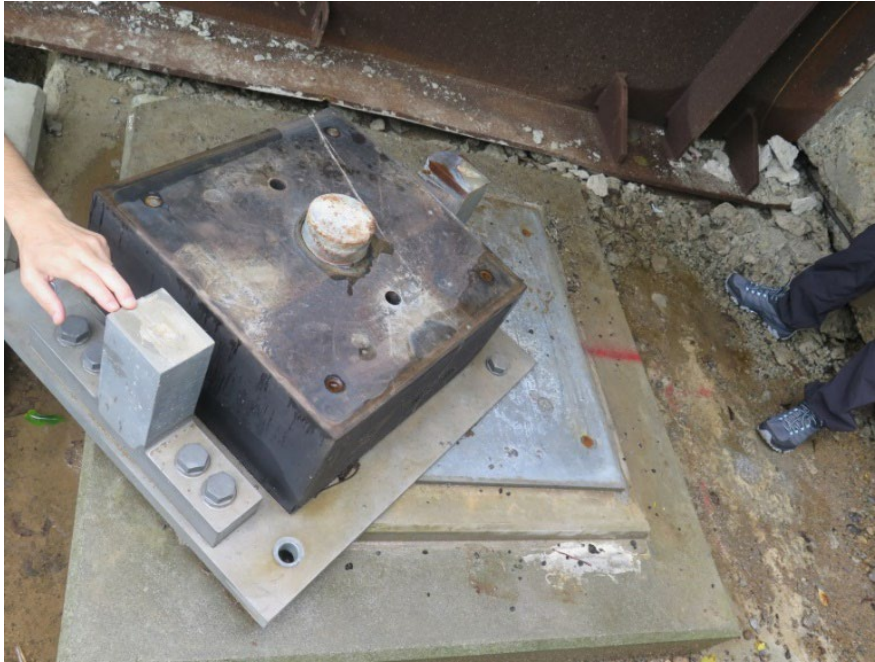
Figure 71 shows a close-up view of an elastomeric bearing and the connection details used on the Tawarayama bridge. Four bolts, one at each corner, were used to anchor the bearing to the masonry plate on the abutment seat. Also seen are two transverse stoppers to guide the bearing in the longitudinal direction. All four bolts were sheared off, and the bearing rotated about 90 degrees at this location.

Figure 71. Photo. Elastomeric bearing and transverse stopper at the east abutment showing rotation of the bearing and implied bolt fractures in anchor plates.

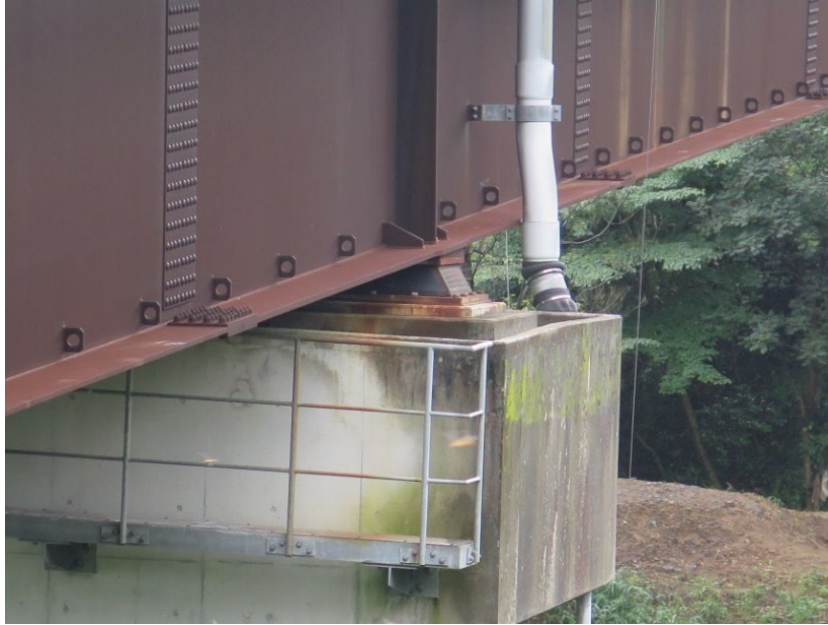
Figure 72 and figure 73 show damage at the pier locations. The superstructure as a system moved laterally, distorting the bearing pads on the pier closest to the west abutment (figure 72). On the second pier, shown in figure 73, the superstructure moved off the bearing pads altogether and is sitting directly on the pier. This movement is about 3 ft (about 1 m). Spalling of the concrete is also present on the pier cap, possibly due to the impact of girders falling from the bearings onto the cap.

Figure 72. Photo. Permanent deformation in the elastomeric bearing on pier P1.

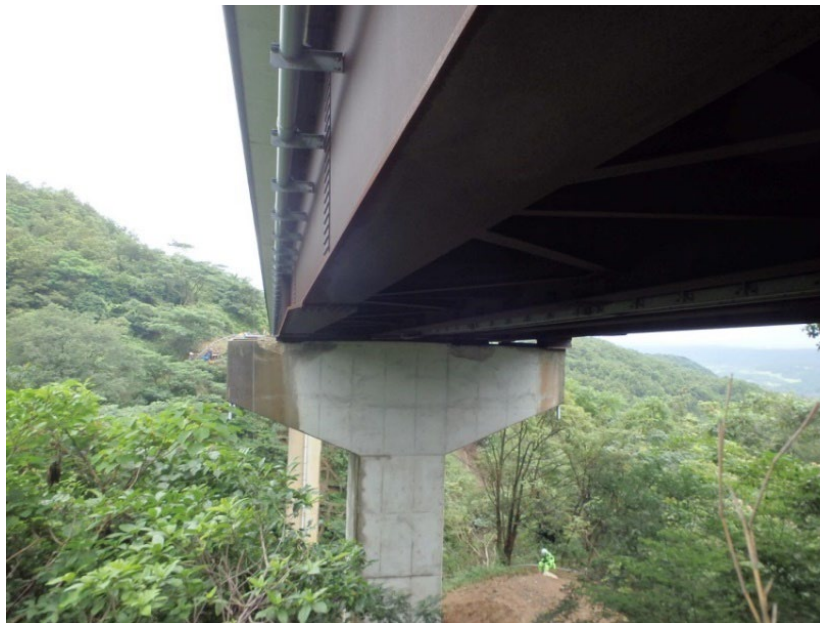
Figure 73. Photo. Permanent lateral movement of the superstructure and girder unseating on pier P2.¹⁸

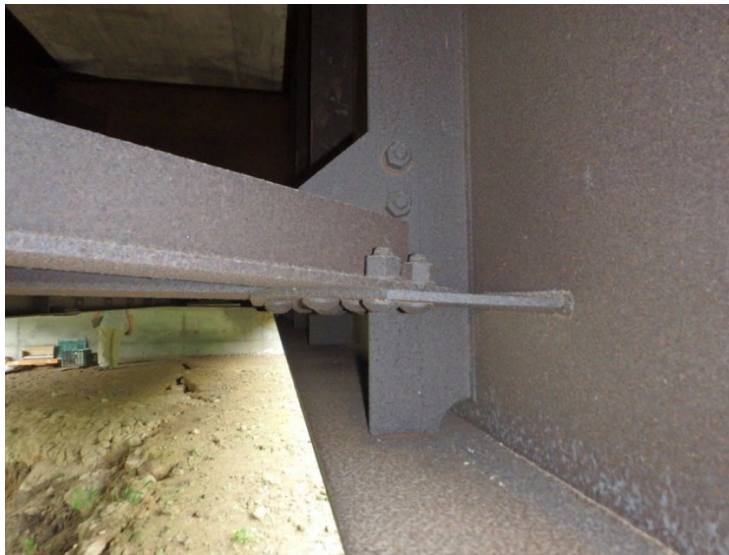
Figure 74 shows a bracing detail in the plane of the lower flange that was not damaged. This lack of damage was also noted in other bridges on Route 28. Despite strong ground shaking and pervasive ground failures, many superstructure details performed very well.

Figure 74. Photo. Undamaged connection detail for lower chord bracing.¹⁹

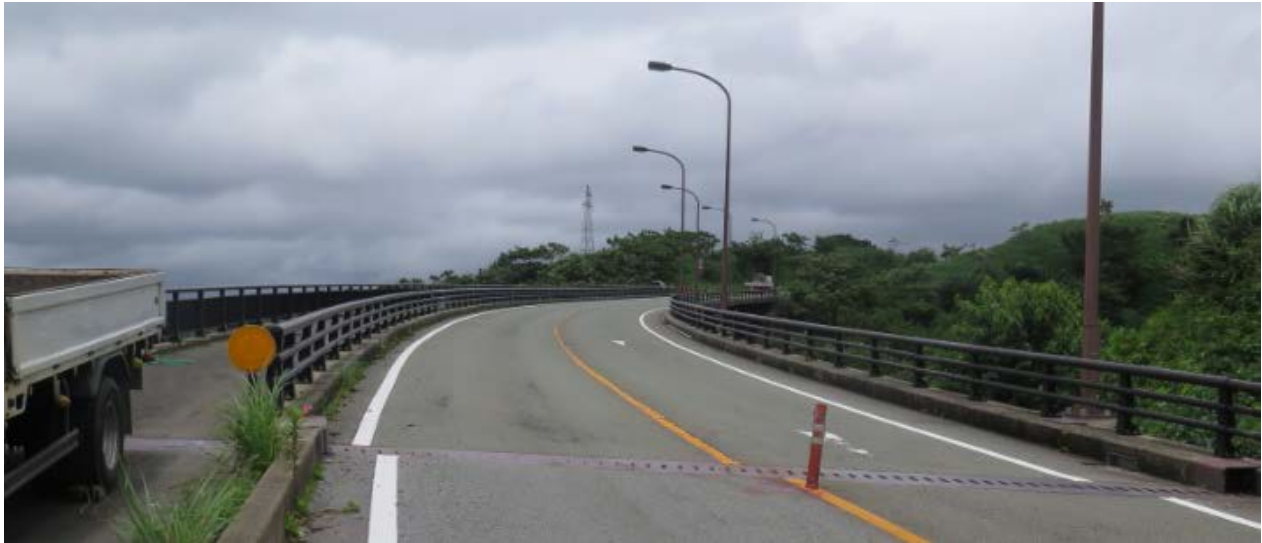
The nature of superstructure and substructure movement was of most interest. Figure 75 shows a seemingly westerly shift of the superstructure relative to its abutment. Figure 76 shows the relocking of finger joints, indicating the bridge moved longitudinally enough to open the joint, shifted, and closed again in a new offset position. The south end shift was approximately 12 inches (0.30 m). Examining the north abutment (figure 77) revealed a 10-inch (0.25-m) easterly shift. This shift suggests a clockwise rotation of the superstructure (figure 78). However, the at-rest position of the intermediate bearings indicates another possibility. Instead of having slightly less displacement of the same direction as the nearest abutment (with rotation about the

Figure 75. Photo. Ooginosaka bridge from the south approach showing left lateral offset at the abutment.

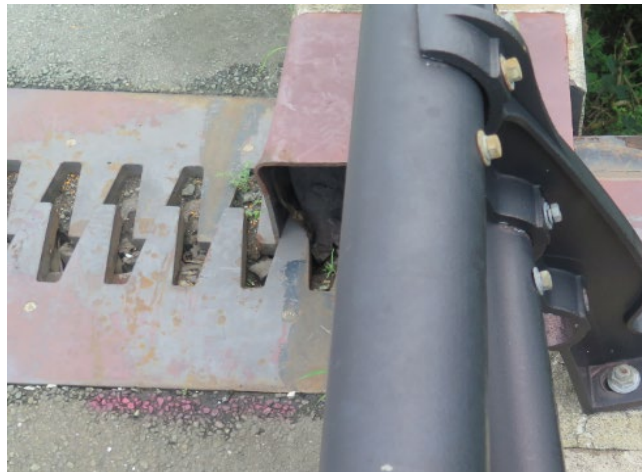
Figure 76. Photo. Finger joint relocking.

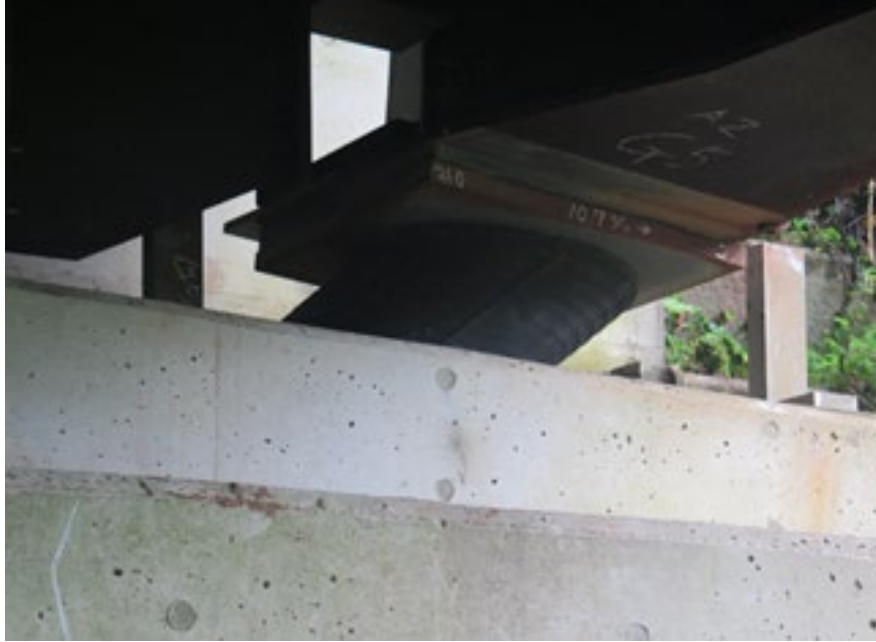
Figure 77. Photo. North abutment with easterly superstructure shift.

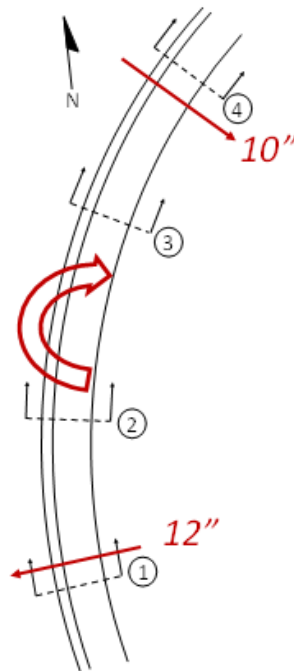
Figure 78. Illustration. Potential rotation of superstructure creating observed abutment offsets.

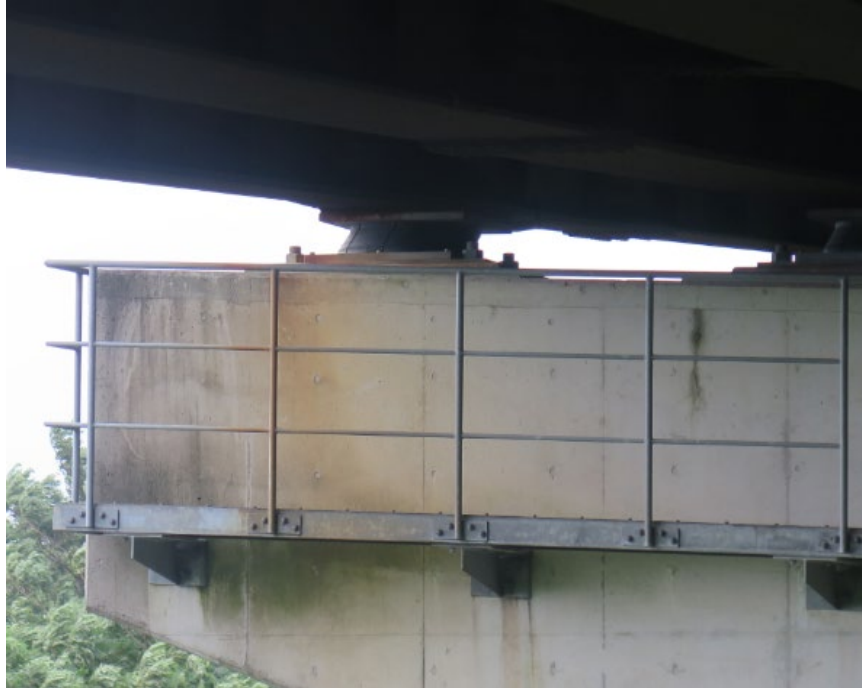
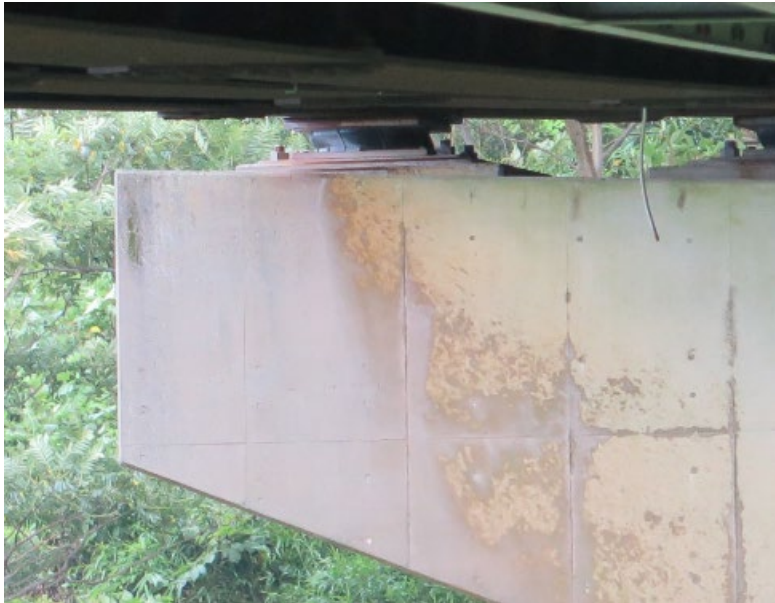
A. Pier P2.

B. Pier P3.

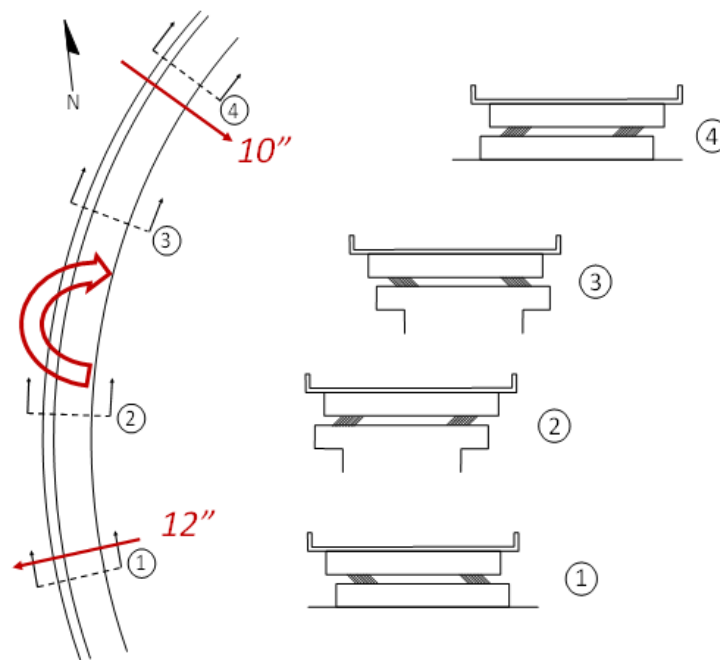
If these movements are entirely caused by superstructure movement, there must be significant in-plane deformation for the deck, which would produce significant cracking. That was not the case. The deck condition indicated that the deck remained a rigid diaphragm. Figure 80 shows the

direction of movement of each substructure that would have produced the bearing offsets. This result means the ground supporting each foundation through the canyon moved in the opposite direction relative to the next foundation. Given the amount of slope instability in the region, this is a conceivable conclusion. One way to check this concept is to view the center supports from each abutment and check for column drift. Aside from construction tolerances, columns that are out of plumb may indicate seismic shifts in local supporting soil and foundations. When one looks south along the column edges from under the north abutment, the column drifts become evident as a gap can be seen between the tops of the columns in figure 81. A corresponding lower gap can also be seen when one looks north from the southerly abutment (figure 82). Other damage at the bridge included failed shear keys. Figure 83 shows the south abutment shear key after being hit by its steel bumper. Keys were located only in the outside direction of transverse travel, as movement to the east would be less due to the geometry of the inside of the curve.

Figure 80. Illustration. Directions of substructure movement necessary to explain observed bearing displacements at each location.

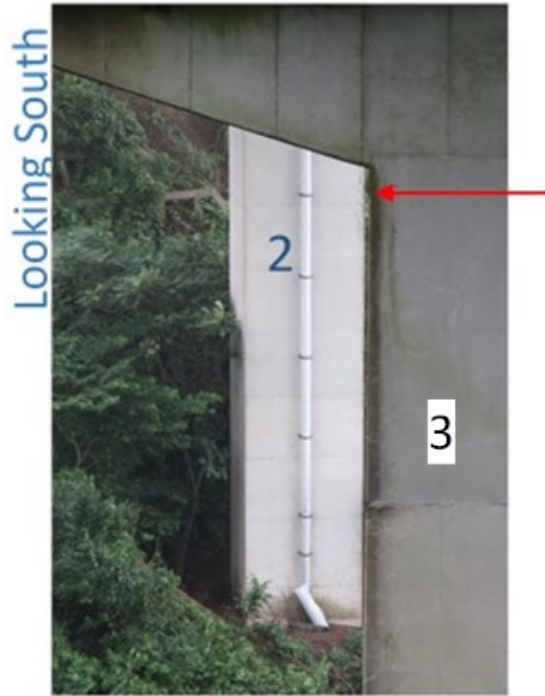
Figure 81. Photo. Gap at the top of superposed column profiles, looking south.

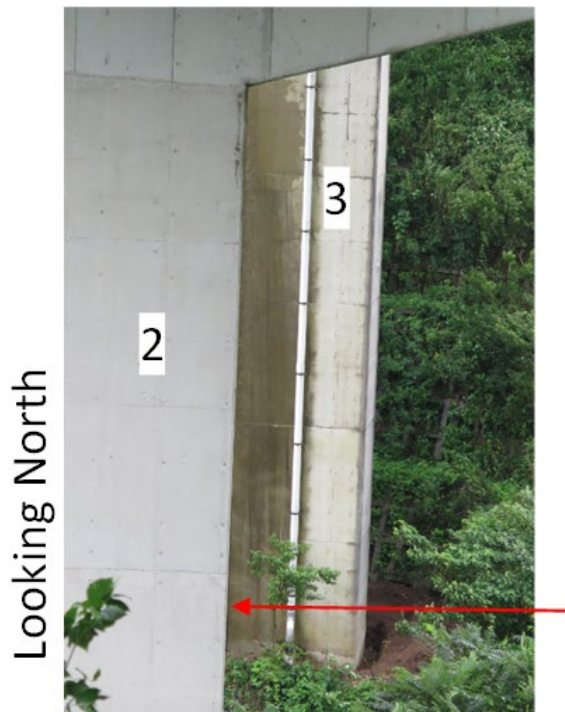
Figure 82. Photo. Gap at the bottom of superposed column profiles, looking north.

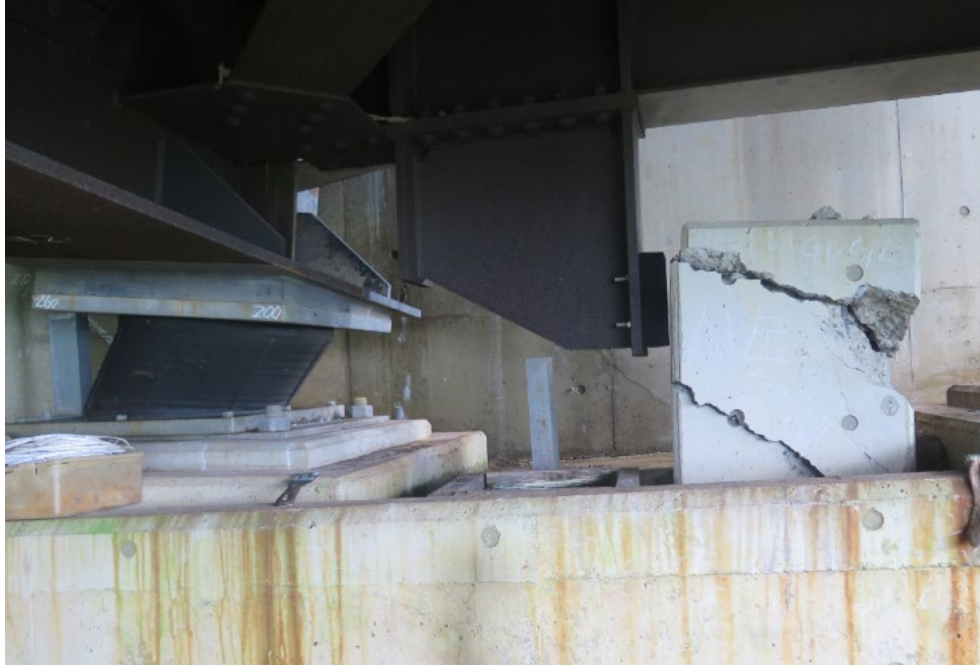
Figure 83. Photo. South abutment shear key damage.

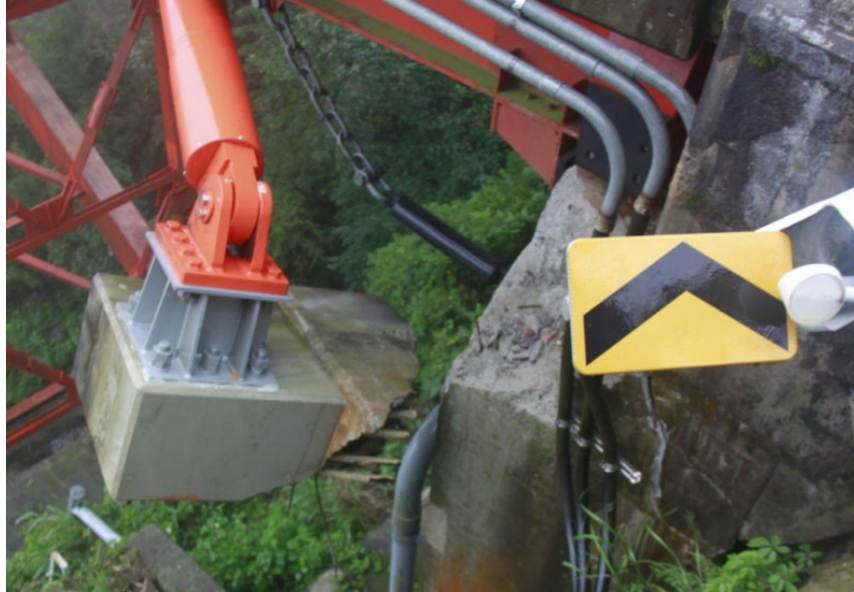
Damage was primarily sustained by the shear keys and back walls at both abutments. Figure 85 and figure 86 show close-ups of shear key failures at both sides of the south abutment. Dampers were secured to the abutments in the upper shear key area. Transverse displacements at the south abutment appear to have broken the keys, rendering the dampers ineffective. Another possible failure scenario is that longitudinal forces in the dampers pulled the keys free and damaged the back wall, but there was no evidence of longitudinal movement in the road joints at either end of the bridge or of damage to the dampers (no oil leakage, mounting bolt yielding, or pin distortion). A more likely scenario is first the transverse failure of shear keys and then anchorage failures in the dampers due to the weakened back wall. This hypothesis is consistent with the angle of the failure plane in the keys as seen in figure 88 and figure 89.

Figure 85. Photo. Damage to the anchorage of longitudinal damper and shear key on the west side of the south abutment.

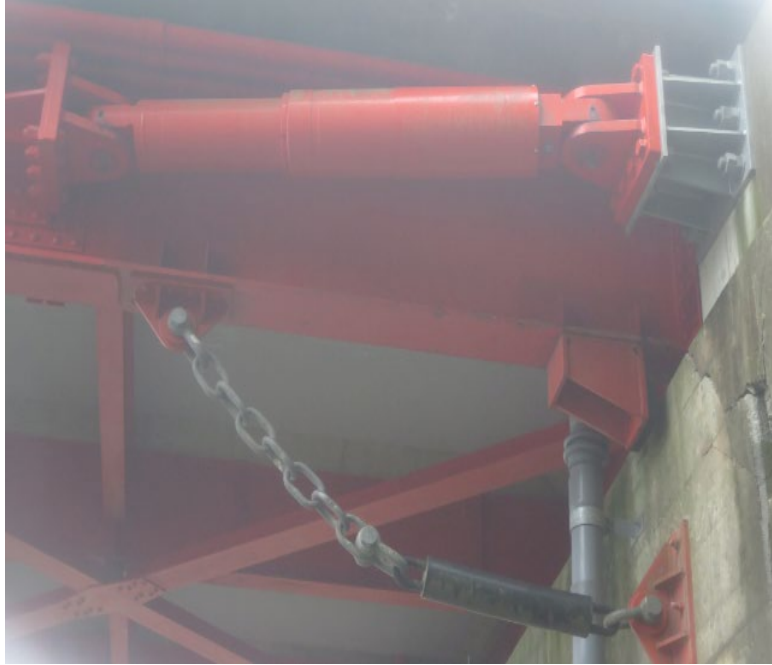
Dampers were still secured at the north abutments. However, shear cracks at both keys were visible (figure 87, figure 88, and figure 89), indicating a high level of transverse demand.

Figure 87. Photo. Longitudinal damper on the east side of the north abutment.

Note the longitudinal bumpers mounted below the bottom girder flanges in figure 87 and figure 89. It is likely these bumpers were designed to prevent dampers from bottoming out in a compression cycle, further supporting the failure sequence in which the keys failed first. All chain restrainers appeared undamaged.

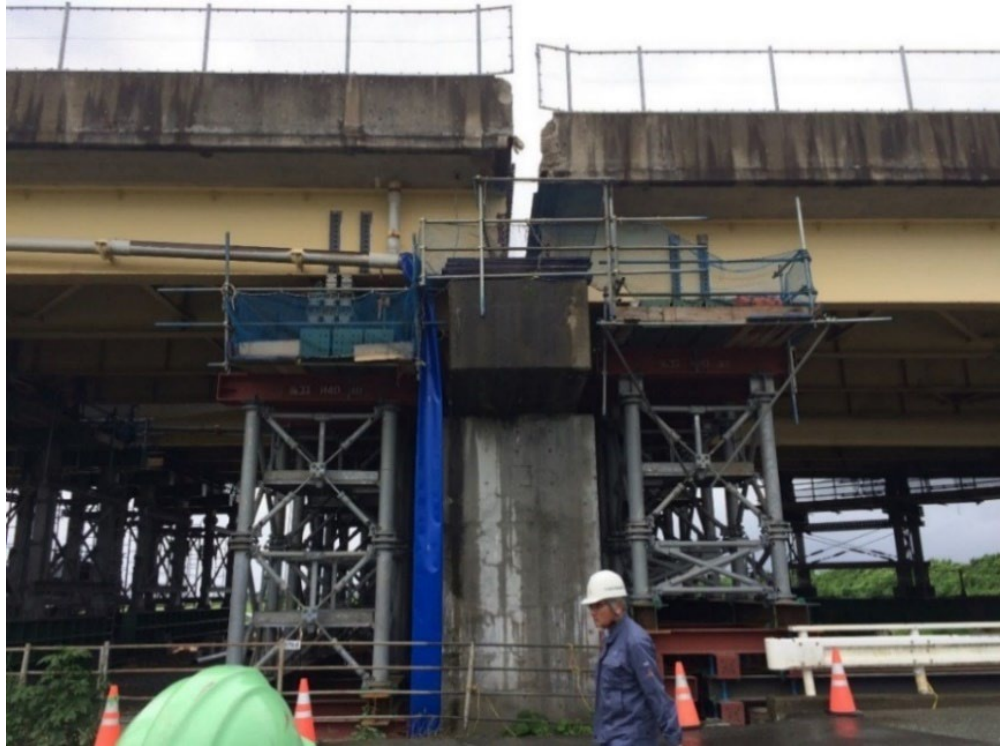
During the Kumamoto earthquake, the eastern bridge moved to the north and east. This movement resulted in the opening of a gap at pier 12 (figure 92) and the misalignment of consecutive spans (figure 93) in the eastern bridge. According to NEXCO West Japan—the company that manages the bridge—the western bridge shifted during the foreshock but then shifted back in the main shock. The heavy damage to the eastern bridge rendered it nonoperational, and it was closed to traffic, but the western bridge remained open.

Figure 92. Photo. Opening of the expansion joint at pier P12 of the east bridge.

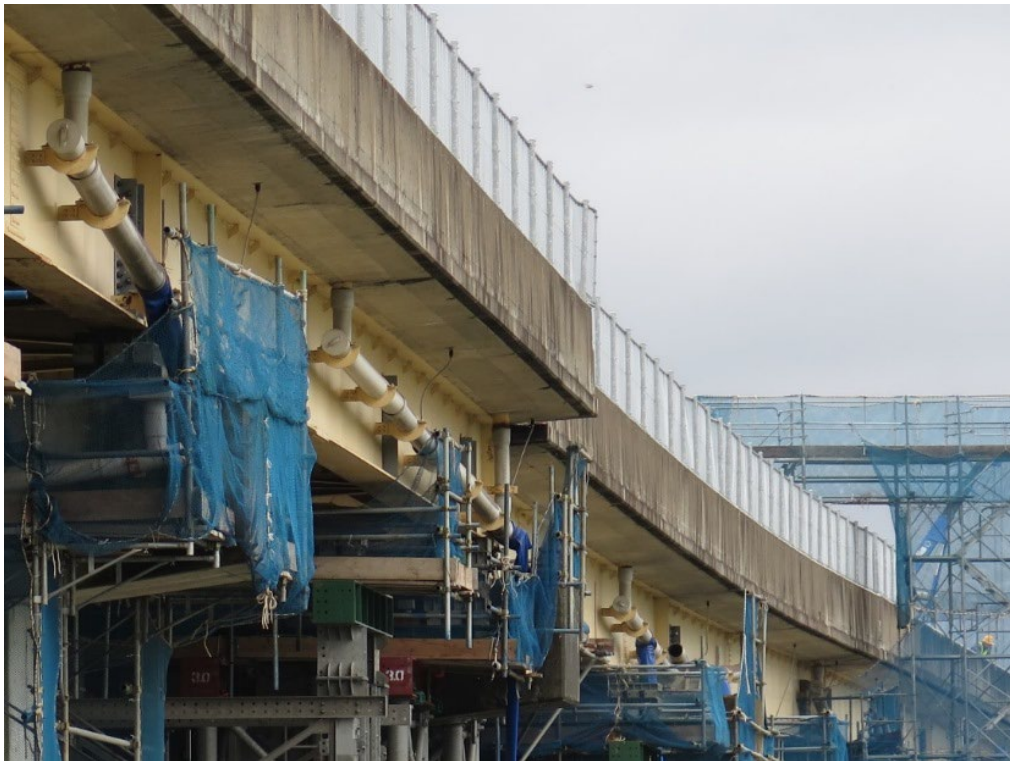
Figure 93. Photo. Misalignment of consecutive spans at pier P12 of the east bridge.

As shown in figure 90, the three piers, P10, P11, and P12, supported a two-span continuous segment with expansion joints at each end. This segment is the one that shifted east by approximately 3 ft (1 m), and the misalignment is observed at the joints of P10 and P12. At the time of the visit of the Reconnaissance Team, falsework and temporary supports had been installed below the segment in order to lift the deck and move it back to its initial position (figure 94).

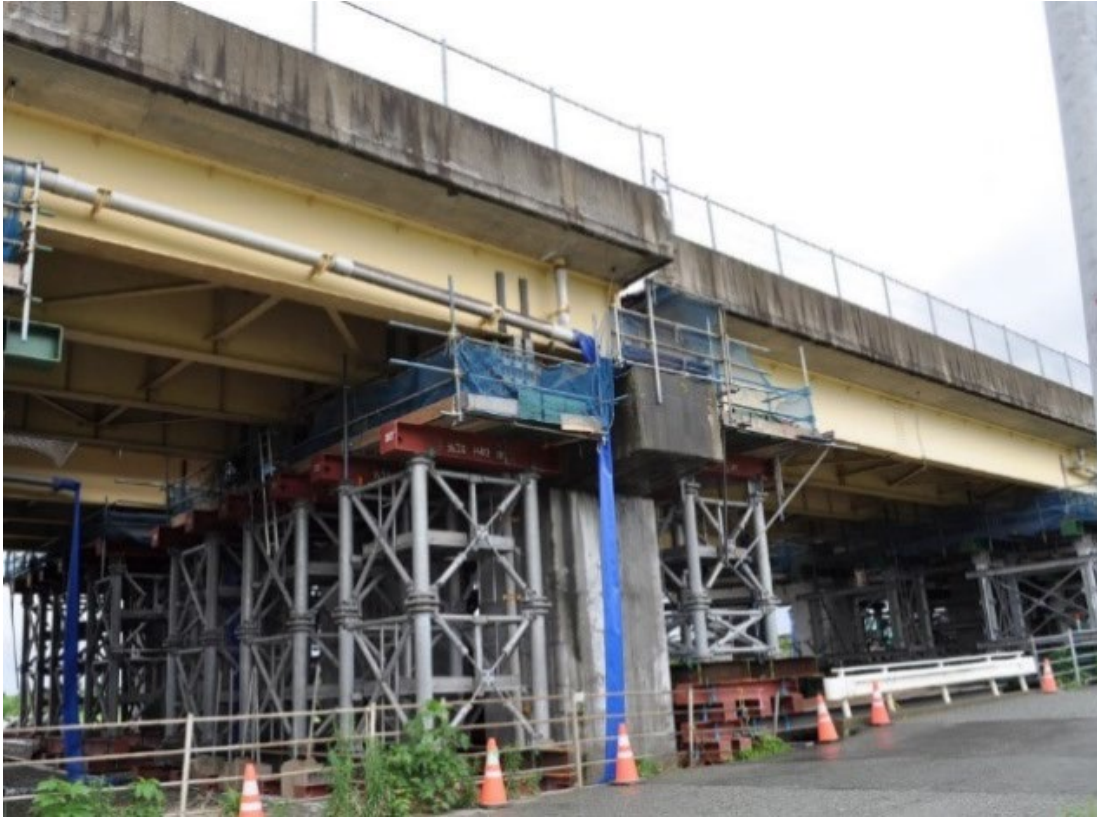
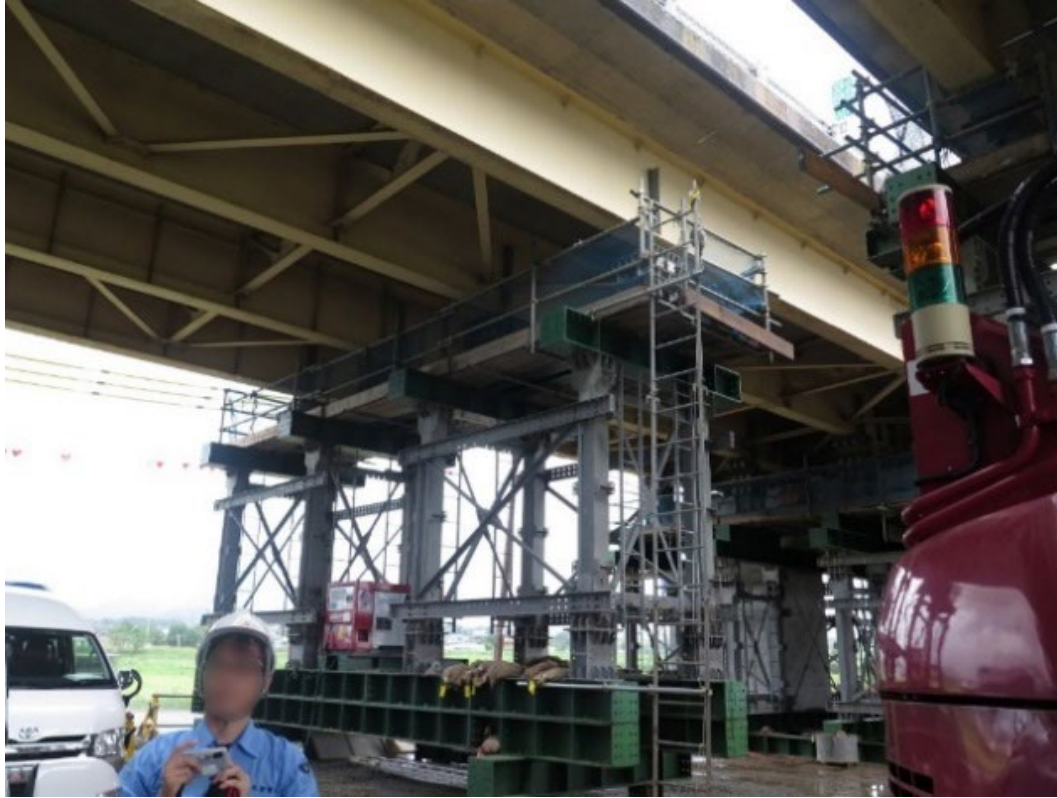
Figure 94. Photos. Temporary support systems at pier P12 of the east bridge.

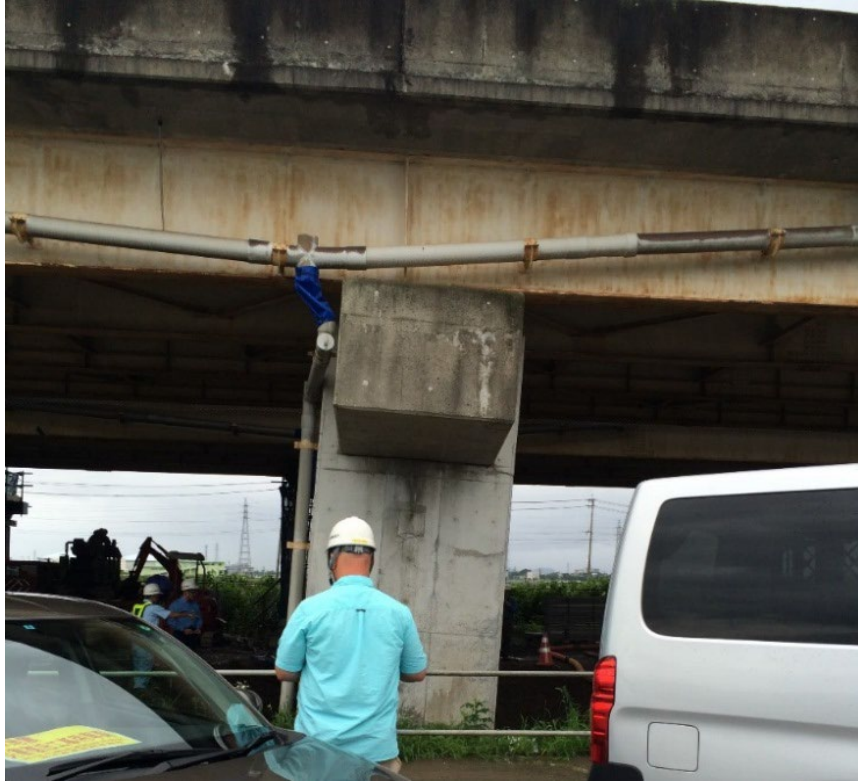
Pier 11 of the east bridge was the only pier reported to have extensive damage. It was also the only pier on which the anchorages of the pinned bearings on the cap beam had not failed, thus, subjecting the pier to significant longitudinal load from the superstructure. The rotation can be seen in figure 95. It opened a vertical gap of about 2.5 inches (6.35 cm) between the column jacket and pile cap, which seemed to run the entire length of the cap. It was observed under both columns of pier P11 of the eastern bridge, indicating the reinforcement connecting the column to the pile cap had been either yielded, pulled out, or sheared. It was not possible to be more definitive without demolishing the column. This damage is shown in figure 96, figure 97, and figure 98.

Figure 95. Photo. Side view of tilted pier P11.

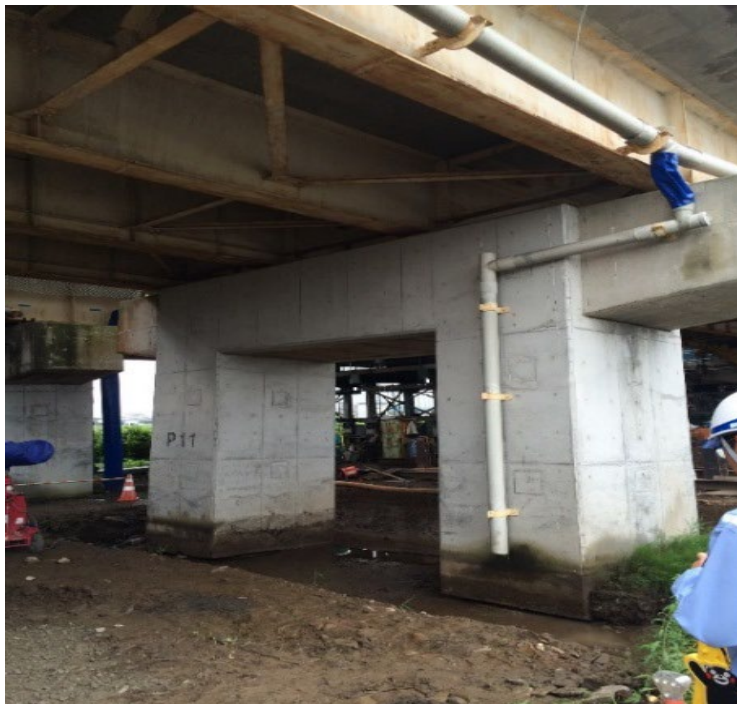
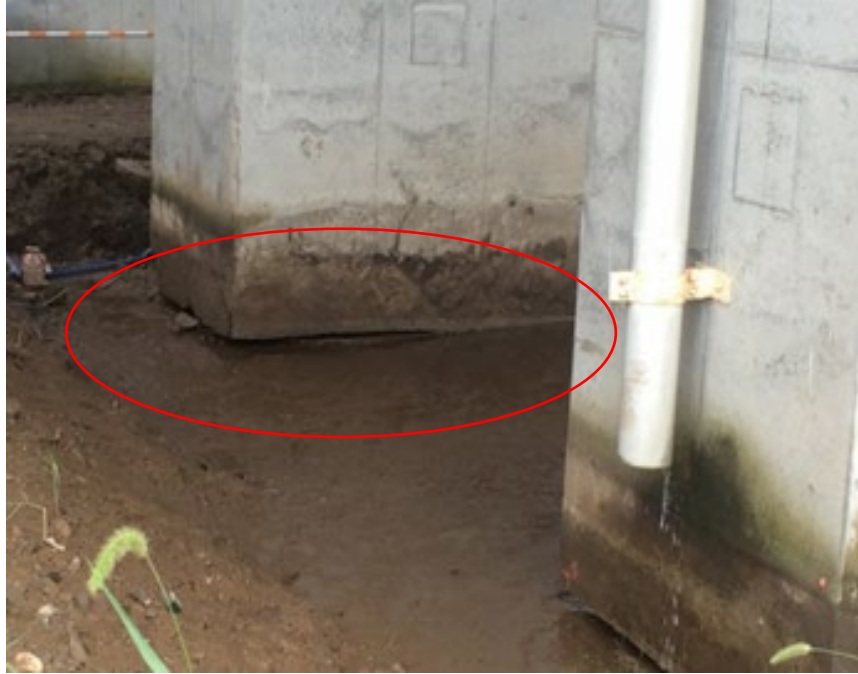
Figure 96. Photos. Exposed column-to-pile cap connection at pier P11 of the east bridge.

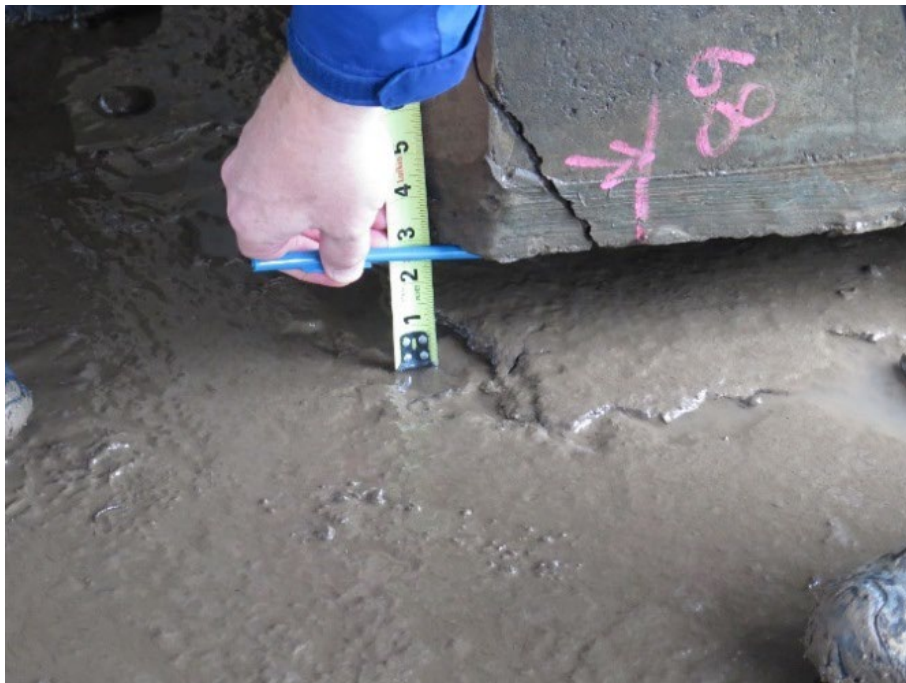
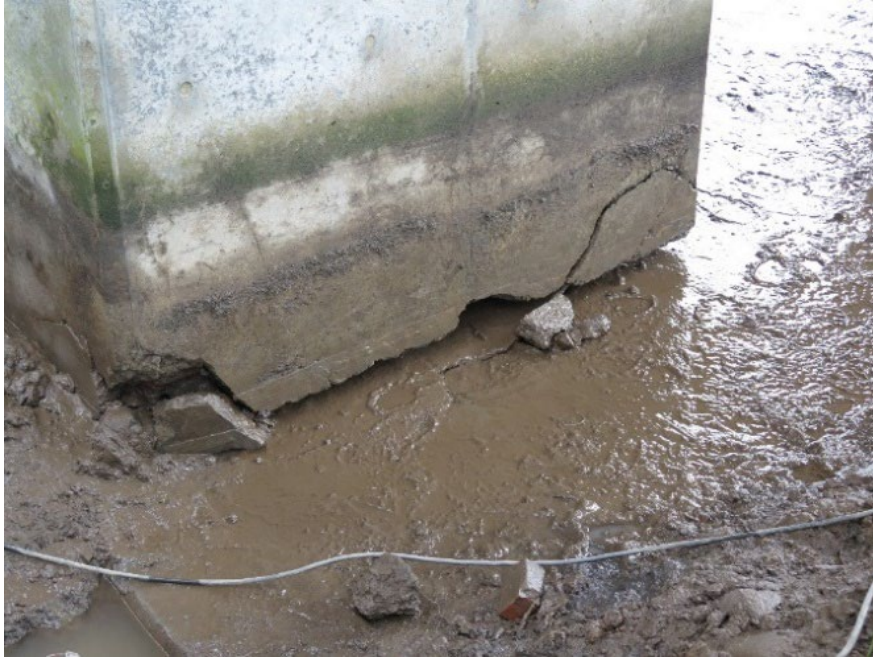
A. Size of the opening.

B. Damaged concrete.

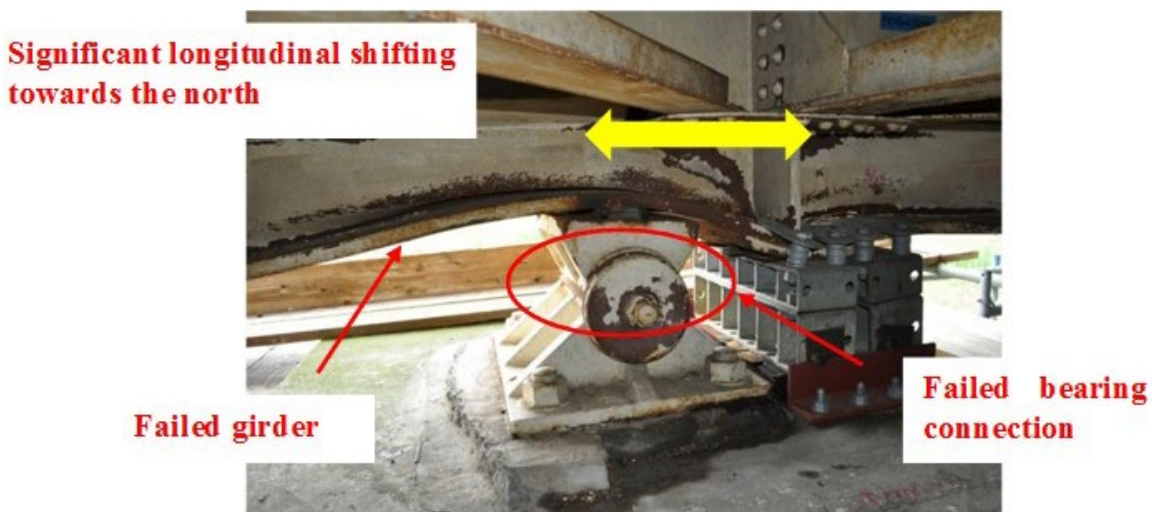
Apart from the damage to the column-to-pile cap connection at pier P11, significant damage also occurred at the bearing connections on the other piers. The superstructure appeared to have “jumped” longitudinally in both directions. There were indentations on both sides of the stiffener. As shown in figure 99, the large longitudinal movement of the bridge deck damaged the bolted connections of the steel bearings to the bottom flanges of the girders. Another consequence of this movement was that the web stiffeners were no longer aligned with the bearings, causing damage to the girder webs and flanges in the vicinity of the bearings. This type of damage was observed in both interior and exterior girders (figure 99 and figure 100). In addition, some bearings were also torn apart (figure 101). However, it appears that the failure of the bearings and/or their connections acted as a fuse, protecting the columns below from damage. As noted in the preceding paragraph, in the only case (pier 11) where the bearings and/or their connections did not fail, the pier below rotated and the pier-to-pile cap connection failed.

Figure 99. Photo. Failed bearing connection under the west girder at pier P10 of the east bridge.

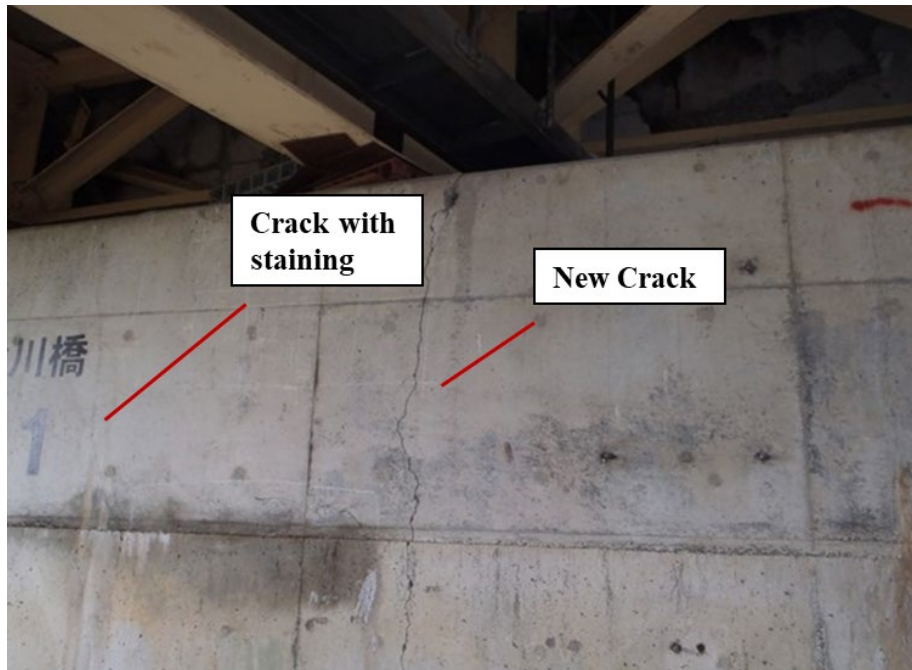
Figure 105. Photo. Vertical cracks in the seat of abutment A1.

Abutment A1 has some vertical shear cracks that are shown in figure 105. One crack looks fresh, but adjacent to it is a similar crack with staining that has obviously been there a long time.

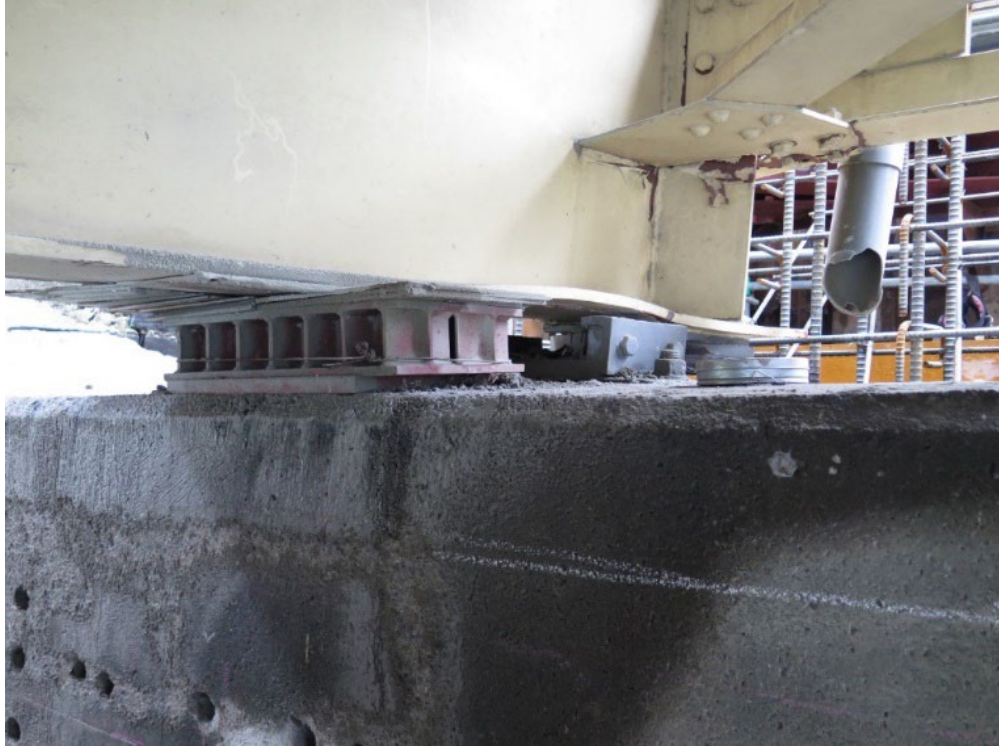
The entire superstructure was reported to have been displaced to the north. Coincident with superstructure displacement northward, abutment A1 may have displaced southward. As a result, the back wall of the abutment was damaged, the bearings suffered damage, and the girder stiffening plates were no longer aligned over the bearings, which resulted in damage to the bottom flange and web of the girder (figure 106).

Figure 106. Photo. Damaged expansion bearing and girder at abutment A1.

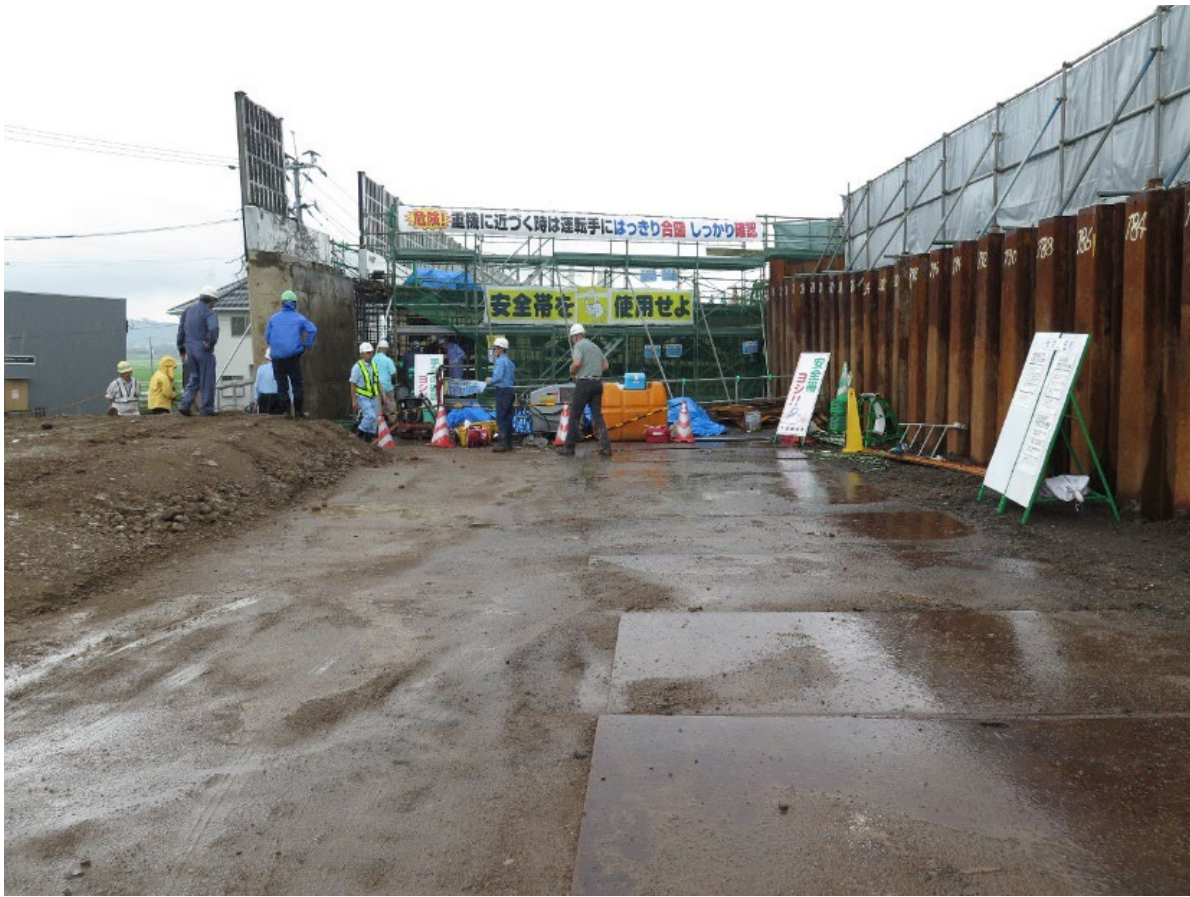
Figure 107. Photo. Bridge approach replacement.

The approach fill was excavated to gain access to the abutment wall for demolition and reconstruction. Figure 107 shows the back of the abutment with the end wall removed. In the left of the figure, the curtain wall is shown still standing with shoring supporting the adjacent roadway.
