Performance of Transportation Infrastructure During Kumamoto Earthquakes of April 14 and 16, 2016— A Reconnaissance Report

PUBLICATION NO. FHWA-HRT-22-110

MARCH 2023

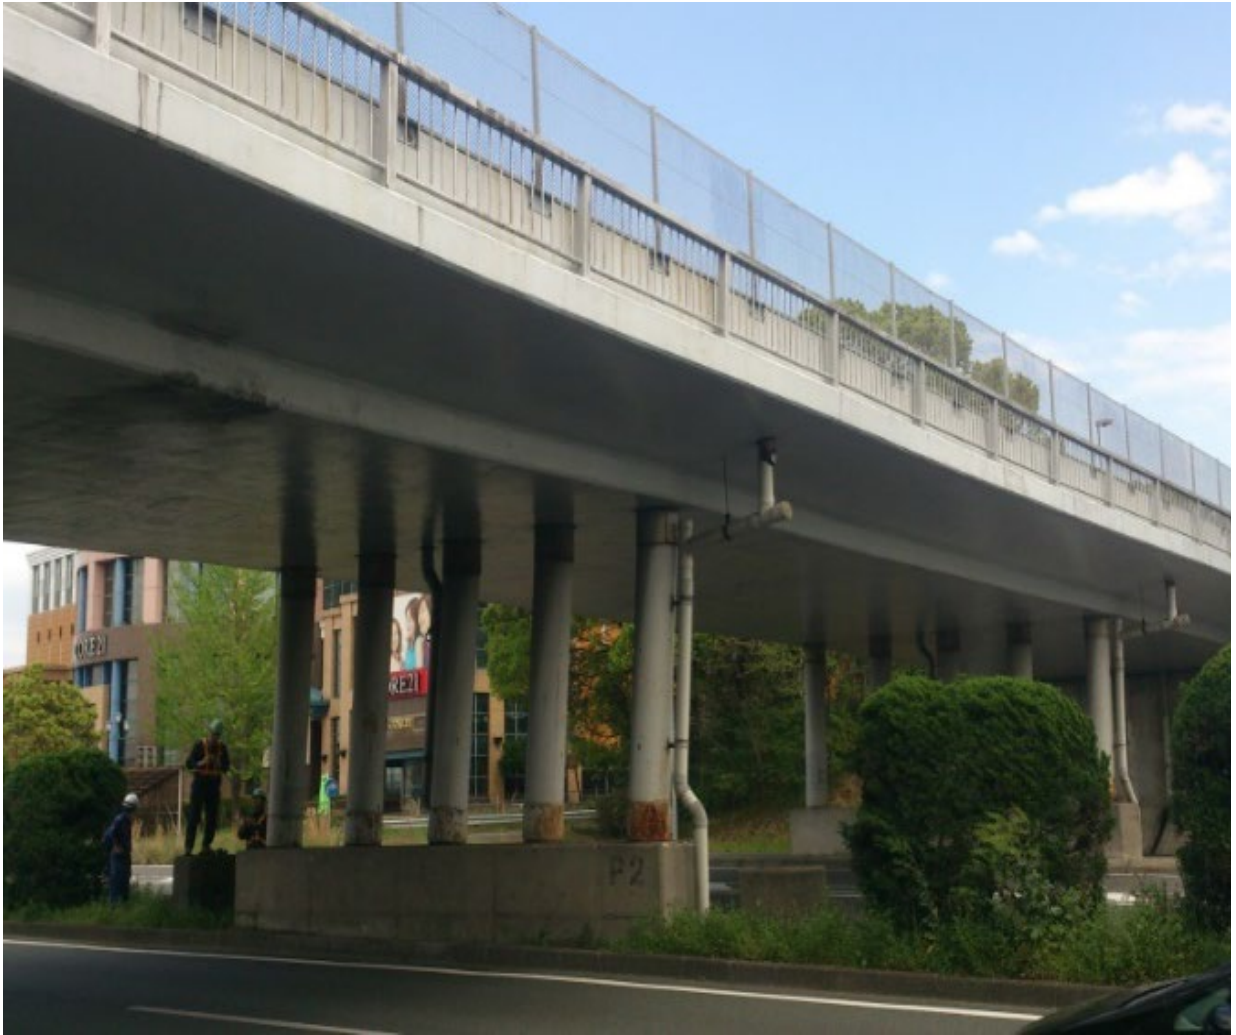
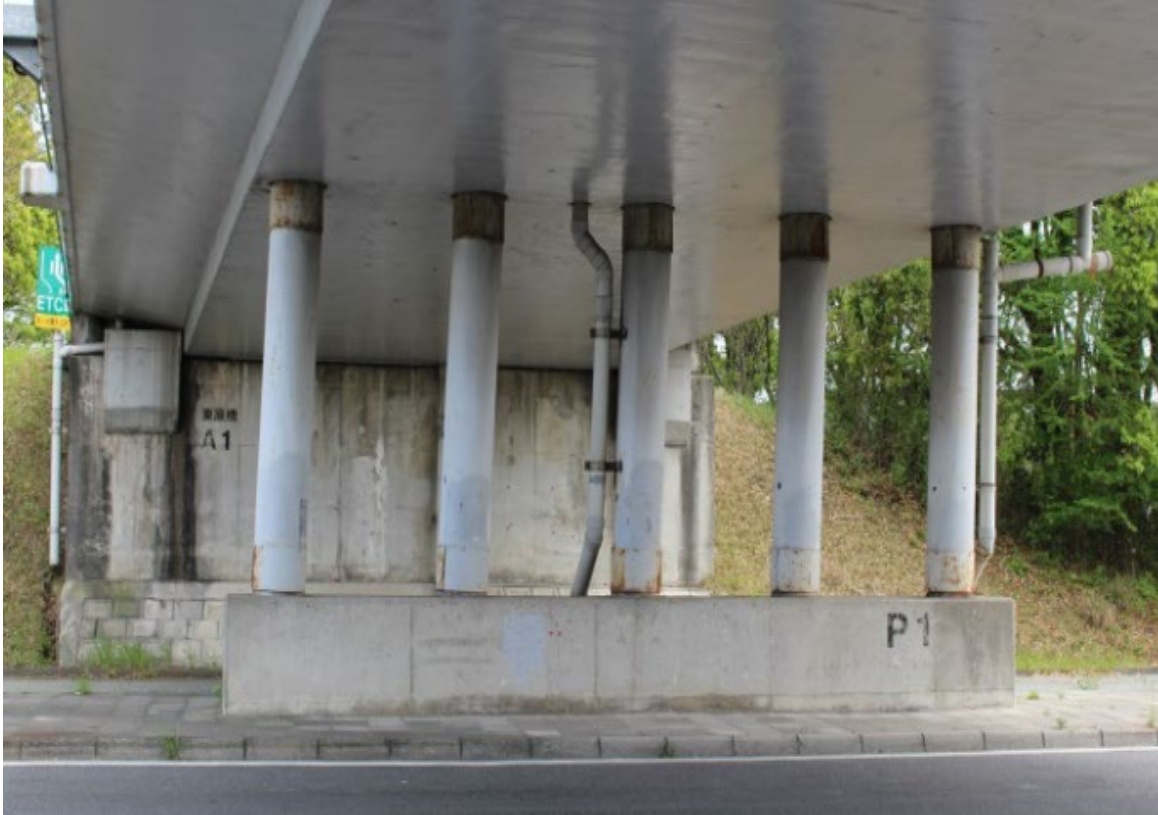
Earthquake damage to the bridge consisted of permanent lateral deformations and damage to abutment A2 (figure 112, figure 113, and figure 114). Damage to the shear keys led to permanent lateral deformation of the bridge. There was no damage to abutment A1.

Figure 112. Photos. Inclination of pinned columns after the earthquake.²²

At the time the team visited the bridge, repairs had already occurred: the columns had been completely encapsulated in concrete (figure 115), and the abutment had also been repaired (figure 116). In effect, the bridge had been converted from a system with pin-pin columns to a pier-wall system with shear keys to constrain lateral movement.

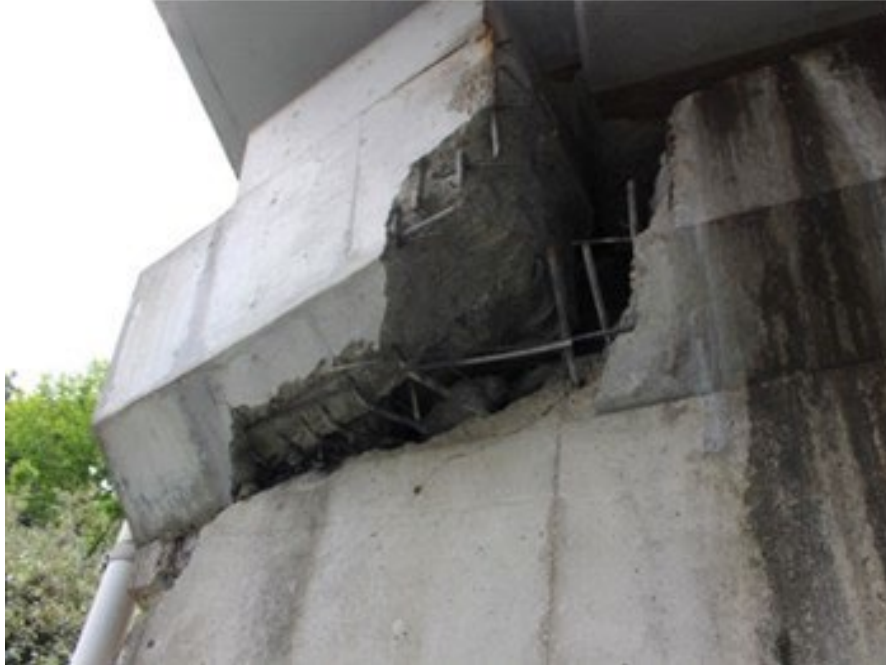
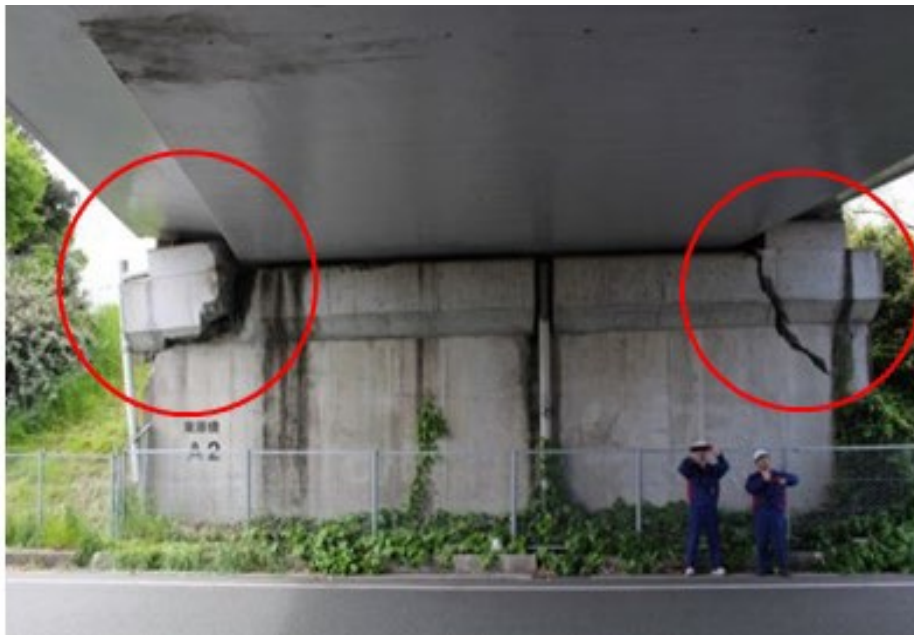
Figure 113. Photos. Shear key damage at abutment A2.²³

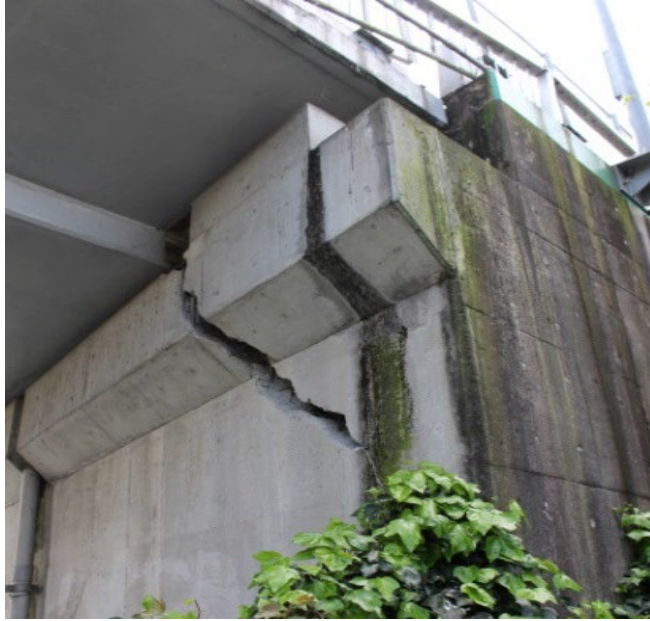
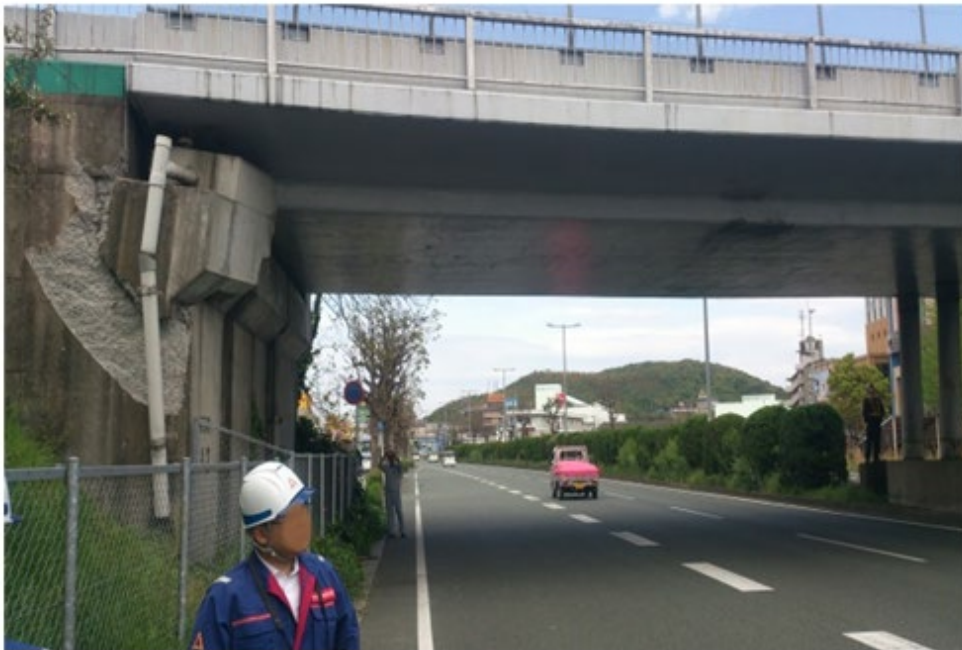
Figure 114. Photos. Side view shear key damage at abutment A2.²⁴

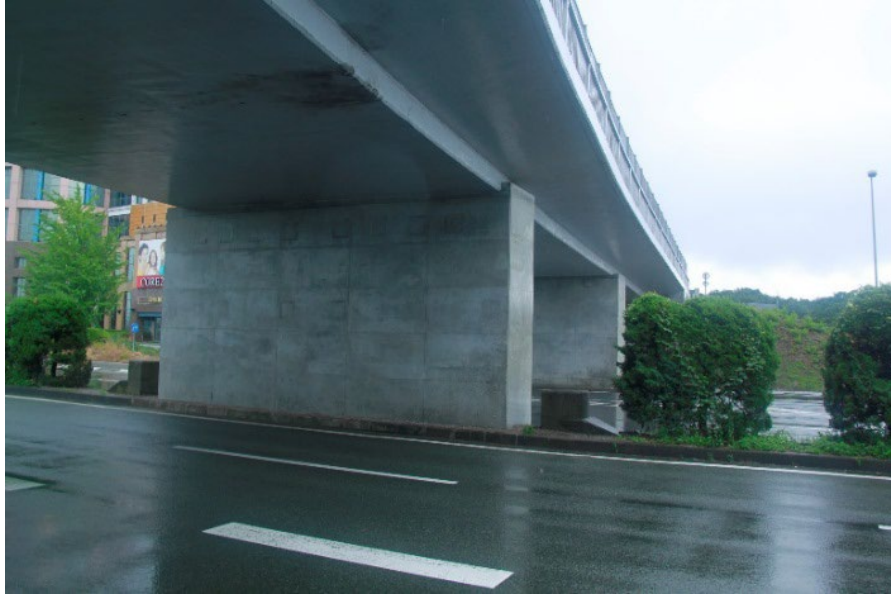
Figure 115. Photo. Repaired piers.

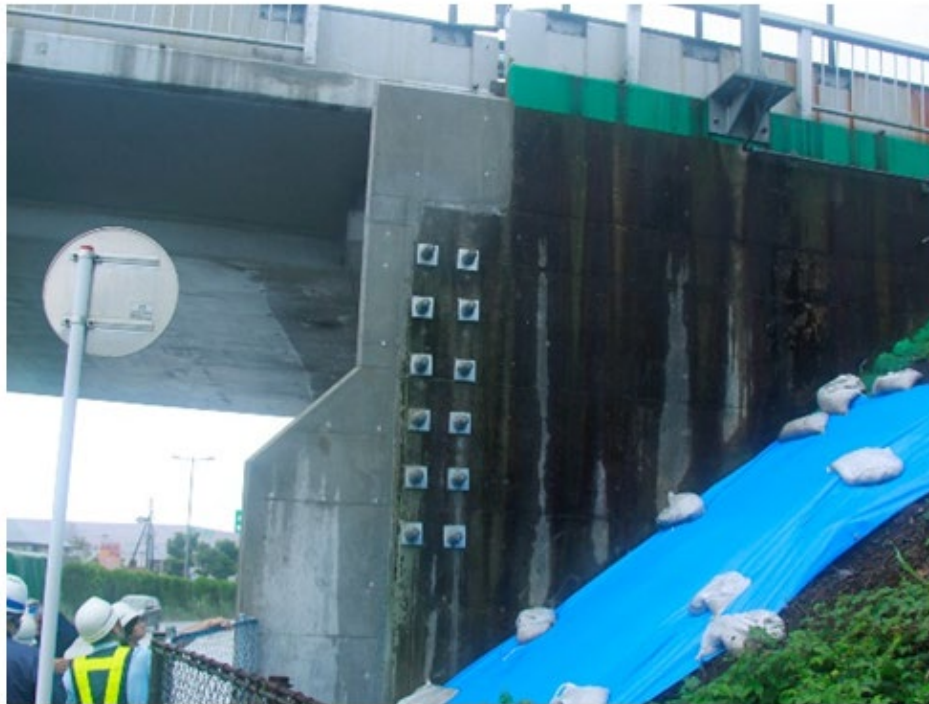
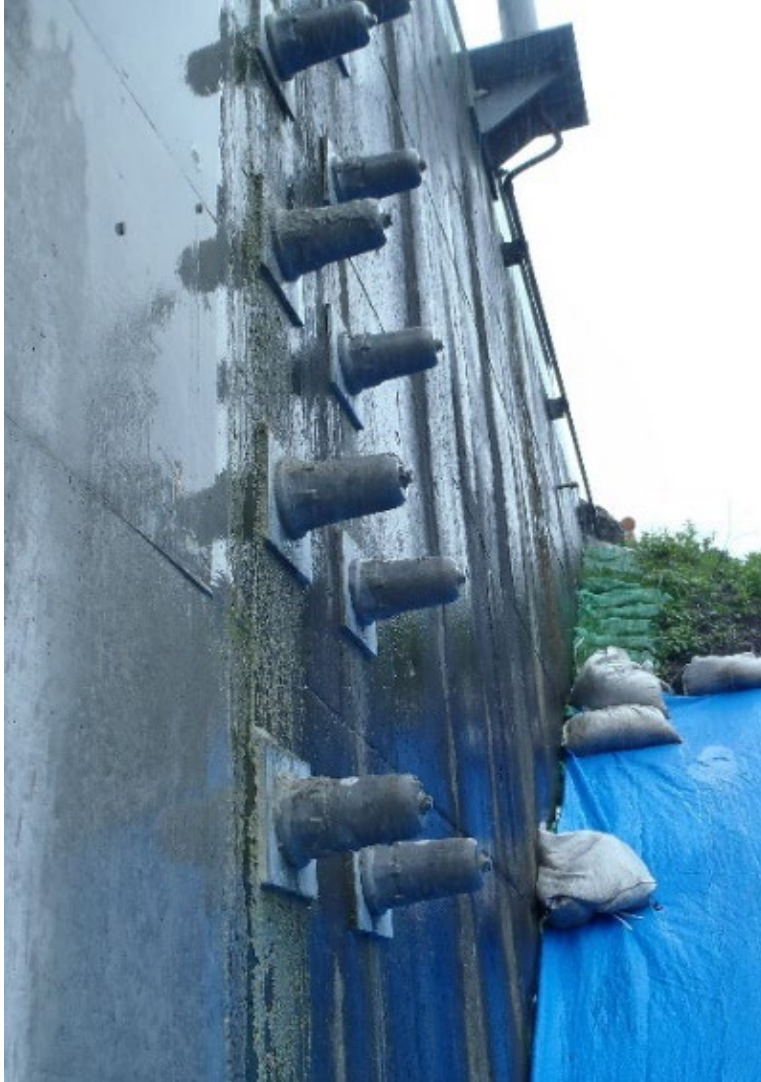
A. Overview.

B. Close-up.

Figure 116. Photos. Repaired abutment A2.

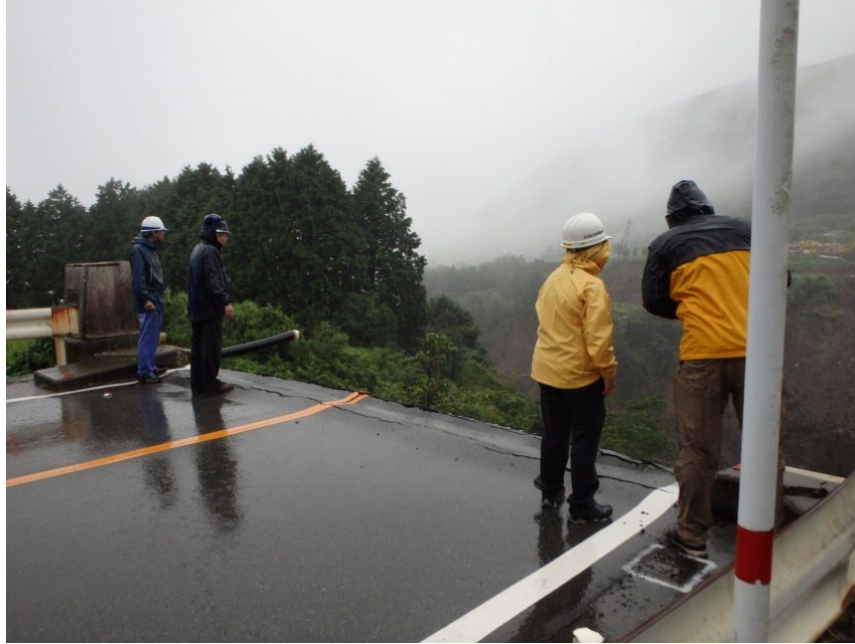
During the earthquake, a massive landslide occurred immediately upstream and above the west abutment. The arch springing just below this abutment was totally undermined, and it collapsed into the river gorge below, taking with it the remainder of the bridge. At the time of the reconnaissance, the east approach remained, and the views from this abutment are shown in figure 120 through figure 124.

Figure 120. Photo. Remainder of the approach slab at the east abutment.

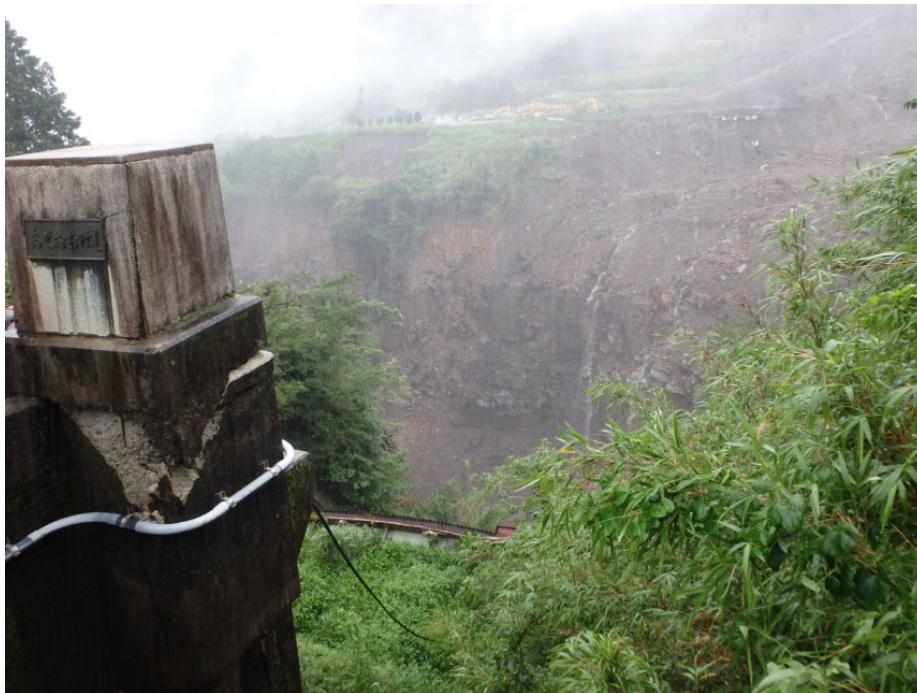
Figure 121. Photo. Remainder of the east abutment and unseated first span.²⁸

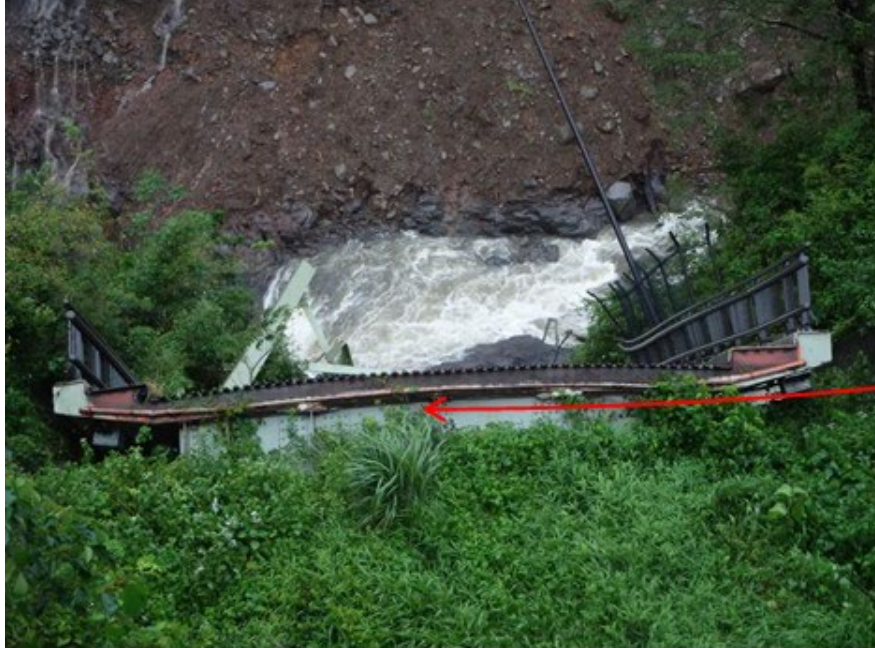
Collapsed bridge section

Figure 122. Photo. Unseated first span below the east abutment.²⁹

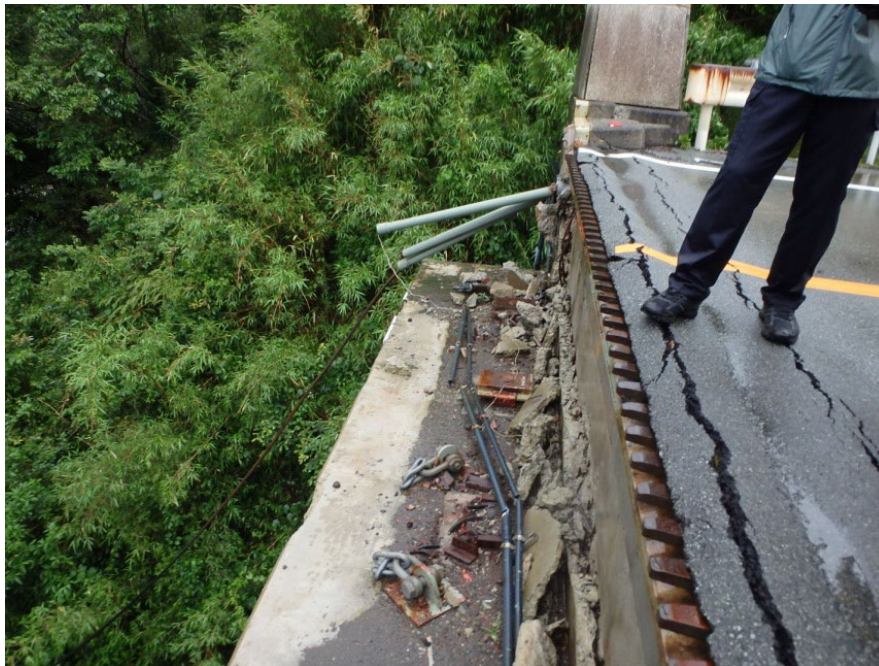
Figure 123. Photo. Seat and back wall of the east abutment and remainder of the expansion joint.³⁰

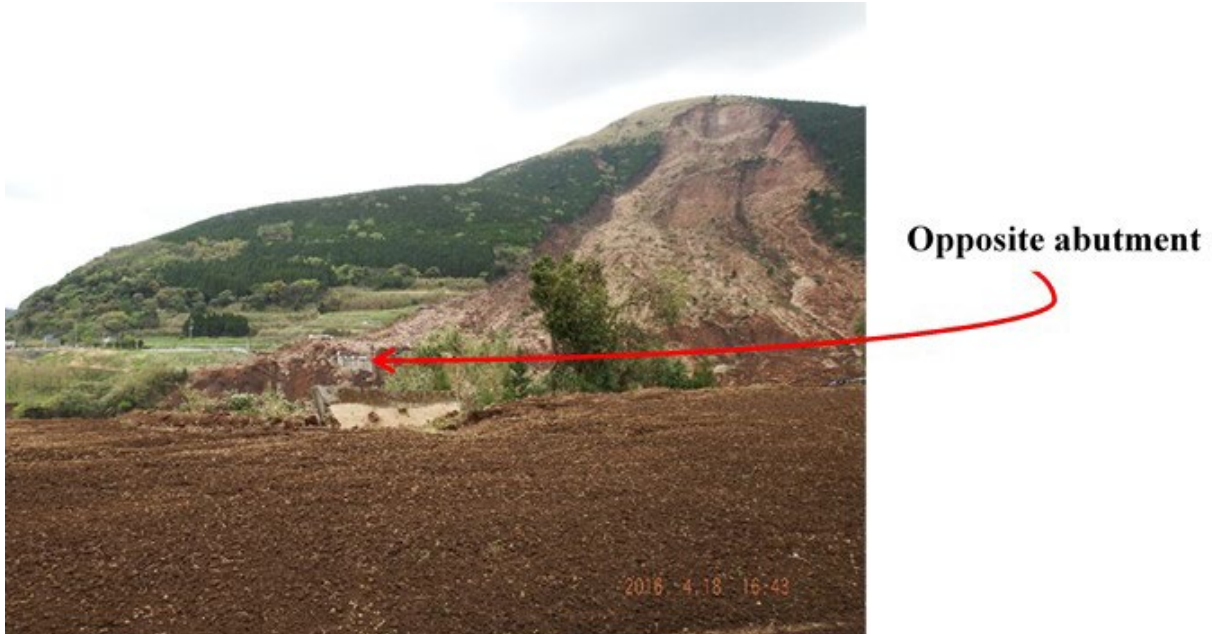
Figure 124. Photo. Landslide upstream of the west abutment across the gorge causing bridge collapse.³¹
