LTPP Pavement Maintenance

Materials: PCC Partial-Depth Spall Repair Experiment, Final Report

PUBLICATION NO. FHWA-RD-99-153

OCTOBER 1999

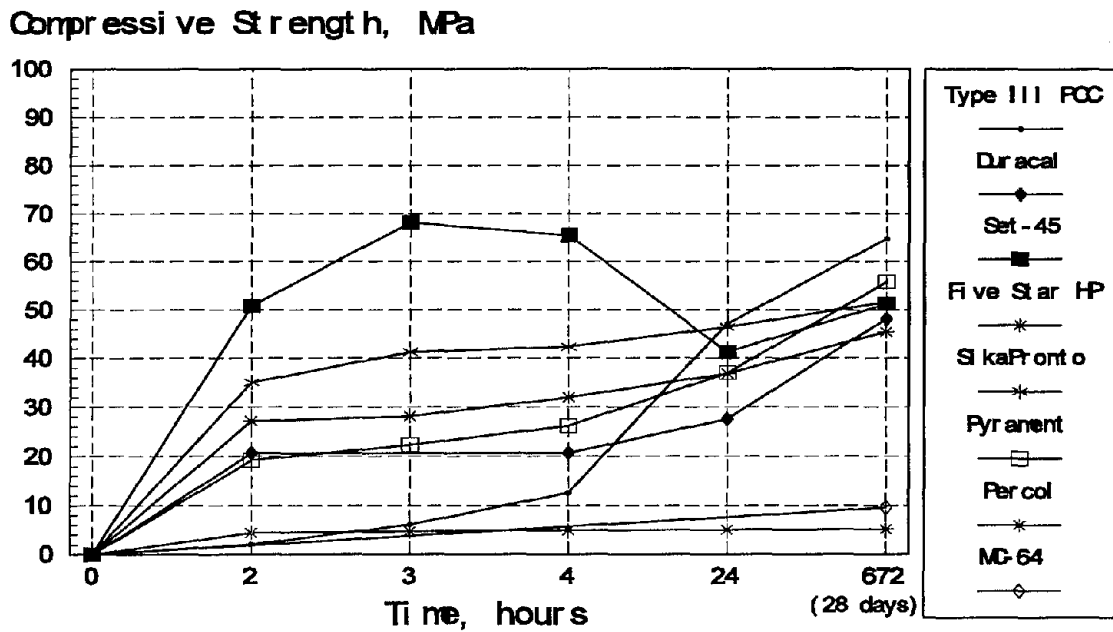
Figure 18. Compressive strengths of spall repair materials.

Compressive strength is often used for specifying and evaluating cementitious spall repair materials. For rapid repairs, early strength gain is of interest. Figure 18 shows the strength-gain curves for the spall repair materials that were tested. It is interesting to see that materials with the highest early strengths were not necessarily those with the highest ultimate strength. The unusual strength-gain curve for Set-45 could not be explained. Based on the Least-Squares Difference T-test and a confidence level of 95 percent, at 2 hours, Set-45 was significantly stronger than the other materials, and Percol FL and Type III PCC were significantly weaker than the others. However, at 28 days, Type III PCC was significantly stronger than all other materials, with Pyrament 505 having the next highest compressive strength. MC-64 and Percol FL were significantly lower in compressive strength than all other materials at 28 days. Set-45, Five Star HP, and Duracal were not significantly different in terms of compressive strength at 28 days.

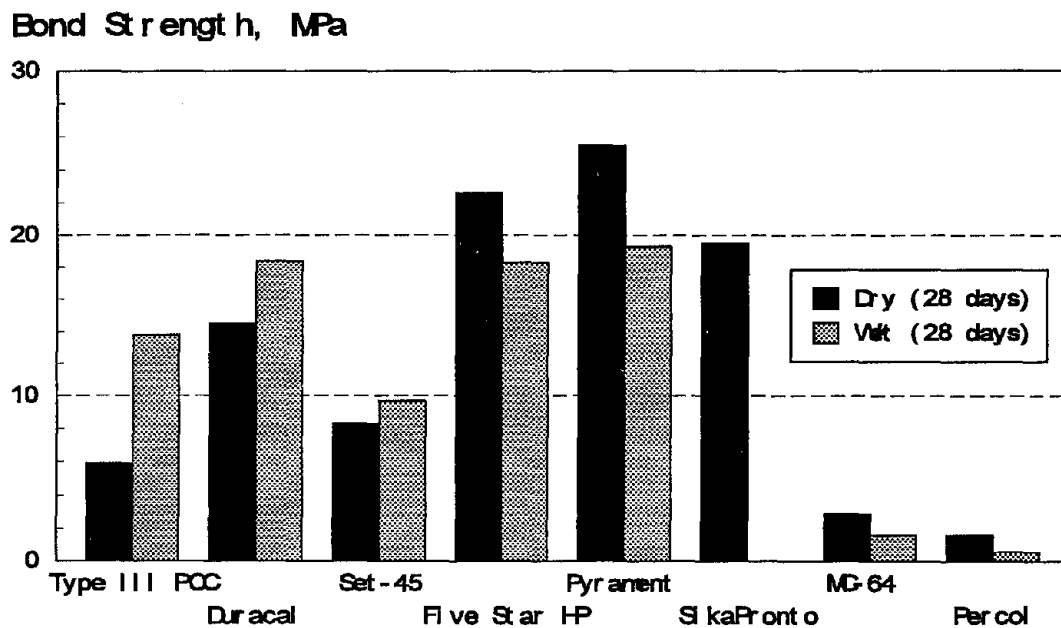
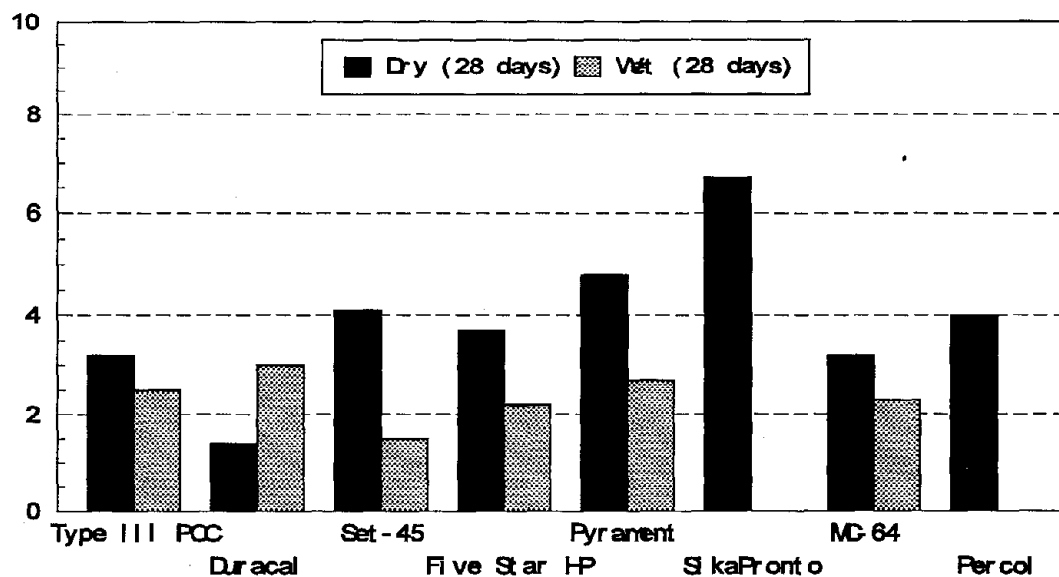
Bond strength is thought to be an important factor in determining field performance. The bond strengths of the spall repair materials are shown in figures 19 and 20. It is interesting to note that, in general, the bond strengths of the materials that were specified to be installed wet decreased when tested using a dry substrate, and materials that were specified to be installed dry lost bond strength when tested using a wet substrate.

Several exceptions to that statement should be noted. Percol FL, whose manufacturer claims that the material is moisture-tolerant, lost strength significantly when applied to a wet substrate. Also, Five Star HP and Pyrament 505 manufacturers recommended that their materials be applied to a saturated, dry (SSD) surface. The slant-shear and center-point bond strength tests indicated that the bond strength was weaker when applied to a wet substrate. It can also be seen that some materials were more tolerant of changed conditions than others. A partial listing of the results of the tests for the cementitious and polymeric materials is given in table 11. Table 12 gives the results of the tests on the bituminous materials when tested using a wet substrate.

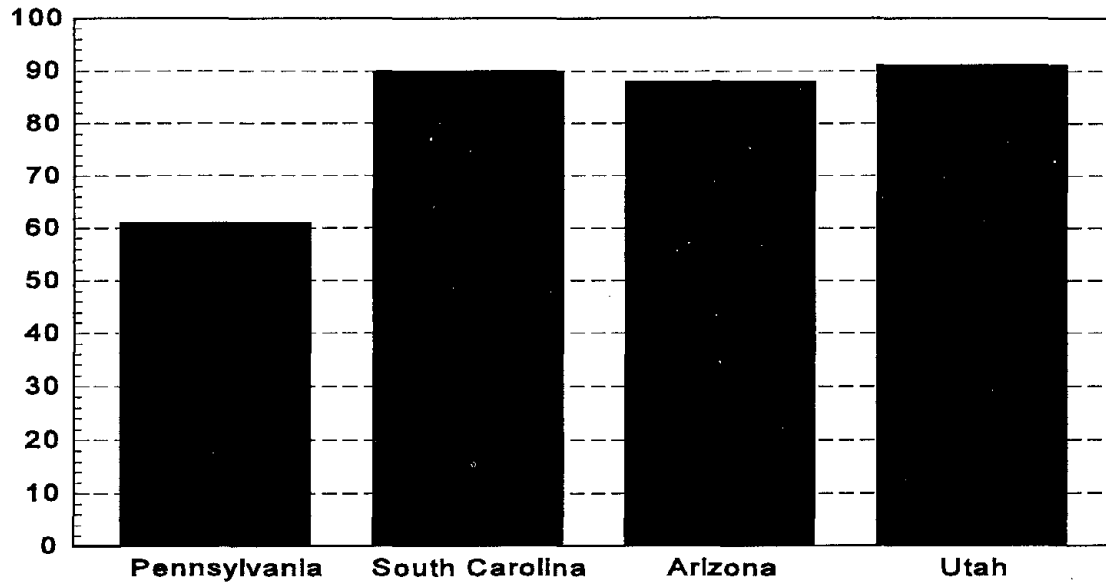
Figure 21. Percentage of surviving patches by test site.

Conceptually, a patch is considered failed if it can no longer service traffic safely. As seen in figure 21, as of the final evaluations, 39 percent of the patches were failed at the Pennsylvania test site, 12 percent were failed at the Arizona test site, 10 percent were failed at the South Carolina test site, and 9 percent were failed at the Utah test site.

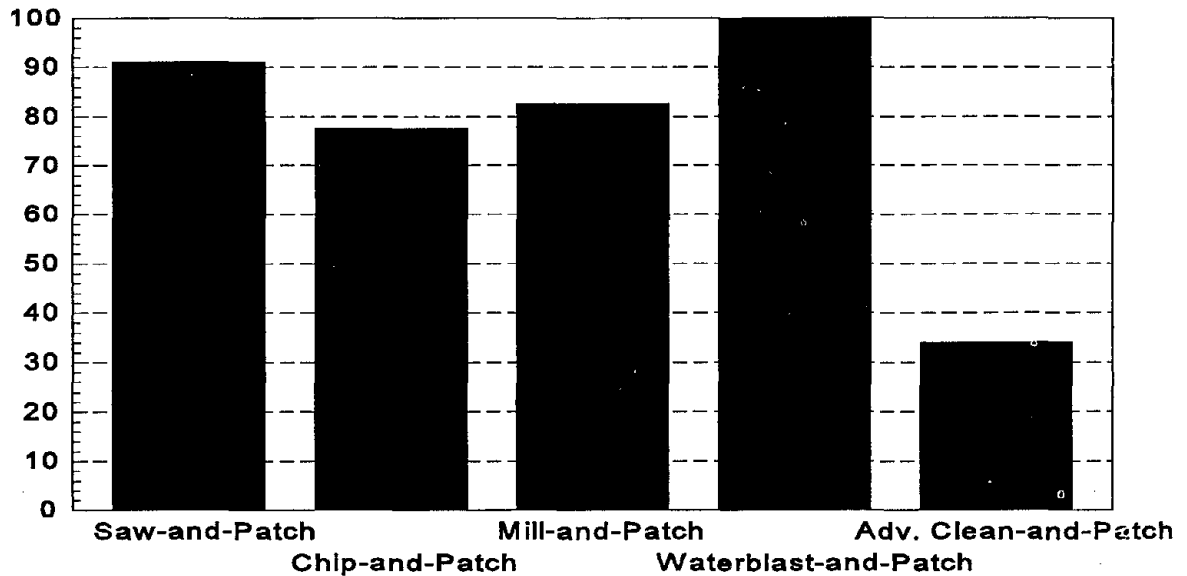
Figure 22. Percentage of surviving patches by concrete-removal procedure.

Of the concrete-removal procedures, the adverse-condition clean-and-patch procedure, not surprisingly, showed the highest percentage of patch failure at 66 percent (figure 22). The procedures conducted under normal conditions experienced patch failure rates as follows: chip-and-patch at 23 percent, mill-and-patch at 17 percent, and saw-and-patch at 9 percent. The waterblast-and-patch had no failures. It should be noted that the waterblast-and-patch result was based on 26 patches placed at the Utah test site, the saw-and-patch result was based on 613 patches, the chip-and-patch on 742 patches, the mill-and-patch on 140 patches, and the adverse-condition clean-and-patch on 56 patches.

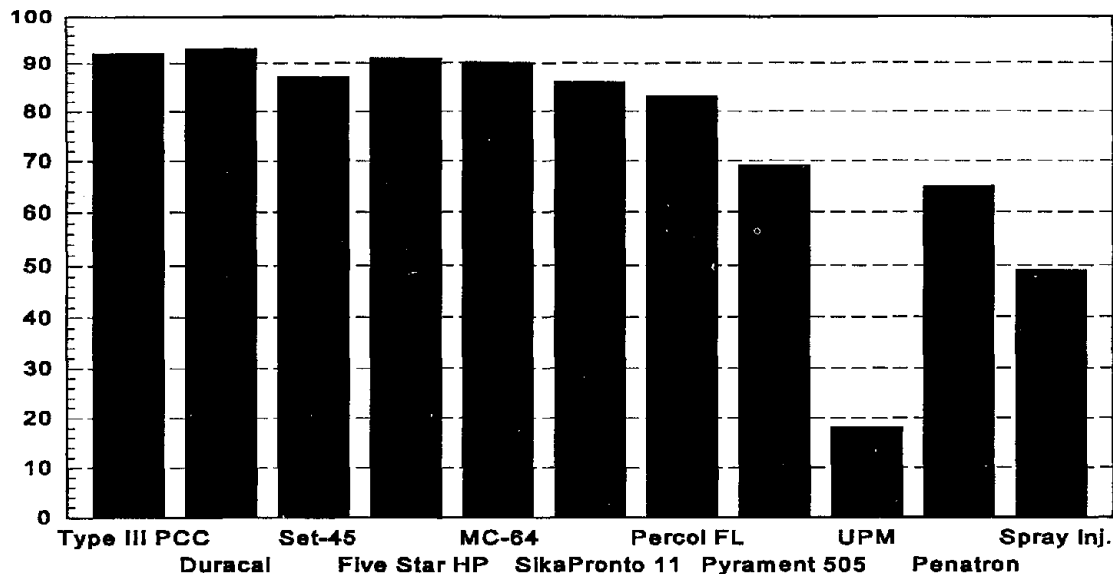
Figure 23. Percentage of surviving patches by material.

The percentages of surviving patches at the final inspection for each site are shown in figures 21 through 23, grouped by site, procedure, and materials, respectively. It is important to note that these charts do not provide rankings of patch performance, but are simply a means of showing the overall performance percentages. Chapter 5 presents the statistically
