# LOCAL ROAD SAFETY PLAN

## PALM BEACH COUNTY LOCAL ROAD SAFETY PLAN DEVELOPMENT

Intersection of Lake Worth Rd (FL 802) & S. Jog Road

Rank 12, Intersection ID 1712

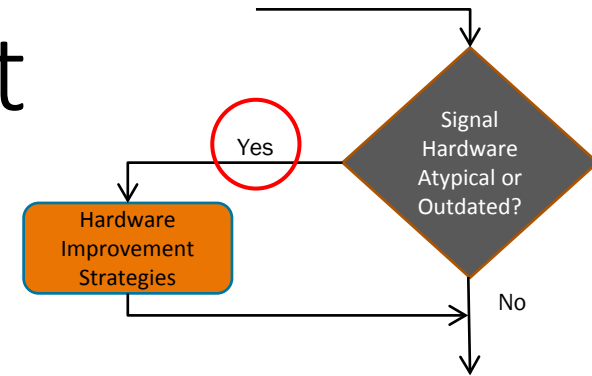
- ❑ Signal heads appear to be outdated (chipped paint) and are inconsistent (based on visual inspection)
  - Some signal heads have LED lenses while some do not
  - EB and WB signal heads have background shields, while NB and SB approaches do not
- ❑ Current signal heads are 12”

- ❑ Improve Signal Visibility:
  - Install signal background shields on northbound and southbound heads to improve visibility.
  - Install supplemental mast arm-mounted signal heads so that each lane has a dedicated signal head. This included mast arms on the approach side and far side of the intersection.

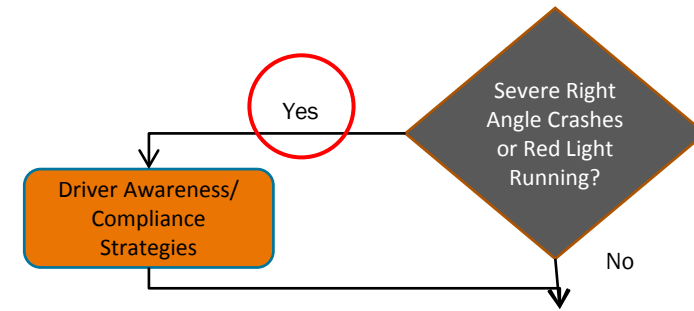
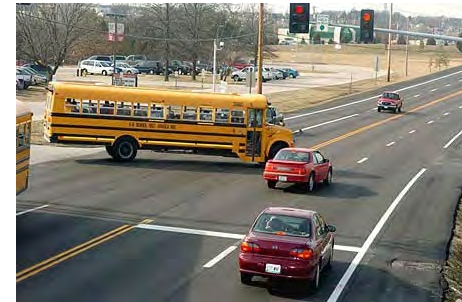
- ❑ The intersection experienced 1 fatal crash and 2 serious injury crashes from 2011 through 2015. Of these crashes, the single fatal crash and one of the serious injury crashes were right-angle crashes.

- ❑ There were 6 red-light running crashes from 2011 through 2015, of which 3 were minor injury, 1 was possible injury, and 2 were property damage only.

- Neither of the angle crashes were noted as visibility-related; however, **visibility will be addressed with upgraded signals as previously noted.**

- The fatal crash involved a pedestrian and will be best addressed with pedestrian-specific countermeasures.
  - The volume of angle crashes is low – advanced dilemma warning systems may address the crashes but the cost is significant. **An advanced dilemma system is not recommended at this time.**

- Red-light running compliance lights combined with enforcement may reduce these crashes; however, these are not the target crashes. Confirmation lights are not recommended.

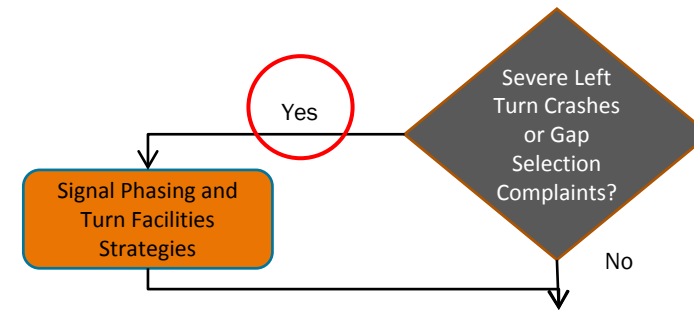
- ❑ 11 crashes involved left turns of which 3 were severe. Specific details on gap acceptance were not available, though they are presumed unrelated given the protected left turn signal timing (assumed based on number of lanes).
  - Storage length of turn facilities is enough to accommodate peak turning movements without through blocking.
- ❑ Turn radius analysis was completed using AutoTurn (design vehicle: WB-62). (Details next figure)
  - It appears concurrent eastbound to northbound and westbound to southbound left turn movements have almost no clearance, which may be slowing down turning traffic. This may be leading to the high level of “Following Too Closely” Crashes (29 crashes).

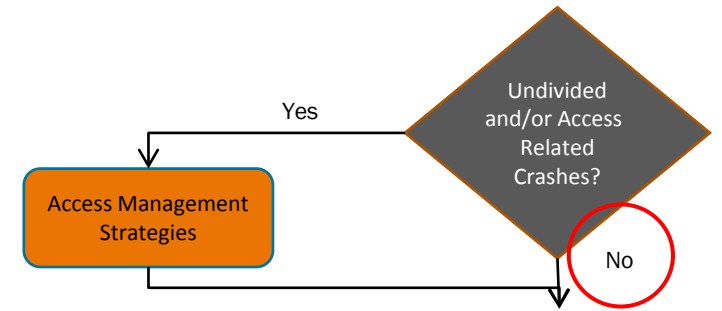
All of the approaches are divided and all of the access points are right-in/right-out. Therefore, **access management improvements are not recommended.**

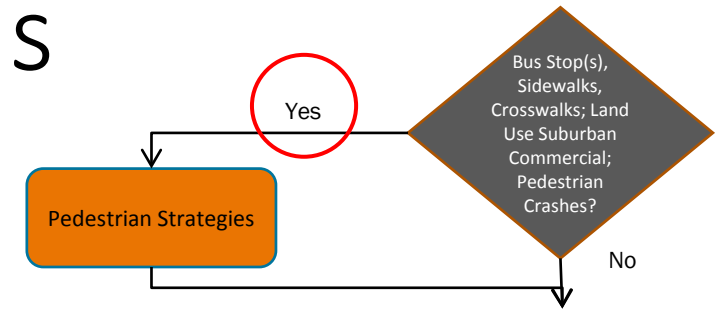
- ❑ The one fatal crash at the site involved a pedestrian. Additionally there is:
  - Evidence of high volume pedestrian traffic
  - Presence of handicapped sidewalk/crosswalk users
  - Two bus stops within 500' on all four legs (totally eight bus stops)
  - Existence of surrounding businesses that generate high volume of pedestrian traffic
  - Crosswalks with long crossing distances (150'-170')
- ❑ Recommended pedestrian upgrades include
  - **Pedestrian countdown timers with pedestrian leading interval signal timing**
  - **Future consideration for raised pedestrian refugee islands** (likely width would have to be taken from lanes and added to median)

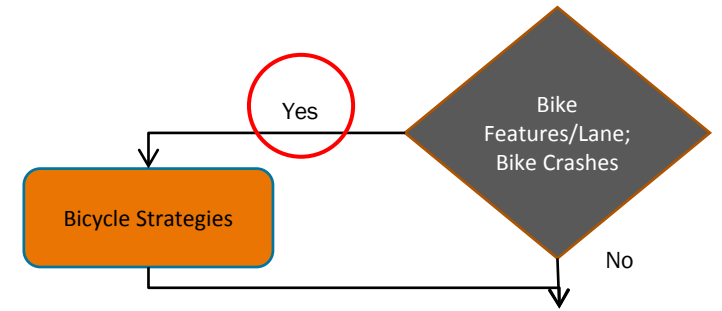
- Bike lanes already exist along all approaches in all directions.
- 5 injury crashes involving bicycles occurred from 2011-2015.
- Proposed bicycle features include **leading bicycle interval signal timing**, and marking the **full bike lane with green markings and white bicycle markings**.
- Advanced bicyclist facilities, like bike bokes and bicycle detectors, should be considered only after lower cost countermeasures do not improve bicyclist safety.
