U.S. Department
of Transportation
**Federal Highway
Administration**

In Reply Refer To:
HSST-1/SS-185

- Telespar Sign Support

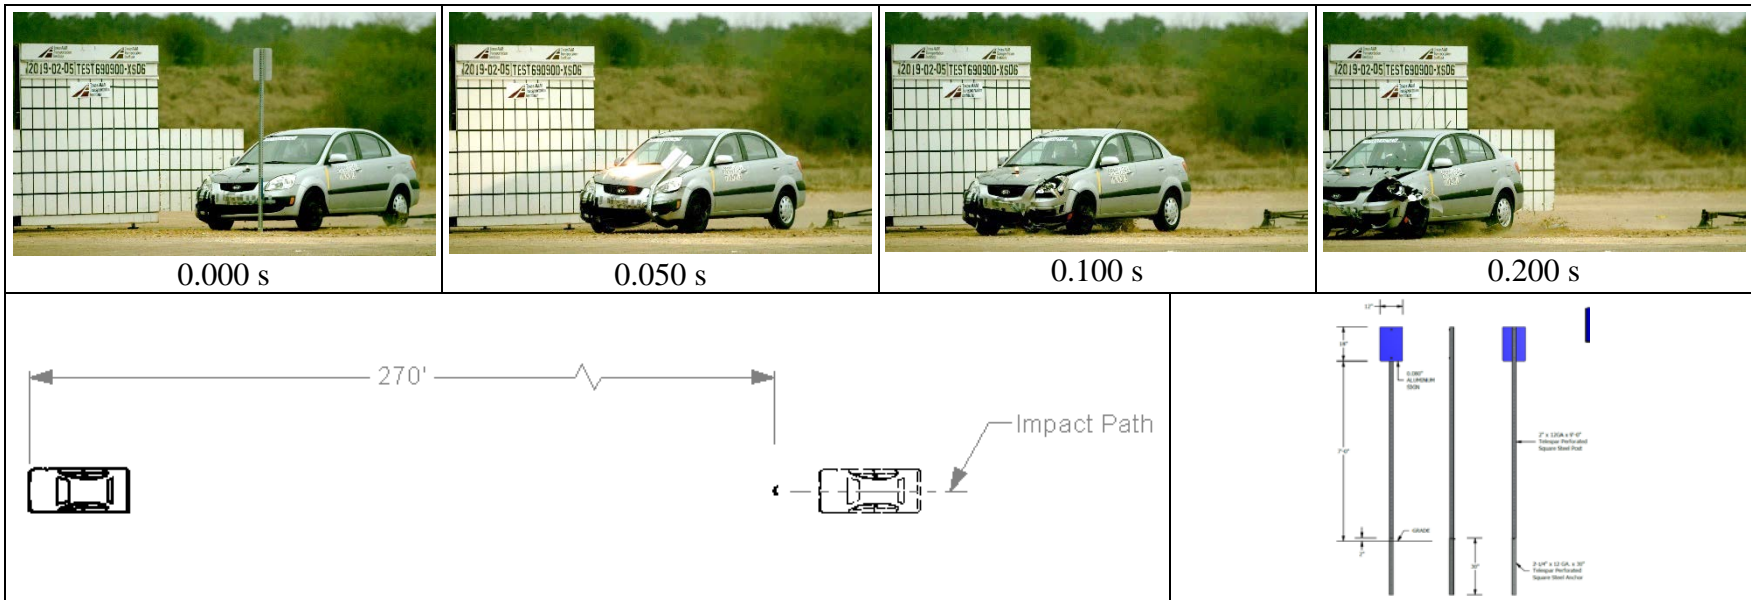
Figure 7.6. Summary of Results for MASH Test 3-61 at 0° on Telespar Sign Support.

Test Agency..... Texas A&M Transportation Institute (TTI)
 Test Standard Test No. MASH Test 3-61
 TTI Test No. 690900-XSD6
 Test Date 2019-02-05

VDS 12FL1
 CDC..... 12FLEN1
 Max. Exterior Deformation..... 1.5 inches
 OCDI..... FS0000000
 Max. Occupant Compartment Deformation None

Required Test Number	Narrative Description	Evaluation Results
3-61 (1100C)	<p>MASH Test 3-61 was successfully performed on the Telespar sign support system at both 0 and 90 degrees. In both tests, the support yielded and was overridden by the vehicle. The vehicle remained stable and upright. In the 0-degree test (690900-XSD 6), the support post was partially fractured at several locations, but the components of the sign support system remained intact. The vehicle sustained minor damage, including a 1.5-inch deep indentation in the hood. Occupant risk indices were within MASH thresholds. No occupant compartment deformation or intrusion was observed.</p> <p>In the 90-degree test (690900-XSD 7), the support post fractured and separated into two pieces. The lower 4 ft of the support remained with the anchor post. The sign detached from the upper section of the post. The vehicle sustained minor damage, including a 2-inch deep indentation in the hood. Occupant risk indices were within MASH thresholds. No occupant compartment deformation or intrusion was observed.</p>	PASS
