U.S. Department  
of Transportation  
**Federal Highway  
Administration**

The following device is eligible within the length-of-need, with details provided in the form which is attached as an integral part of this letter:

- Hercules Crash Cushion

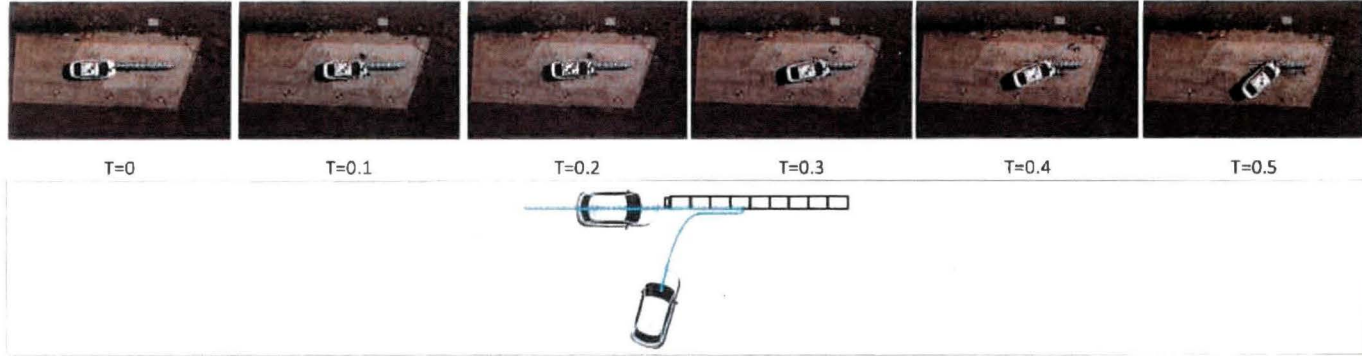
N° 0059\ME\HRB\18 Rev. 3

Test agency..... CSI S.p.A.  
Test No. .... 0059/ME/HRB/18  
Date..... 01/06/2018

Type..... HERCULES  
Installation length [m]..... 5.83  
Size and/or dimension and material of key Elements..... See attached drawings

Type/ Designation..... 1100C  
Model..... Kia Rio  
Mass [kg]  
Curb..... 1065.0  
Test Inertial..... 1114.2  
Gross static..... 1189.8

Speed [km/h]..... 97.2  
Angle [deg]..... 0.0  
Impact Severity [kJ]..... 433.7  
Impact Location..... Frontal, offset W/4, 0°  
Exit Speed [km/h]..... < 10  
Exit Angle [deg]..... 60.0

Vehicle Stability..... Satisfactory  
Stopping Distance..... 3 m upstream  
5 m lateral

Impact Velocity [m/s]  
X-direction..... 11.2  
Y-direction..... 0.8  
Ridedown Acceleration [g's]  
X-direction..... -18.2  
Y-direction..... -5.8

THIV ..... 40.5  
PHD ..... 18.2  
ASI 2010..... 1.11  
Test Article Damage .....

Permanent ..... 2.57  
Dynamic ..... 2.57  
Working Width..... N/A

See appendix A  
Maximum internal deformation..... 10 mm  
Maximum external deformation..... 280 mm

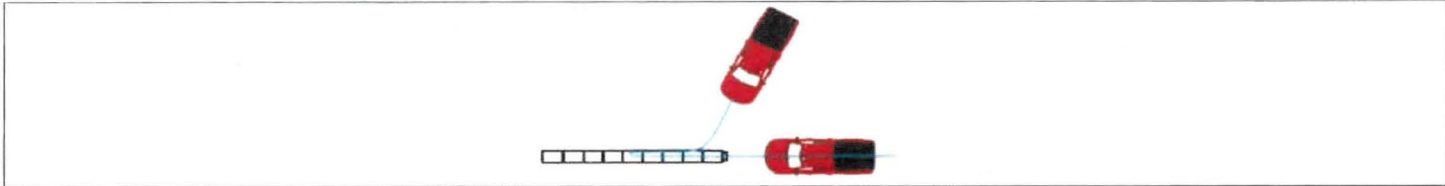
N° 0051\ME\HRB\18 Rev. 3

T=0 T=0.1 T=0.2 T=0.3 T=0.4 T=0.5

<b>General Information</b>		<b>Post-impact Trajectory</b>	
Test agency.....	CSI S.p.A.	Vehicle Stability.....	Satisfactory
Test No. ....	0051/ME/HRB/18	Stopping Distance.....	7 m upstream
Date.....	30/05/2018	Vehicle snagging.....	None
<b>Test Article</b>		Vehicle pocketing.....	None
Type.....	HERCULES	<b>Occupant Risk Values</b>	
Installation length [m].....	5.83	Impact Velocity [m/s]	
Size and/or dimension and material of key		X-direction.....	9.7
Elements.....	See attached drawings	Y-direction.....	0.1
Foundation type and condition.....	Concrete (anchored)	Ridedown Acceleration [g's]	
<b>Test Vehicle</b>		X-direction.....	-18.6
Type/ Designation.....	2270P	Y-direction.....	-1.5
Model.....	Dodge RAM 1500	THIV .....	35.0
Mass [kg]		PHD .....	18.6
Curb.....	2248.2	ASI 2010.....	1.25
Test Inertial.....	2282.6	Test Article Damage .....	Moderate
Gross static.....	2282.6	<b>Test Article Deflections [m]</b>	
<b>Impact Conditions</b>		Permanent .....	4.02

Speed [km/h].....	97.9	Dynamic .....	4.05
Angle [deg].....	0.0	Working Width.....	N/A
Impact Severity [kJ].....	844.0	<b>Vehicle Damage</b>	
Impact Location.....	Frontal, head centered, 0°	See appendix A	
Exit Speed [km/h].....	< 10	Maximum internal deformation.....	64 mm
Exit Angle [deg].....	10.0	Maximum external deformation.....	455 mm

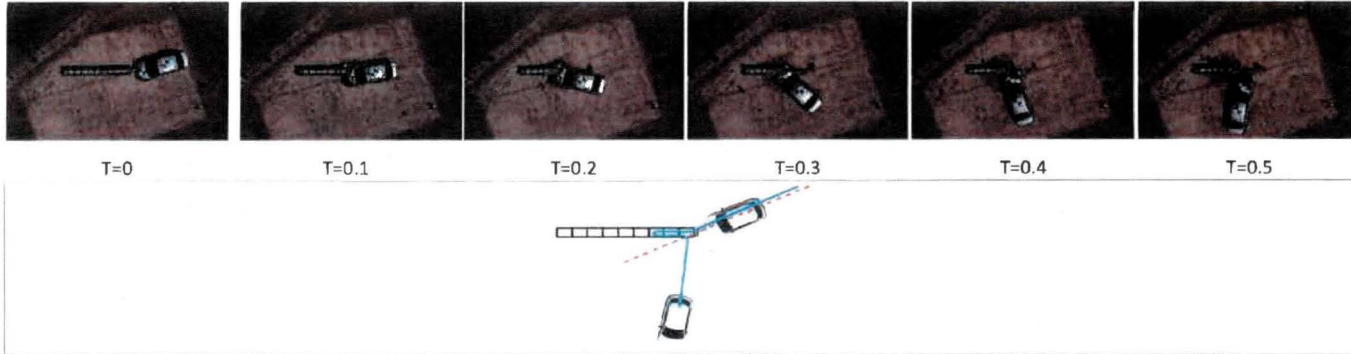
N° 0061\ME\HRB\18 Rev. 3

Test agency..... CSI S.p.A.  
Test No. .... 0061/ME/HRB/18  
Date..... 05/06/2018

THIV ..... 42.4  
PHD ..... 14.0  
ASI 2010..... 1.15  
Test Article Damage ..... Moderate

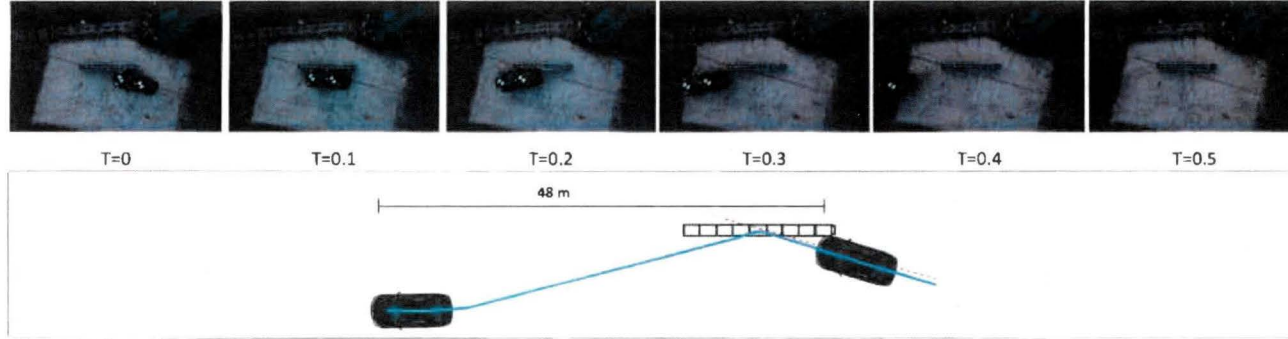
N° 0058\ME\HRB\18 Rev. 3

Test agency..... CSI S.p.A.  
Test No. .... 0058/ME/HRB/18  
Date..... 31/05/2018

THIV ..... 24.6  
PHD ..... 13.2  
ASI 2010..... 1.18  
Test Article Damage ..... Moderate

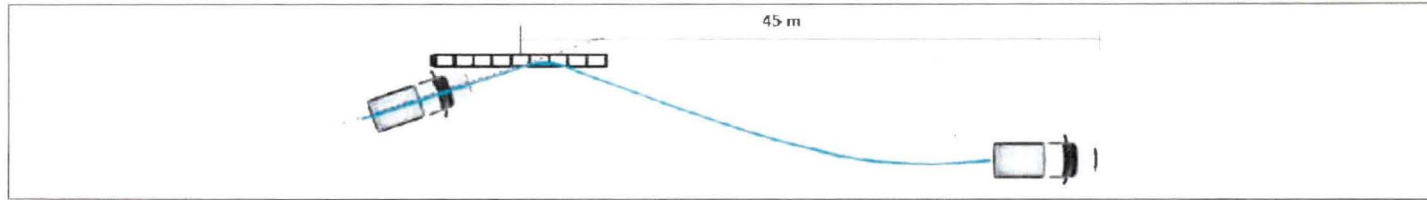
T=0 T=0.1 T=0.2 T=0.3 T=0.4 T=0.5

Test agency..... CSI S.p.A.  
Test No. .... 0046/ME/HRB/18  
Date..... 22/05/2018

Type..... HERCULES  
Installation length [m]..... 5.83  
Size and/or dimension and material of key  
Elements..... See attached drawings  
Foundation type and condition..... Concrete (anchored)

THIV ..... 30.9  
PHD ..... 11.8  
ASI 2010..... 1.29  
Test Article Damage ..... Moderate

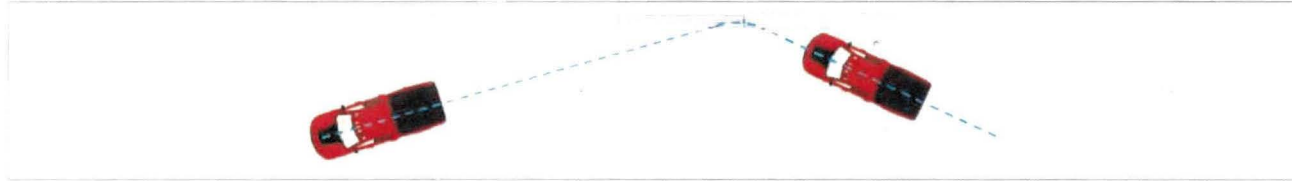
N° 0099\ME\HRB\18 Rev. 3

Test agency..... CSI S.p.A.  
Test No. .... 0099/ME/HRB/18  
Date..... 13/09/2018
