U.S. Department
of Transportation
**Federal Highway
Administration**

In Reply Refer To:
HSST-1/ WZ - 381

- Type III Barricade with X-Tube upright and footing

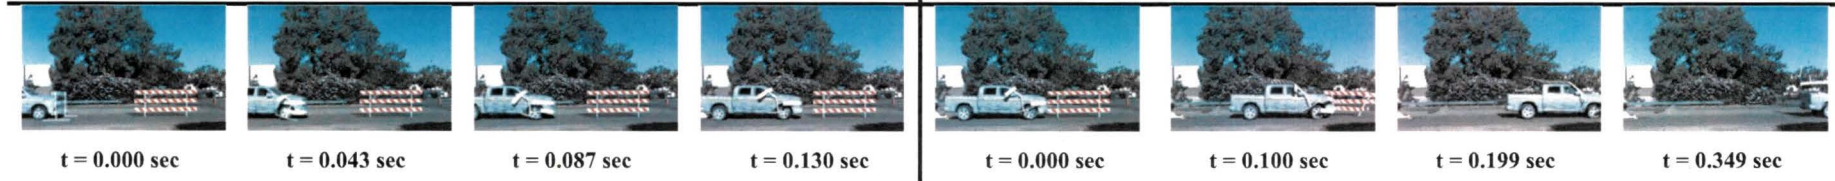
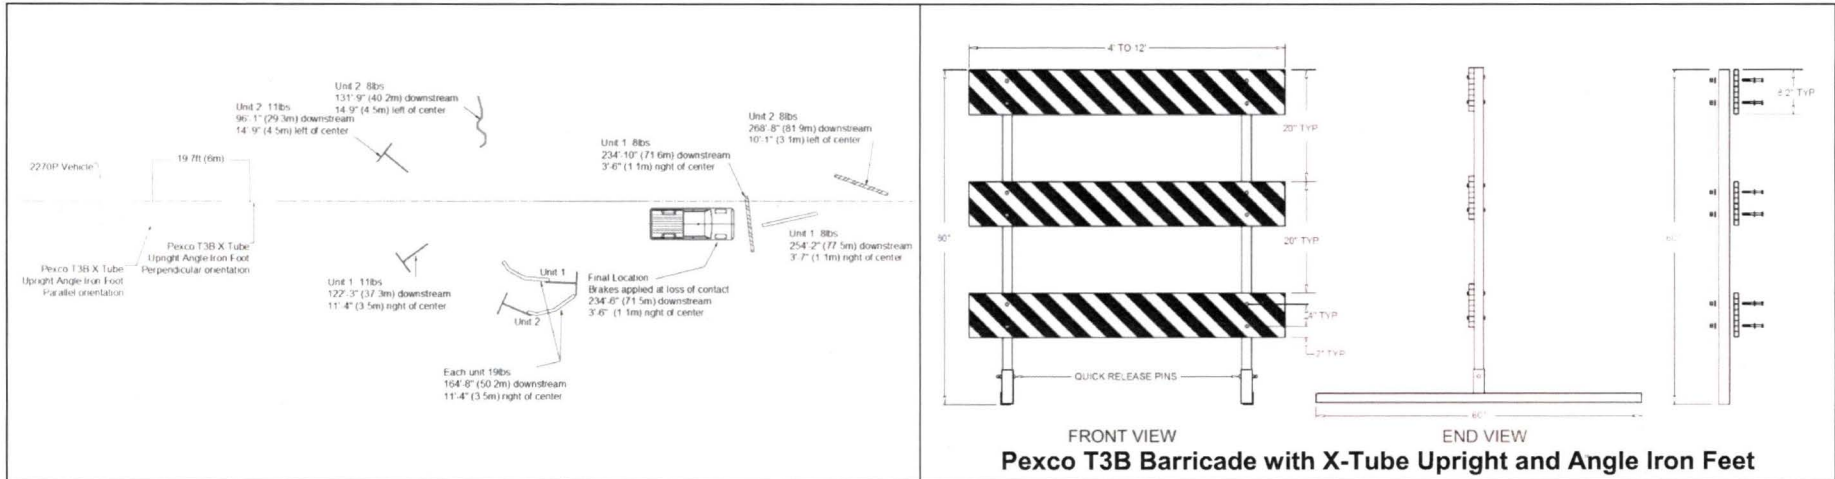
Normal (0 deg) Orientation

Perpendicular (90 deg) Orientation

Test Agency E-TECH Testing Services
 Test Designation MASH Test 3-72
 Test No. 81-0461-002
 Date 6/28/2017

Type Pexco
 12 m wide T3B Barricade with X-Tube Upright and Angle Iron Feet Work-Zone Traffic Control Device
 Dimensions 1.52 m OA Height x 3.66 m Wide
 Installation Details Three horizontal panels measuring 1.52 m, 1.02 m and 0.51 m high (Top of Panel to Grade)
 Material and Key and Elements 19.5 kg Complete, Steel Legs, RPVC Uprights and (3) 3.66 m wide HDPE Panels with Reflective Sheeting
 Foundation Type Asphalt, clean and dry and Condition

For the 90 deg test article, the 1100C vehicle's front bumper first impacted the cantilevered lower HDPE panel of the test article. The lower panel was pushed forward then buckled as the uprights began to deform. The lower corner of the middle panel then contacted the test vehicle's hood and buckled as it slid up towards the windshield. The lower corner of the upper panel initially contacted the vehicle's windshield and cracked/deformed the windshield as the panel began to buckle. The entire test article remained forward of the windshield and continued to push forward. Pieces of the test article began to separate as the vehicle came to rest.

The test vehicle sustained negligible damage to the front bumper, hood and roof. As the ends of the barricade (0 deg orientation only) wrapped around the front end of the car, it contacted the driver mirror which partially detached. There was deformation on the windshield from direct contact from the HDPE panel with reflective sheeting (90

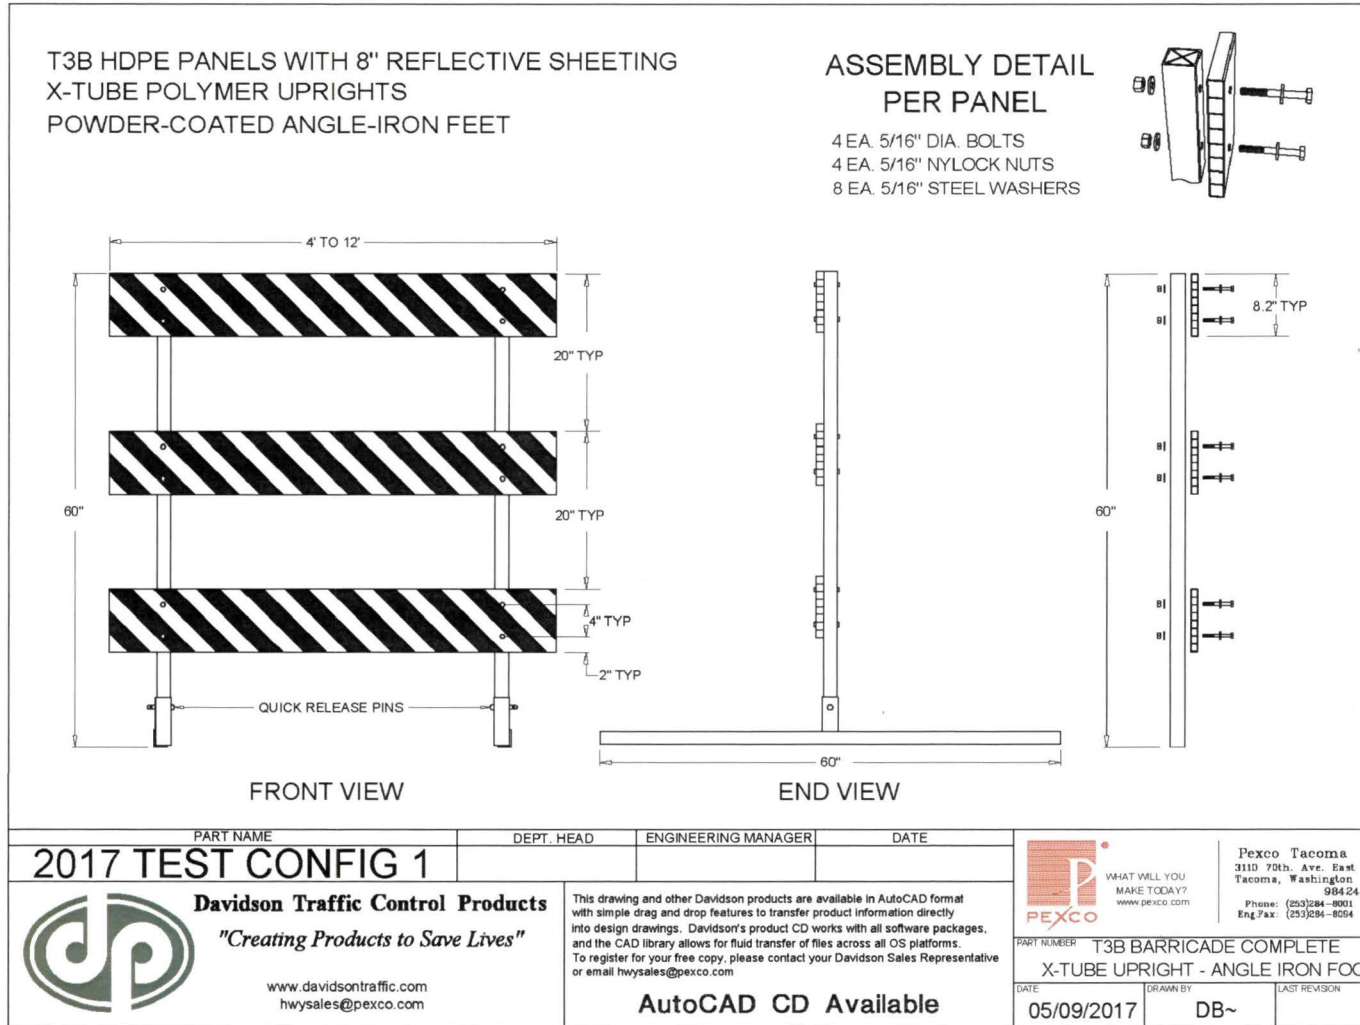
Illustration 1 – Pexco T3B Barricade with X-Tube Upright and Angle Iron Feet Technical Drawing

Appendix A - Details of Test Article
