• Dicke Safety Products TF18-RUB Traffic Control Sign

Name of system: Dicke Safety Products TF18-RUB Traffic Control Sign

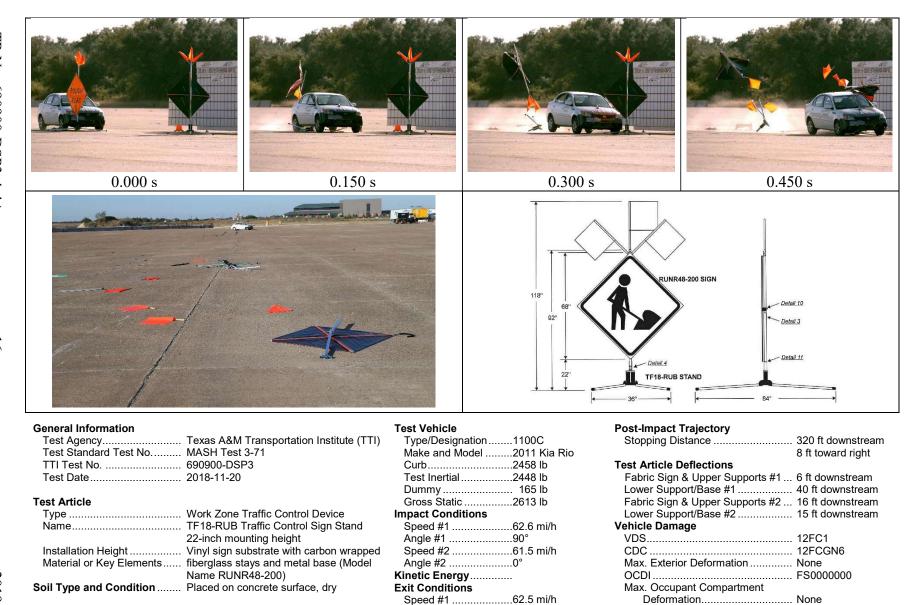
Figure 5.7. Summary of Results for MASH Test 3-71 on TF18-RUB Traffic Control Sign Stand.

Page 3 of 6
RequiredTest	Narrative	Evaluation
Number	Description	Results
3-71 (1100C)	MASHTest 3-71 involves an 1100C vehicle weighing 2420 lb ±55 lb impacting the traffic control device at an impact speed of 62 mi/h ±2.5 mi/h. Per MASH recommendations, the device was tested at critical impact angles (CIAs) of 90°±1.5° and 0°±1.5°. The results of test 690900-DSP3 conducted on November 20, 2018 are found in TTITest Report number 690900-DSP3-4-4a. The test vehicle was traveling at 62.6 mi/h when it contacted the first traffic control device at an impact angle of 90°, and was traveling at 61.5 mi/h when it contacted the second device at an impact angle of 0°. The vehicle came to rest 320 ft downstream of the impact and 8 ft to the right of centerline of the vehicle path. Both assemblies fractured into several pieces with the debris field measuring 15 ft left and 16 ft downstream of the first impact. There were scuff marks on the front bumper, hood, and windshield. The windshield was cracked, but there was no tear or hole. No measurable exterior crush to the vehicle was noted, and no occupant compartment deformation or intrusion was noted. MASH does not require instrumentation of the vehicle for tests of traffic control devices weighing less than 220 lb, thus, the occupant risk factors were not calculated for this test. The evaluation of the second impact was not hindered by the first impact. The device performed acceptably for MASH test 3-71.	PASS

0° ±1.5°. The results of test 690900-DSP4 conducted on November 20, 2018 are found in TTITestReport number 690900-DSP3-4-4a. The test vehicle was traveling at an impact speed of 62.7 mi/h when it contacted the first traffic control device at an impact angle of 90°. After impacting the first device, the pickup truck's trajectory slightly shifted, which caused the impact with the second device to be of a glancing nature, instead of fully engaging the device. This hindered evaluation of impact performance of the second device. Therefore, as eparate test (Test No. 690900-DSP4A) was conducted to evaluate the impact performance of the device at 0°. Test 690900-DSP4A is described below. In test 690900-DSP4, the vehicle came to rest 355 ft downstream of the impact and in the centerline of the vehicle path. The test assemblies fractured into several pieces with the debris field measuring 18 ft right and 260 ft downstream of the first impact. The front bumper and hood sustained scuff marksand two small dents. There wasa 2inch long \times 0.75 inch wide tear on the right front edge of the hood, and another 2.25inch long × 1.25-inch wide tear in the right rear of the hood. The windshield was cracked, but there was no tear or hole. No measurable exterior crush to the vehicle was noted (other than the above mentioned hood damage), and no occupant compartment deformation or intrusion was noted. MASH does not require PASS instrumentation of the vehicle for tests of traffic control devices weighing less than 220 lb, thus, the occupant risk factors were not calculated for this test. The device performed acceptably for MASH test 3-72 with an impact angle of 90°. The results of test 690900-DSP4A conducted on November 21, 2018 are found in TTITestReport number 690900-DSP3-4-4a. The test vehicle was traveling at an impact speed of 63.5 mi/h when it contacted the traffic control device at an impact angle of 0°. The vehicle came to rest 327 ft downstream of the impact and 10 ft to the left of the centerline of the vehicle path. The assembly fractured into several pieces with the debris field measuring 17 ft left and 155 ft downstream of the impact

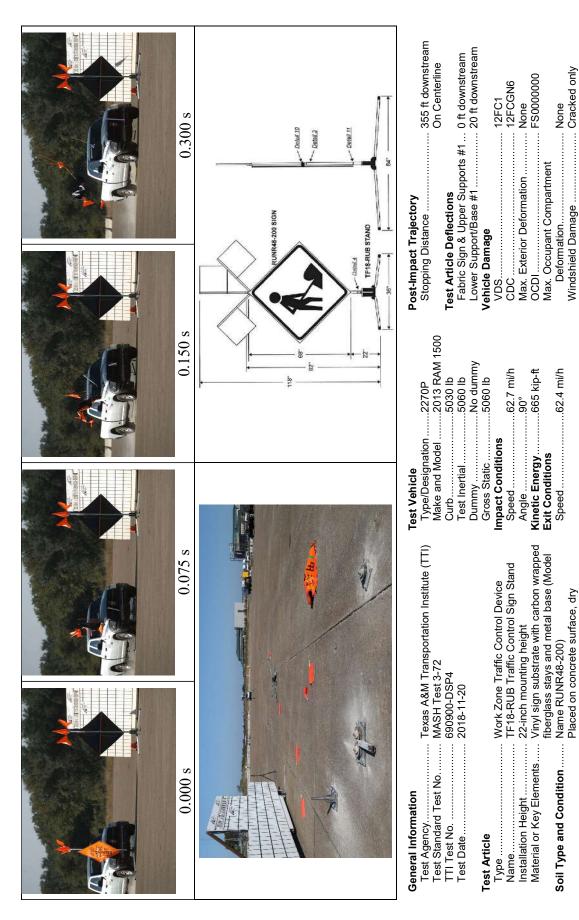
Figure 6.6. Summary of Results for MASH Test 3-72 at 90° on TF18-RUB Traffic Control Sign Stand.

recommendations, the device was tested at critical impact angles (CIAs) of 90° ±1.5° and

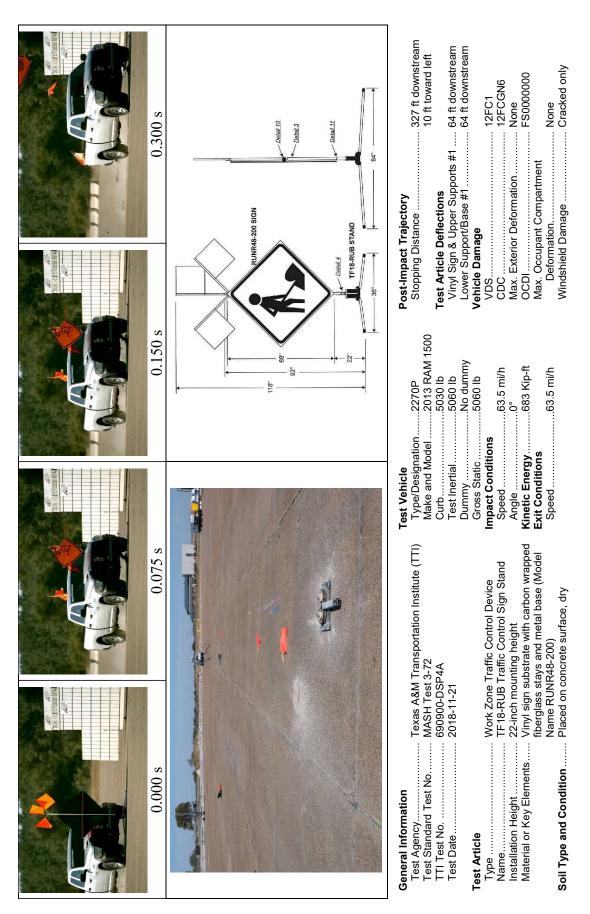
Figure 7.6. Summary of Results for MASH Test 3-72 at 0° on TF18-RUB Traffic Control Sign Stand.
