U.S. Department  
of Transportation  
**Federal Highway  
Administration**

In Reply Refer To:  
HSST-1/B-322

- HighwayGuard LDS

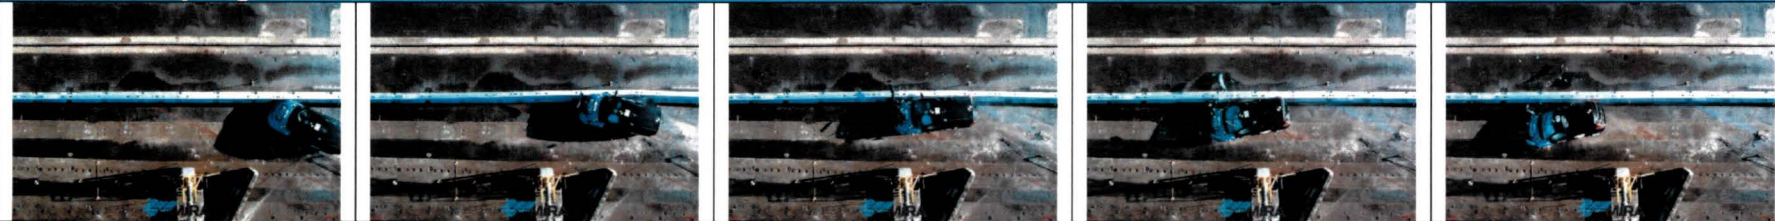
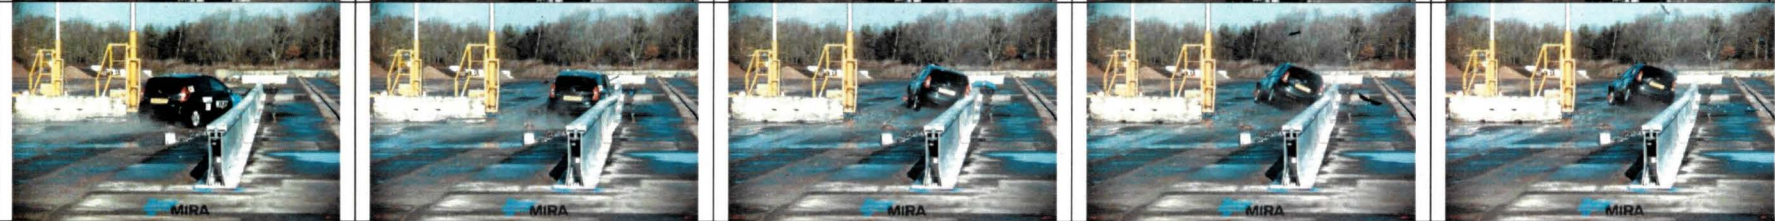
Test Summary Page

<b>4. General Information</b>		<b>10. Post-Impact Trajectory</b>		
Test Agency	HORIBA MIRA Ltd	Vehicle Stability	Satisfactory	
Test no.	W0207	Stopping distance ft. (m)	Braked to a halt 238 (72m) downstream and 118 (36m) in front of the traffic face.	
Test Date	23/01/2019	<b>11. Occupant Risk Values</b>		
<b>5. Test Article</b>		Impact Velocity ft./s (m/s)	X-direction	21.2 (6.45)
Type	HighwayGuard		Y-direction	-3.3 (-1.00)
Installation Length, ft. (m)	196.9 (60)	THIV (optional), ft/s (km/h)	20 (22)	
Size and/or dimension and material key elements, in. (mm)	Barrier Width: 21.3 (540), Barrier Height: 31.5 (800), Barrier Unit Length: 236.2 (6000). Ground fixings: 5 pairs of M24x330 threaded rod drilled into asphalt staggered along front and rear of system fixed with grout.			
<b>6. Ground Conditions</b>		Occupant Ride down Acceleration (g)	X-direction	-2
Test surface/Ground	Tarmac (roadway construction)		Y-direction	-5

<b>7. Test Vehicle</b>		PHD (g) (optional)	5	
Designation	1100C (Small Passenger Car)	ASI (optional)	0.9	
Make / Model	Nissan Note (VIN: SJNTAAE12U1001327)	<b>12. Test Article Damage</b>		
Mass, lb (kg)	Kerb 2337.3 (1060)	Minor damage to barrier front face with some denting and bending. Bending to barrier anchor plate at IP and ground anchor rod at IP lifting 3.34in (85mm)		
	Test Inertial 2418.9 (1097)	<b>13. Test Article Deflections</b>		
<b>8. Impact Conditions</b>		Dynamic top of barrier, in. (m)	8.7 (0.22)	
Speed, mile/h (km/h)	62.0 (99.8)	Dynamic base of barrier, in. (m)	3.5 (0.09)	
Angle (deg)	24.4	Permanent Set, in. (m)	1.6 (0.04)	
Location	Vehicle Centreline aligned to anchor bolt point close to halfway along barrier	Working Width, in. (m)	24.8 (0.63)	
<b>9. Exit Conditions</b>		<b>14. Vehicle Damage</b>		
Speed, mile/h (km/h)	54.3 (87.4)	Airbags deployed during impact. Damage to vehicles front longitudinal beams, Damage to RHF vehicle body, wing and inner wheel arch. Extensive damage to RHF wheel assembly, ball joint detached and wishbone folded back. Wheel and hub remained attached via the suspension strut.

Angle (deg)	9.7			
Exit Box	Compliant
