## Improving Pavement Friction for Safety at a Florida Signalized Intersection *Project Case Study*

## **HFST Increases Friction to Reduce Intersection Crashes**

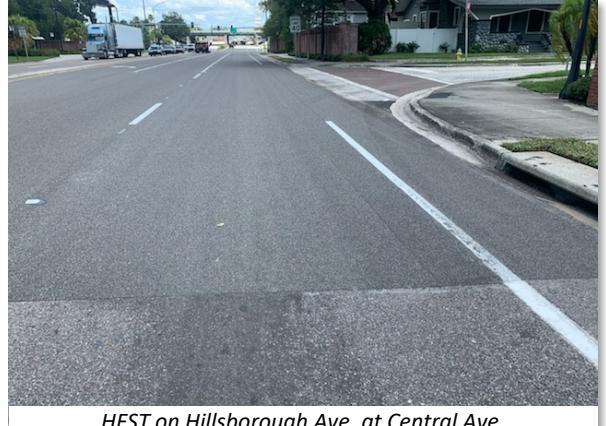
HFST on Hillsborough Ave. at Central Ave. (Source: Florida DOT)

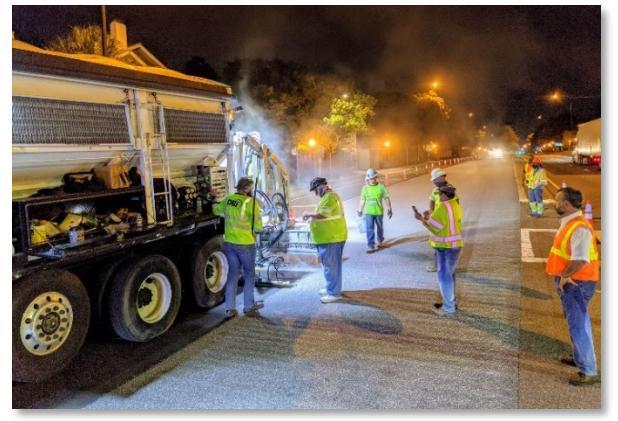
Application of HFST to Hillsborough Ave. using fullyautomated installation. (Source: Florida DOT)

and Central Ave. in Tampa, Florida. From 2015-2020 there were approximately 13.5 crashes per year at this intersection, with the vast majority (86 percent) being dry pavement crashes and the predominant crash type (68 percent) being rear-end crashes. Just over 2,700 square yards of HFST were applied to the left-turn lane and two thru lanes during two consecutive nighttime installation operations, minimizing disruption to the traveling public. Friction testing after completion of the installation revealed that HFST more than doubled pavement friction at the intersection approach.

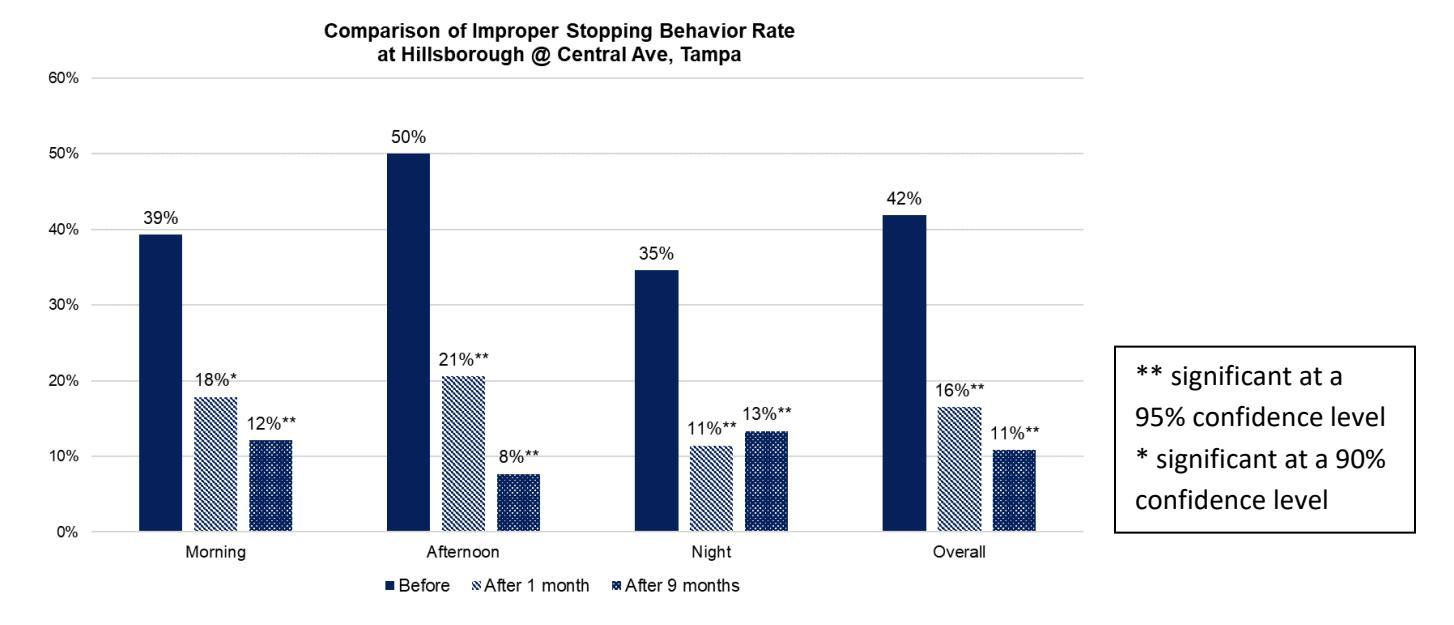
Results from analysis of stopping behavior at Central Ave. intersection before and after HFST application. (Source: CUTR)

While the original intent was to reduce friction-related crashes at this intersection, HFST has demonstrated potential safety benefits to pedestrians by reducing crosswalk incursions through improvement in stopping behavior. The Center for Urban Transportation Research (CUTR) at the University of South Florida analyzed stopping Crosswalk incursions decreased 31 percent after HFST application.

behavior through a review of video captured at the intersection. Specifically, the researchers documented crosswalk incursions while the traffic light was red at three different periods of the day (morning and afternoon rush hour and late night). Stopping behavior was analyzed prior to HFST application, then at one month and nine months after application. This analysis revealed a 26-percent overall reduction in improper stopping behavior one month after HFST application and 31 percent reduction nine months after application. While crash reduction benefits have not yet been quantified for this intersection, a reduction in crosswalk incursions demonstrates another important safety benefit of HFST for intersection applications. A holistic approach to CPFM —which for this case study included starting with continuous pavement friction measurement, incorporating friction data into safety assessments, and implementing friction improvements—can benefit all users.
