Raised Crosswalks Raise Visibility for Pedestrians in Harrisburg

Pennsylvania Department of Transportation

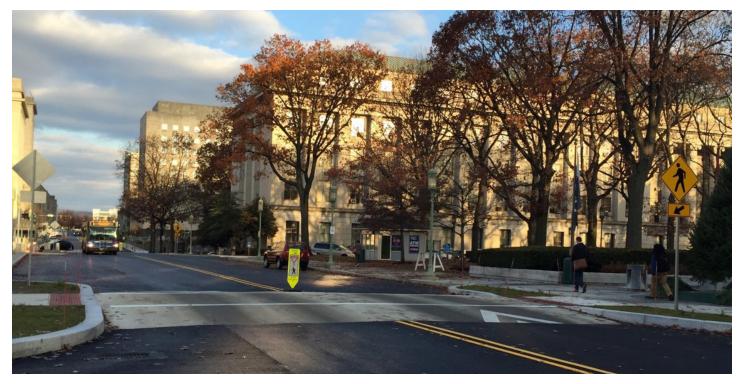
Figure 2. Raised pedestrian crossing with in-street signage.1

- Intersection improvements (bulb-outs) at Forster Street and Commonwealth Avenue.
- Six raised crosswalks at key midblock locations along Commonwealth Avenue and North Street.
- A Road Diet that reduced travel lanes from two to one on one-way North Street, to provide space for a bicycle lane.
- A raised intersection at Commonwealth Avenue and North Street—the busiest intersection in the project site (a Capitol Police Officer directs traffic during the morning and afternoon rush).
- Intersection and pedestrian crossing improvements throughout the project site, including in front of the Capitol steps.
