Subject: <u>ACTION</u>: Supplementary Guidance for the Selection of W-Beam Barrier Date: NOV 17 2005 Terminals

Full Scale Crash Test Results for W-Beam Terminals

Post Impact Vehicle Trajectories

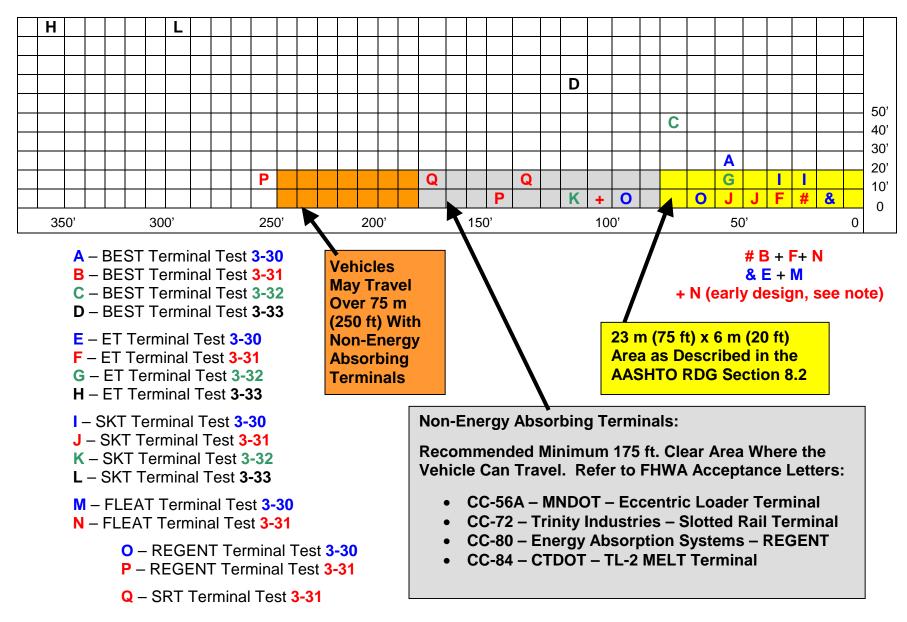
To assist the designer in selecting an appropriate terminal at a specific site, I am attaching both a tabular and a graphic summary showing the distances traveled and the reported resting positions of both types of test vehicles in selected certification tests. These test data show the reported resting positions of both the small car and the pickup truck after impacts into energy-absorbing designs (BEST, ET-series, SKT, and FLEAT) and non-energy absorbing designs (REGENT, SRT). As would be expected, in the end-on tests (3-30 and 3-31) the impacting vehicles traveled

a greater distance behind the barrier after striking non-energy absorbing terminals. Also as expected, terminal type has little affect on a vehicle's post-crash travel distance when impacted at an angle (tests 3-32 and 3-33) because energy-absorbing terminals are most effective in limiting penetration behind the barrier in head-on crashes. Finally, as noted above, higher weight vehicles traveled further distances after impact.

(Shown are Final Resting Positions for Various NCHRP 350 Roadside Terminals)

The selection of an appropriate W-beam terminal must be a deliberate choice based on specific site conditions. At locations where:

- flat angle impacts are possible and the terrain behind and adjacent to the barrier could allow a vehicle to reach the shielded hazard, or
- where the terrain behind and adjacent to the barrier in advance of the primary (shielded) area of concern is itself likely to cause serious occupant injuries in a crash,

either the barrier itself should be lengthened to lessen the likelihood that a vehicle behind the rail will reach the primary (or any secondary) fixed object or non-traversable terrain, or an energy-absorbing terminal should be considered. Even in the latter instance, the recommended minimum runout area should be provided wherever practical.
