Name of system: MASH Sequentially Kinking Terminal (MSKT) Powder Coated

Type of system: Terminal

Subject: Powder Coated Rail and Impact Heads for FLEAT and SKT W-Beam  
Terminals

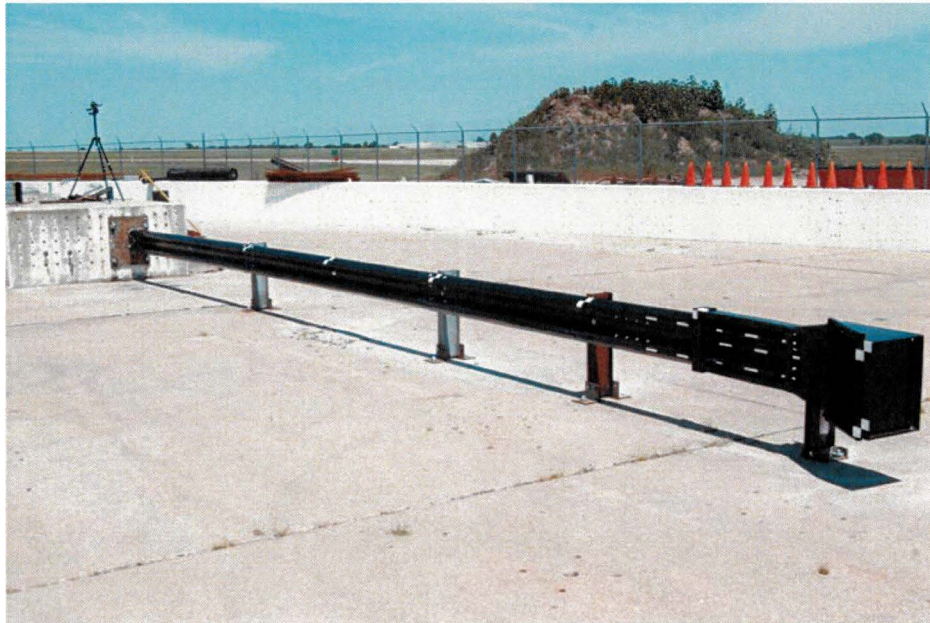
Figure 1. Photographs of Bogie Test Installation

Bogie Test. A bogie test of the powder coated rail was conducted at the Midwest Roadside Safety Facility (MwRSF). The test setup was similar to previous bogie tests conducted with standard galvanized rail. The test installation consisted of 11.43 m (37 ft 6 in.) of straight guardrail installation, as shown in Figure 1. The first 3.81-m (12 ft-6 in.) rail section was a special end rail for the FLEAT terminal with a FLEAT impact head installed at the upstream end. Posts 1 and 2 were terminal end posts spaced at 1.91 m (6 ft 3 in.). Note that the test installation did not have a cable anchor. Posts 3 and 4 were breakaway line posts, spaced at 1.91 m (6 ft 3 in.) and 3.81 m (12 ft 6 in.), respectively. The downstream end of the rail was bolted to an immovable block of concrete.

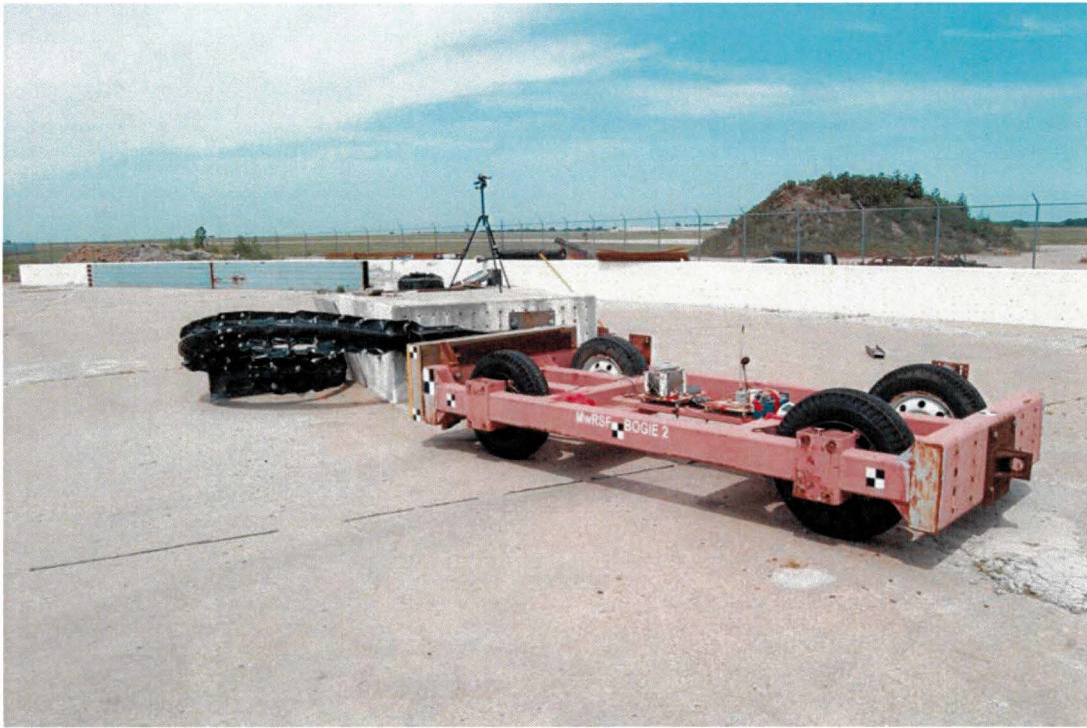
Figure 2. Photographs of Bogie Test Installation After Test

A bogie vehicle, weighing 2000 kg (4,405 lbs), impacted the FLEAT impact head head-on at a speed of 78.2 km/h (48.6 mph or 71.3 fps). The center of the bogie vehicle was aligned with the end of the rail. Upon impact, the impact head was pushed forward,

breaking the end post. The rail began to kink as designed. As the vehicle proceeded forward, the kinking continued and the posts broke away upon impact by the impact head. The entire length of 11.43 m (37 ft 6 in.) of rail was kinked and the bogie vehicle came to rest against the concrete block, as shown in Figure 2. A photograph of the kinked rail is shown in Figure 3. Detailed data and a video of the test are also available upon request.

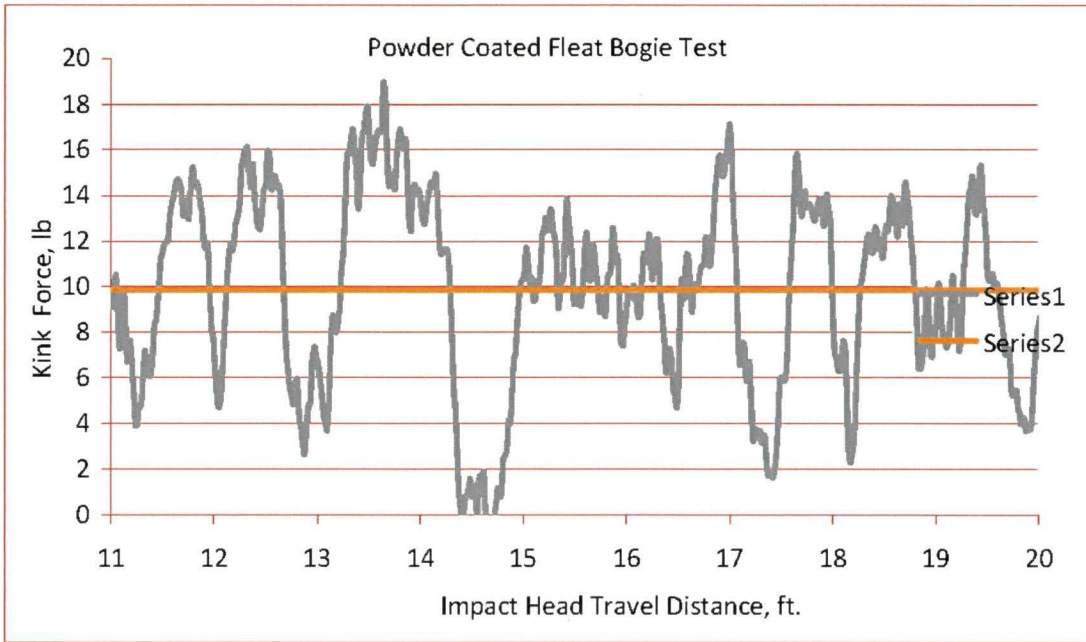
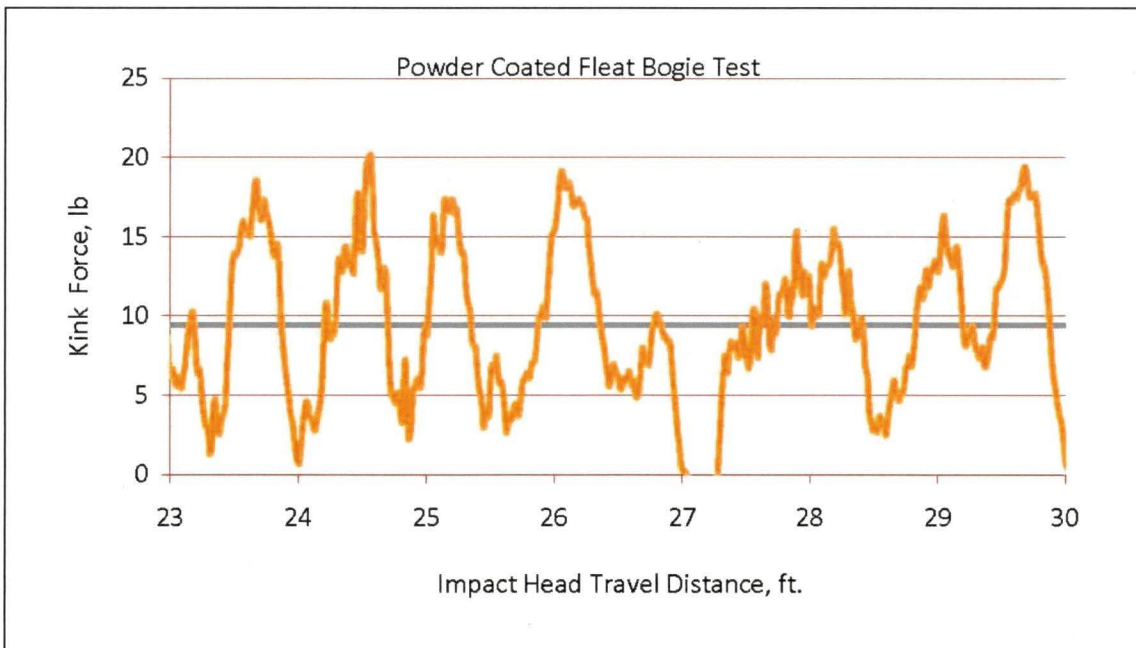
Figure 4. Plot of Kink Force v. Impact Head Travel Distance  
Powder Coated FLEAT Bogie Test

Data Analysis. Figure 4 shows two partial plots of the kinking force over the impact head travel distance, one for 3.4 to 6.1 m (11 to 20 ft) and the second for 7 to 9.1 m (23 to 30 ft). As may be expected, the kinking force varies depending on the locations of the kinks and the breakaway posts. The kinking force averages 4,500 kg (9.9 kips) over the distance 3.4 to 6.1 m (11 to 20 ft) and 4,270 kg (9.4 kips) over the distance of 7 to 9.1 m (23 to 30 ft). In comparison, the average kinking force for a similar bogie test on a galvanized rail is 4,140 kg (9.1 kips), as shown in Figure 5.

Conclusions. The kinking force for the galvanized rail with a powder coated surface is similar, actually slightly higher, than that of a standard galvanized rail. Given the similarity in kinking force, it is logical to conclude that the impact performance of the powder coated rail would be similar to that of the standard galvanized rail. Thus, it is believed that the powder coated rail and impact heads can be used in place of the standard galvanized rail with no modification to the SKT or FLEAT terminal designs.
