U.S. Department
of Transportation
**Federal Highway
Administration**

In Reply Refer To:
HSST-CC-128

- SCI SmartCushion® TL-3 SCI100GM Impact Attenuator

Name of system:	SCI SmartCushion® SCI100GM
Type of system:	Permanent Crash Cushion for concrete or asphalt pavements.
Test Level:	MASH Test Level 3 (TL3)
Testing conducted by:	KARCO Engineering
Date of requests:	April 20, 2015, and May 18, 2016
Date of completed package:	July 28, 2016

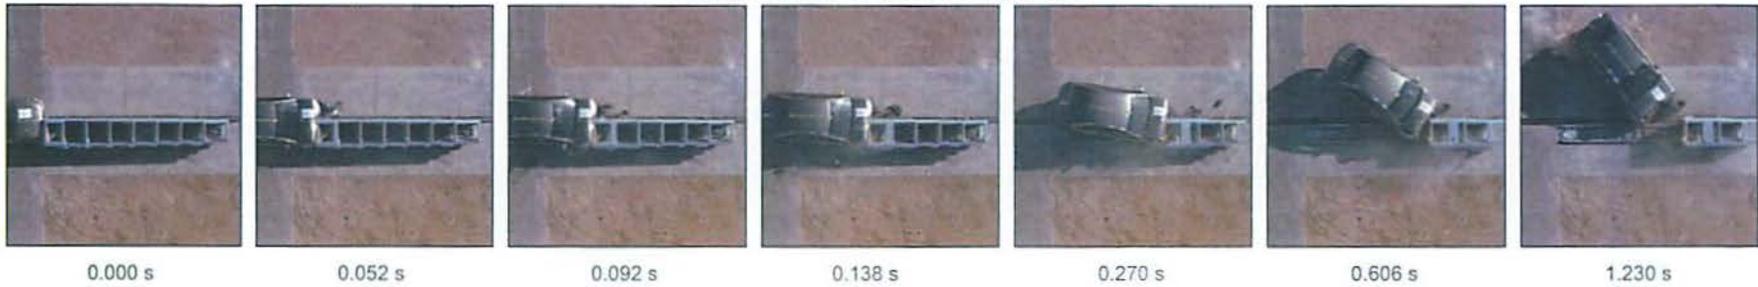
SEQUENTIAL PHOTOGRAPHS

MASH TEST 3-30 SUMMARY

Project No. P36055-01

Test Program: MASH 3-30

Test Date: 03/10/16

Required Test Number	Narrative Description	Evaluation Results
3-30 (1100C)	<p>Test Date: 3-10-2016-KARCO Test TR-P36055-01-A Complete Report KARCO Test No. P36055-01. Test 3-30 involves a 1100C passenger car impacting the crash cushion at a nominal impact speed of 100 km/h (62.2 mph) and an impact at 0 degrees with the quarter point of the vehicle aligned with the center line of the crash cushion. This test is primarily intended to evaluate occupant risk and vehicle trajectory criteria.</p> <p>For this test a 2010 Kia Rio weighing 2,453.6 lbs (1,113.0 kg) impacted the SCI Smart Cushion at a speed of 63.74 mph (102.67 km/h) and an angle of 0 degrees. Upon impact the vehicle forced the SCI Smart Cushion's sled rearward and began to collapse the sections in between the support frames. The crash cushion brought the vehicle to a controlled stop.</p> <p>The test vehicle sustained damage to its front end. The occupant compartment was not penetrated and the deformation was within allowable limits. The maximum roll and pitch angles did not exceed 75 deg. and the occupant risk values were within limits per the MASH specifications for Occupant Impact Velocity (OIV) and Ridedown Acceleration (RA). The SCI Smart Cushion redirective crash cushion passed all evaluation criteria for test 3-30.</p>	PASS

GENERAL INFORMATION		EXIT CONDITIONS		
TEST AGENCY	KARCO Engineering, LLC.	EXIT VELOCITY	N/A	
TEST NUMBER	P36055-01	EXIT ANGLE	N/A	
TEST DESIGNATION	3-30	VEHICLE STABILITY	Satisfactory	
TEST DATE	3/10/16	FINAL VEHICLE POSITION	6.0 ft (1.8 m) downstream, 7.6 ft (2.3 m) left of barrier	
TEST ARTICLE		VEHICLE SNAGGING	None	
NAME / MODEL	SCI Smart Cushion	VEHICLE POCKETING	None	
TYPE	Redirective Crash Cushion	MAXIMUM ROLL ANGLE (°)	-11.1	
KEY ELEMENTS	Base Structure, Sled, Wire Rope Cable, Sheaves, Shock Arresting Cylinder	MAXIMUM PITCH ANGLE (°)	8.4	
		MAXIMUM YAW ANGLE (°)	52.4	
ARTICLE LENGTH	21.7 ft (6.6 m)	KINETIC ENERGY	333.2 kip-ft (451.8 kJ)	
TOTAL INSTALLATION LENGTH	21.7 ft (6.6 m)	OCCUPANT RISK VALUES		
HEIGHT	33.5 in (851 mm)	OCCUPANT IMPACT VELOCITY	Longitudinal	34.1 ft/s (10.4 m/s)
MAXIMUM WIDTH	37.4 in (951 mm)		Lateral	4.3 ft/s (1.3 m/s)
ROAD SURFACE	Concrete	RIDEDOWN ACCELERATION	Longitudinal	-11.9 g

TEST VEHICLE			Lateral	-3.6 g
TYPE / DESIGNATION	1100C	THIV	34.4 ft/s (10.5 m/s)	
YEAR, MAKE AND MODEL	2010 Kia Rio	PHD	12.2 g	
CURB MASS	2,480.2 lbs (1,125.0 kg)	ASI	1.60	
TEST INERTIAL MASS	2,453.8 lbs (1,113.0 kg)	TEST ARTICLE DEFLECTIONS		
GROSS STATIC MASS	2,613.5 lbs (1,185.5 kg)	STATIC	13.8 ft (4.2 m)	
IMPACT CONDITIONS		DYNAMIC	13.8 ft (4.2 m)	
IMPACT VELOCITY	63.74 mph (102.58 km/h)	ARTICLE DAMAGE	Minor	
IMPACT ANGLE (°)	0	VEHICLE DAMAGE		
IMPACT LOCATION / ORIENTATION	0.6 in (16 mm) to the left of vehicle centerline	VEHICLE DAMAGE SCALE	12-FD-3	
		COLLISION DAMAGE CLASSIFICATION	12FDEW2

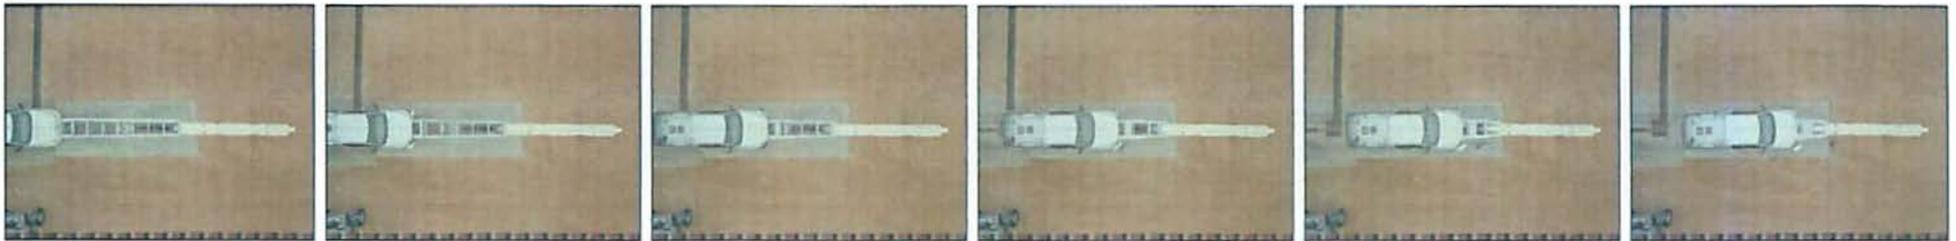
SEQUENTIAL PHOTOGRAPHS

SECTION 4
MASH TEST 3-31 SUMMARY

Test Article: Work Area Protection SCI Smart Cushion
Test Program: MASH 3-31

Project No. P35022-01
Test Date: 03/11/15

Required Test Number	Narrative Description	Evaluation Results
3-31 (2270P)	<p>Test Date 3-11-2015 - Karco Test #TR-P35022-01-B Complete Report. KARCO Test No. P35022-01. Test 3-31 involves a 2270P pickup truck impacting the crash cushion at a nominal impact speed of 100 km/h (62.2 mph) and an impact at 0 degrees with the centerline of the vehicle aligned with the center line of the crash cushion. This test is primarily intended to evaluate the capacity of the attenuator to stop the vehicle in a controlled manner. For this test, a 2009 Ram 1500 weighing 5,004.5 lbs (2,270.0 kg) impacted the SCI Smart Cushion at a speed of 60.70 mph (97.67 km/h) and an angle of .3 degrees. Upon impact the vehicle forced the SCI Smart Cushion's sled rearward and began to collapse the sections in between the support frames. The crash cushion brought the vehicle to a controlled stop. The test vehicle sustained damage to its front end. The occupant compartment was not penetrated and the deformation was within allowable limits. The maximum roll and pitch angles did not exceed 75 deg. and the occupant risk values were within limits per the MASH specifications for Occupant Impact Velocity (OIV) and Ridedown Acceleration (RA). The SCI Smart Cushion redirective crash cushion passed all evaluation criteria for test 3-31.</p>	PASS

GENERAL INFORMATION		EXIT CONDITIONS		
TEST AGENCY	KARCO Engineering, LLC.	EXIT VELOCITY	N/A	
TEST NUMBER	P35022-01	EXIT ANGLE	N/A	
TEST DESIGNATION	3-31	VEHICLE STABILITY	Satisfactory	
TEST DATE	3/11/15	FINAL VEHICLE POSITION	14.7 ft (4.5 m) downstream	
TEST ARTICLE		VEHICLE SNAGGING	None	
NAME / MODEL	SCI Smart Cushion	VEHICLE POCKETING	None	
TYPE	Redirective Crash Cushion	MAXIMUM ROLL ANGLE (°)	3.4	
KEY ELEMENTS	Base Structure, Sled, Wire Rope Cable, Sheaves, Shock Arresting Cylinder	MAXIMUM PITCH ANGLE (°)	3.7	
		MAXIMUM YAW ANGLE (°)		
ARTICLE LENGTH	21.7 ft (6.6 m)	KINETIC ENERGY	616.4 kip-ft (835.7 kJ)	
TOTAL INSTALLATION LENGTH	41.5 ft (12.7 m)	OCCUPANT RISK VALUES		
HEIGHT	33.5 in (851 mm)	OCCUPANT IMPACT VELOCITY	Longitudinal	25.6 ft/s (7.8 m/s)
MAXIMUM WIDTH	37.4 in (951 mm)		Lateral	0.3 ft/s (0.1 m/s)
ROAD SURFACE	Concrete	RIDEDOWN ACCELERATION	Longitudinal	-20.3 g
TEST VEHICLE			Lateral	-2.4 g

TYPE / DESIGNATION	2270P	THIV		
YEAR, MAKE AND MODEL	2009 RAM 1500	PHD		
CURB MASS	4,866.7 lbs (2,207.5 kg)	ASI		1.41
TEST INERTIAL MASS	5,004.5 lbs (2,270.0 kg)	TEST ARTICLE DEFLECTIONS		
GROSS STATIC MASS	5,004.5 lbs (2,270.0 kg)	STATIC	17.1 ft (5.2 m)	
IMPACT CONDITIONS		DYNAMIC	17.1 ft (5.2 m)	
IMPACT VELOCITY	60.70 mph (97.67 km/h)	ARTICLE DAMAGE	Minor	
IMPACT ANGLE (°)	0.3	VEHICLE DAMAGE		
IMPACT LOCATION / ORIENTATION	Centerline of crash cushion face	VEHICLE DAMAGE SCALE		12-FD-3
		COLLISION DAMAGE CLASSIFICATION		12FDBW2

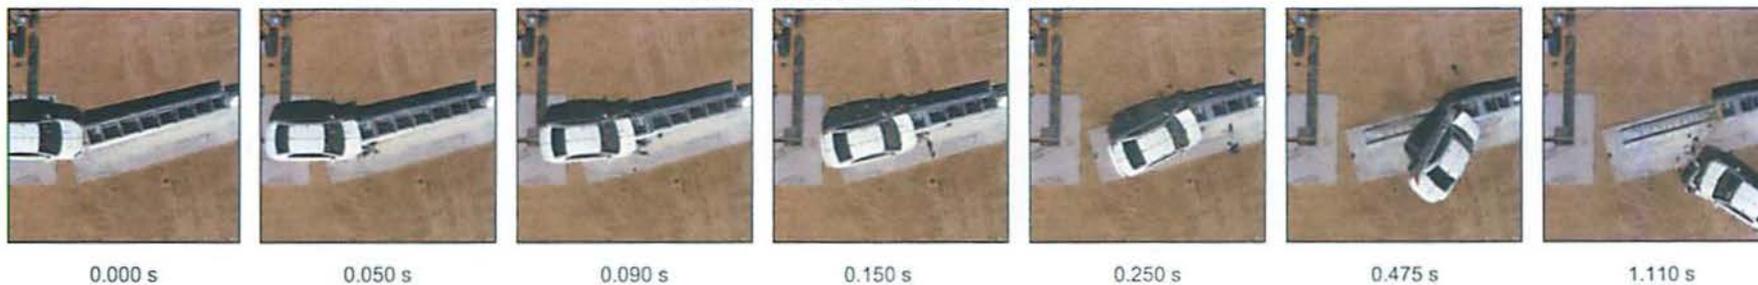
SEQUENTIAL PHOTOGRAPHS

SECTION 4
MASH TEST 3-32 SUMMARY

Test Article: Work Area Protection SCI Smart Cushion
Test Program: MASH 3-32

Project No. P36056-01
Test Date: 03/08/16

3-32 (1100C)	<p>Test Date 3-8-2016 - Karco Test #TR-P36056-01-A Complete Report KARCO Test No. P36056-01. Test 3-32 involves a 1100C passenger car impacting the crash cushion at a nominal impact speed of 100 km/h (62.2 mph) and an impact at 15 degrees with the center point of the vehicle aligned with the center line of the crash cushion. This test is primarily intended to evaluate occupant risk and vehicle trajectory criteria.</p> <p>For this test a 2010 Kia Rio weighing 2,444.9 lbs (1,109.0 kg) impacted the SCI Smart Cushion at a speed of 64.00 mph (103.00 km/h) and an angle of 15.3 degrees. Upon impact the vehicle forced the SCI Smart Cushion's sled rearward and began to collapse the sections in between the support frames. The crash cushion brought the vehicle to a controlled stop.</p> <p>The test vehicle sustained damage to its front end. The occupant compartment was not penetrated and the deformation was within allowable limits. The maximum roll and pitch angles did not exceed 75 deg. and the occupant risk values were within limits per the MASH specifications for Occupant Impact Velocity (OIV) and Ridedown Acceleration (RA). The SCI Smart Cushion redirective crash cushion passed all evaluation criteria for test 3-32.</p>	PASS

GENERAL INFORMATION		EXIT CONDITIONS		
TEST AGENCY	KARCO Engineering, LLC.	EXIT VELOCITY	N/A	
TEST NUMBER	P36056-01	EXIT ANGLE	N/A	
TEST DESIGNATION	3-32	VEHICLE STABILITY	Satisfactory	
TEST DATE	3/8/16	FINAL VEHICLE POSITION	21.5 ft (6.6 m) downstream, 20.0 ft (6.1 m) right	
TEST ARTICLE		VEHICLE SNAGGING	None	
NAME / MODEL	SCI Smart Cushion	VEHICLE POCKETING	None	
TYPE	Redirective Crash Cushion	MAXIMUM ROLL ANGLE (°)	-40.3	
KEY ELEMENTS	Base Structure, Sled, Wire Rope Cable, Sheaves, Shock Arresting Cylinder	MAXIMUM PITCH ANGLE (°)	-39.6	
		MAXIMUM YAW ANGLE (°)	-104.5	
ARTICLE LENGTH	21.7 ft (6.6 m)	KINETIC ENERGY	334.6 kips-ft (453.7 kJ)	
TOTAL INSTALLATION LENGTH	41.5 ft (12.7 m)	OCCUPANT RISK VALUES		
HEIGHT	33.5 in (851 mm)	OCCUPANT IMPACT VELOCITY	Longitudinal	35.1 ft/s (10.7 m/s)
MAXIMUM WIDTH	37.4 in (951 mm)		Lateral	4.9 ft/s (1.5 m/s)
ROAD SURFACE	Concrete	RIDEDOWN ACCELERATION	Longitudinal	-8.1 g

TEST VEHICLE			Lateral	-2.5 g
TYPE / DESIGNATION	1100C	THIV	35.4 ft/s (10.8 m/s)	
YEAR, MAKE AND MODEL	2010 Kia Rio	PHD	18.4 g	
CURB MASS	2,490.2 lbs (1129.5 kg)	ASI	1.67	
TEST INERTIAL MASS	2444.9 lbs (1109.0 kg)	TEST ARTICLE DEFLECTIONS		
GROSS STATIC MASS	2618.0 lbs (1187.5 kg)	STATIC	13.7 ft. (4.2 m)	
IMPACT CONDITIONS		DYNAMIC	13.7 ft. (4.2 m)	
IMPACT VELOCITY	64.00 mph (103.00 km/h)	ARTICLE DAMAGE	Minor	
IMPACT ANGLE (°)	15.3	VEHICLE DAMAGE		
IMPACT LOCATION / ORIENTATION	0.7 in (18 mm) right of crash cushion centerline	VEHICLE DAMAGE SCALE	12-FD-3	
		COLLISION DAMAGE CLASSIFICATION	12FDEW1

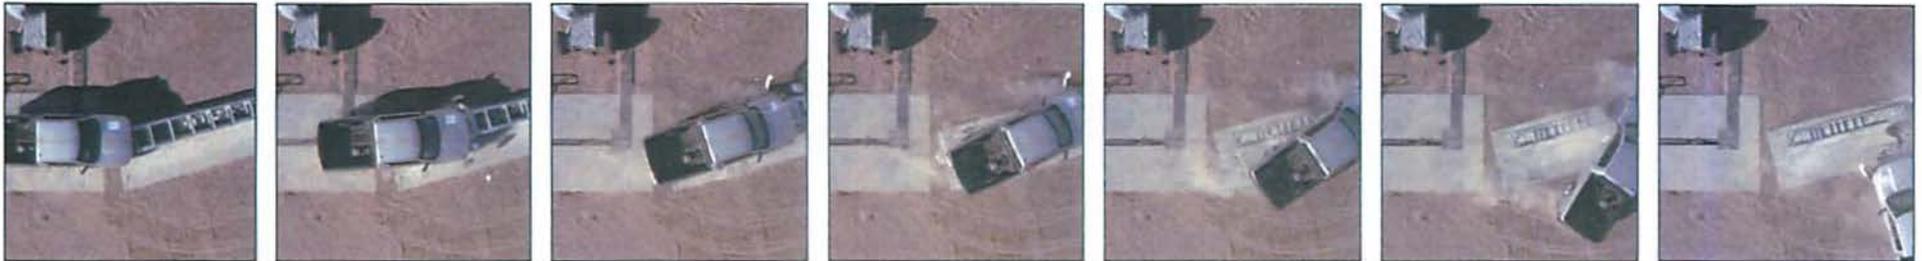
SEQUENTIAL PHOTOGRAPHS

MASH TEST 3-33 SUMMARY

Test Article: Work Area Protection SCI Smart Cushion

Project No. P36051-01

3-33 (2270P)	<p>Test Date 3-7-2016 - Karco Test #TR-P36051-01-A Complete Report KARCO Test No. P36051-01. Test 3-33 involves a 2270P pickup impacting the crash cushion at a nominal impact speed of 100 km/h (62.2 mph) and an impact at 15 degrees with the centerline of the vehicle aligned with the center line of the crash cushion. This test is primarily intended to evaluate occupant risk, vehicle trajectory and the capacity of the attenuator to stop the vehicle in a controlled fashion on oblique impacts.</p> <p>For this test, a 2012 Ram 1500 weighing 4,998.9 lbs (2,267.5 kg) impacted the SCI Smart Cushion at a speed of 63.99 mph (102.98 km/h) and an angle of 14.9 degrees. Upon impact the vehicle forced the SCI Smart Cushion's sled rearward and began to collapse the sections in between the support frames. The crash cushion brought the vehicle to a controlled stop.</p> <p>The test vehicle sustained damage to its front end. The occupant compartment was not penetrated and the deformation was within allowable limits. The maximum roll and pitch angles did not exceed 75 deg. and the occupant risk values were within limits per the MASH specifications for Occupant Impact Velocity (OIV) and Ridedown Acceleration (RA). The SCI Smart Cushion redirective crash cushion passed all evaluation criteria for test 3-33.</p>	PASS

GENERAL INFORMATION		EXIT CONDITIONS		
TEST AGENCY	KARCO Engineering, LLC.	EXIT VELOCITY	N/A	
TEST NUMBER	P36051-01	EXIT ANGLE	N/A	
TEST DESIGNATION	3-33	VEHICLE STABILITY	Satisfactory	
TEST DATE	3/7/16	FINAL VEHICLE POSITION	13.5 ft (4.1 m) downstream, 38.6 ft (11.8m) to the right side	
TEST ARTICLE		VEHICLE SNAGGING	None	
NAME / MODEL	SCI Smart Cushion	VEHICLE POCKETING	None	
TYPE	Redirective Crash Cushion	MAXIMUM ROLL ANGLE (°)	-7.7	
KEY ELEMENTS	Base Structure, Sled, Wire Rope Cable, Sheaves, Shock Arresting Cylinder	MAXIMUM PITCH ANGLE (°)	-8.9	
		MAXIMUM YAW ANGLE (°)	-105.6	
ARTICLE LENGTH	21.7 ft (6.6 m)	KINETIC ENERGY	684.0 kips-ft (927.4 kJ)	
TOTAL INSTALLATION LENGTH	41.5 ft (12.7 m)	OCCUPANT RISK VALUES		
HEIGHT	33.5 in (851 mm)	OCCUPANT IMPACT VELOCITY	Longitudinal	25.9 ft/s (7.9 m/s)
MAXIMUM WIDTH	37.4 in (951 mm)		Lateral	6.6 ft/s (2.0 m/s)
ROAD SURFACE	Concrete	RIDEDOWN ACCELERATION	Longitudinal	-16.9 g

TEST VEHICLE			Lateral	-7.1 g
TYPE / DESIGNATION	2270P	THIV	26.9 ft/s (8.2 m/s)	
YEAR, MAKE AND MODEL	2012 RAM 1500	PHD	18.4 g	
CURB MASS	4,883.2 lbs (2,215.0 kg)	ASI	1.02	
TEST INERTIAL MASS	4,998.9 lbs (2,267.5 kg)	TEST ARTICLE DEFLECTIONS		
GROSS STATIC MASS	4,998.9 lbs (2,267.5 kg)	STATIC	17.0 ft (5.2 m)	
IMPACT CONDITIONS		DYNAMIC	17.0 ft (5.2 m)	
IMPACT VELOCITY	63.99 mph (102.98 km/h)	ARTICLE DAMAGE	Minor	
IMPACT ANGLE (°)	14.9	VEHICLE DAMAGE		
IMPACT LOCATION / ORIENTATION	0.5 in (13 mm) right of the article centerline	VEHICLE DAMAGE SCALE	12-FD-3	
		COLLISION DAMAGE CLASSIFICATION	12FDEW2

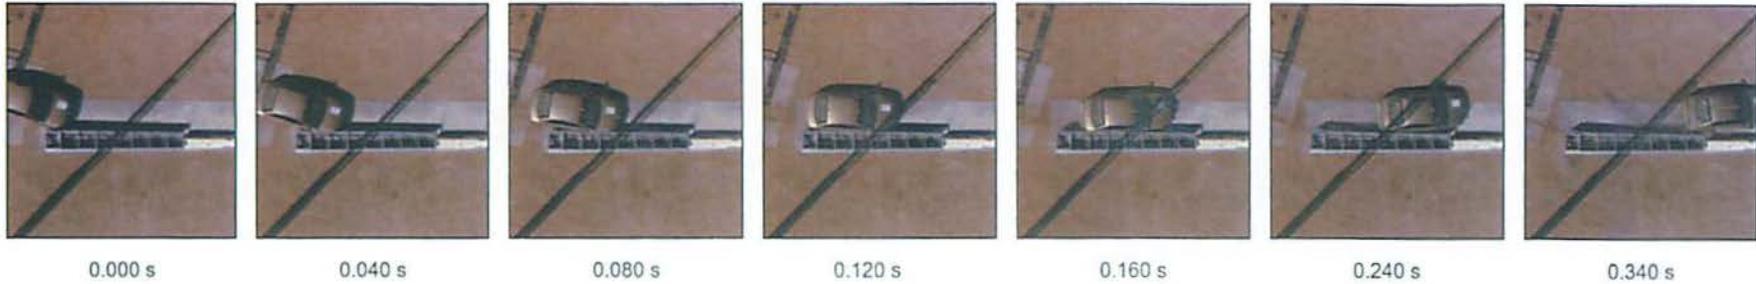
SEQUENTIAL PHOTOGRAPHS

SECTION 4
MASH TEST 3-34 SUMMARY

Test Article: Work Area Protection SCI Smart Cushion
Test Program: MASH 3-34

Project No. P36054-01
Test Date: 03/09/16

3-34 (1100C)	<p>Test Date 3-9-2016 - Karco Test #TR-P36054-01-A Complete Report KARCO Test No. P36054-01. Test 3-34 involves a 1100C passenger car impacting the crash cushion at a nominal impact speed of 100 km/h (62.2 mph) and an impact at 15 degrees with the CIP at the point where the crash cushion behavior changes from gating to redirective. This test is primarily intended to evaluate occupant risk and vehicle trajectory criteria.</p> <p>For this test a 2010 Kia Rio weighing 2,442.7 lbs (1,108.0 kg) impacted the SCI Smart Cushion at a speed of 60.17 mph (96.83 km/h) and an angle of 15.2 degrees. The impact point was 18.9" downstream of the front delineator plate. Upon impact the vehicle was smoothly redirected.</p> <p>The test vehicle sustained damage to its right front corner, doors and rear quarter panel. The occupant compartment was not penetrated and the deformation was within allowable limits. The maximum roll and pitch angles did not exceed 75 deg. and the occupant risk values were within limits per the MASH specifications for Occupant Impact Velocity (OIV) and Ridedown Acceleration (RA). The SCI Smart Cushion redirective crash cushion passed all evaluation criteria for test 3-34.</p>	PASS

GENERAL INFORMATION		EXIT CONDITIONS		
TEST AGENCY	KARCO Engineering, LLC.	EXIT VELOCITY	50.28 mph (80.92 km/h)	
TEST NUMBER	P36054-01	EXIT ANGLE (°)	4.3	
TEST DESIGNATION	3-34	VEHICLE STABILITY	Satisfactory	
TEST DATE	3/9/16	FINAL VEHICLE POSITION	190.6 ft (58.1 m) downstream, 25.8 ft (7.8 m) to the left side	
TEST ARTICLE		VEHICLE SNAGGING	None	
NAME / MODEL	SCI Smart Cushion	VEHICLE POCKETING	None	
TYPE	Redirective Crash Cushion	MAXIMUM ROLL ANGLE (°)	-3.8	
KEY ELEMENTS	Base Structure, Sled, Wire Rope Cable, Sheaves, Shock Arresting Cylinder	MAXIMUM PITCH ANGLE (°)	4.1	
		MAXIMUM YAW ANGLE (°)	-22.0	
ARTICLE LENGTH	21.7 ft (6.6 m)	KINETIC ENERGY	19.8 kip-ft (26.8 kJ)	
TOTAL INSTALLATION LENGTH	41.5 ft (12.7 m)	OCCUPANT RISK VALUES		
HEIGHT	33.5 in (851 mm)	OCCUPANT IMPACT VELOCITY	Longitudinal	7.5 ft/s (2.3 m/s)
MAXIMUM WIDTH	37.4 in (951 mm)		Lateral	19.0 ft/s (5.8 m/s)
ROAD SURFACE	Concrete	RIDEDOWN ACCELERATION	Longitudinal	-2.0 g

Lateral	-9.7 g
TEST VEHICLE		THIV	20.7 ft/s (6.3 m/s)	
TYPE / DESIGNATION	1100C	PHD	9.7 g	
YEAR, MAKE AND MODEL	2010 Kia Rio	ASI	1.28	
CURB MASS	2,503.3 lbs (1,135.5 kg)	TEST ARTICLE DEFLECTIONS		
TEST INERTIAL MASS	2,442.7 lbs (1,108.0 kg)	STATIC	0.9 in (23 mm)	
GROSS STATIC MASS	2,610.3 lbs (1,184.0 kg)	DYNAMIC	2.0 in (51 mm)	
IMPACT CONDITIONS		ARTICLE DAMAGE	Minor	
IMPACT VELOCITY	60.17 mph (96.83 km/h)	VEHICLE DAMAGE		
IMPACT ANGLE (°)	15.2	VEHICLE DAMAGE SCALE	1-RD-1	
IMPACT LOCATION / ORIENTATION	18.9 in (480 mm) downstream from crash cushion front face	COLLISION DAMAGE CLASSIFICATION	01RDES1

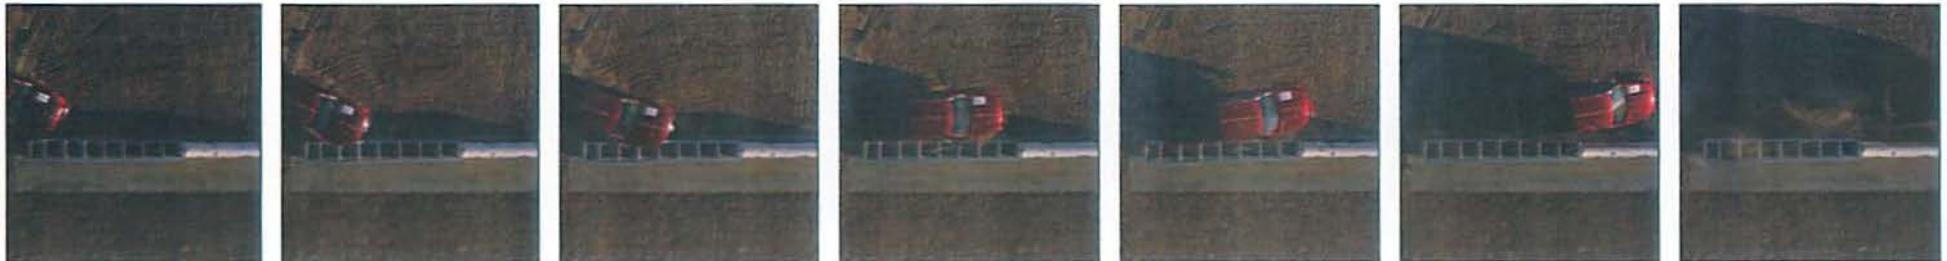
SEQUENTIAL PHOTOGRAPHS

MASH TEST 3-35 SUMMARY

Test Article: Work Area Protection SCI Smart Cushion

Project No. P36053-01

3-35 (2270P)	<p>Test Date 3-8-2016 - Karco Test #TR-P36053-01-A Complete Report KARCO Test No. P36053-01. Test 3-35 involves a 2270P pickup impacting the crash cushion at a nominal impact speed of 100 km/h (62.2 mph) and an impact at 25 degrees with the CIP at the point where the crash cushion behavior changes from gating to redirective (beginning of length-of-need). This test is primarily intended to evaluate the capacity of the attenuator for redirection/containment of heavy vehicles at the front of the system.</p> <p>For this test a 2010 Ram 1500 weighing 5,009.9 lbs (2,272.5 kg) impacted the SCI Smart Cushion at a speed of 60.02 mph (96.59 km/h) and an angle of 25.9 degrees. The impact point was 19" downstream of the front delineator plate. Upon impact the vehicle was smoothly redirected without snagging.</p> <p>The test vehicle sustained damage to its right front corner, doors and rear quarter panel. The occupant compartment was not penetrated and the deformation was within allowable limits. The maximum roll and pitch angles did not exceed 75 deg. and the occupant risk values were within limits per the MASH specifications for Occupant Impact Velocity (OIV) and Ridedown Acceleration (RA). The SCI Smart Cushion redirective crash cushion passed all evaluation criteria for test 3-35.</p>	PASS

GENERAL INFORMATION		EXIT CONDITIONS		
TEST AGENCY	KARCO Engineering, LLC.	EXIT VELOCITY	52.55 mph (84.58 km/h)	
TEST NUMBER	P36053-01	EXIT ANGLE (°)	9.2	
TEST DESIGNATION	3-35	VEHICLE STABILITY	Satisfactory	
TEST DATE	3/8/16	FINAL VEHICLE POSITION	225.4 ft (68.9 m) downstream, 76.2 ft (23.2 m) left side	
TEST ARTICLE		VEHICLE SNAGGING	None	
NAME / MODEL	SCI Smart Cushion	VEHICLE POCKETING	None	
TYPE	Redirective Crash Cushion	MAXIMUM ROLL ANGLE (°)	-10.7	
KEY ELEMENTS	Base Structure, Sled, Wire Rope Cable, Sheaves, Shock Arresting Cylinder	MAXIMUM PITCH ANGLE (°)	22.0	
		MAXIMUM YAW ANGLE (°)	-33.2	
ARTICLE LENGTH	21.7 ft (6.6 m)	KINETIC ENERGY	115.7 kip-ft (156.1 kJ)	
TOTAL INSTALLATION LENGTH	41.5 ft (12.7 m)	OCCUPANT RISK VALUES		
HEIGHT	33.5 in (851 mm)	OCCUPANT IMPACT VELOCITY	Longitudinal	15.7 ft/s (4.8 m/s)
MAXIMUM WIDTH	37.4 in (951 mm)		Lateral	29.5 ft/s (9.0 m/s)
ROAD SURFACE	Concrete	RIDEDOWN ACCELERATION	Longitudinal	-2.6 g

TEST VEHICLE			Lateral	-13.2 g
TYPE / DESIGNATION	2270P	THIV	33.1 ft/s (10.1 m/s)	
YEAR, MAKE AND MODEL	2010 Ram 1500	PHD	13.2 g	
CURB MASS	4822.5 lbs (2187.5 kg)	ASI	1.81	
TEST INERTIAL MASS	5009.9 lbs (2272.5 kg)	TEST ARTICLE DEFLECTIONS		
GROSS STATIC MASS	5009.9 lbs (2272.5 kg)	STATIC	0.7 in (17 mm)	
IMPACT CONDITIONS		DYNAMIC	2.6 in (66 mm)	
IMPACT VELOCITY	60.02 mph (96.59 km/h)	ARTICLE DAMAGE	Minor	
IMPACT ANGLE (°)	25.9	VEHICLE DAMAGE		
IMPACT LOCATION / ORIENTATION	19.0 in (483 mm) downstream of crash cushion front face	VEHICLE DAMAGE SCALE	01-RFQ-3	
		COLLISION DAMAGE CLASSIFICATION	01RDEW2

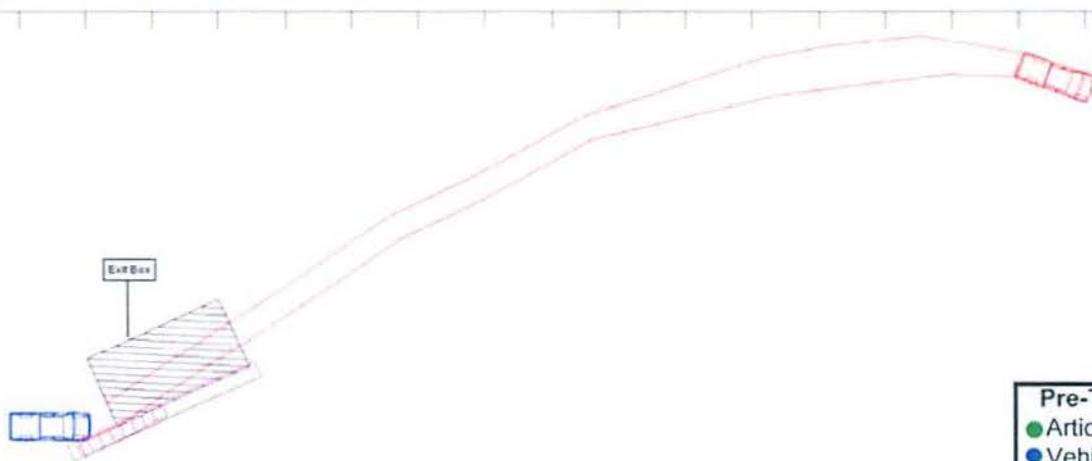
PLAN VIEW

-30 ft -15 ft 0 15 ft 30 ft 45 ft 60 ft 75 ft 90 ft 105 ft 120 ft 135 ft 150 ft 165 ft 180 ft 195 ft 210 ft 225 ft 240 ft

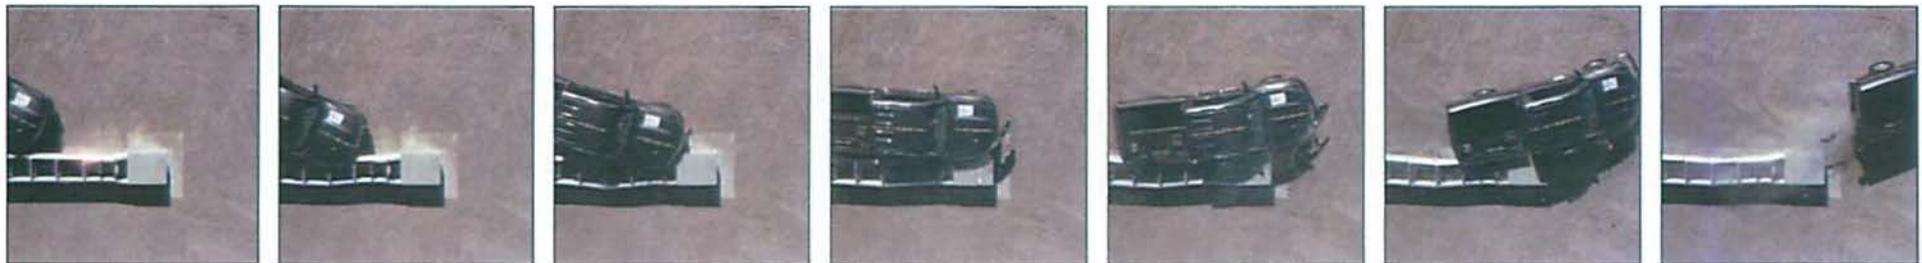
SEQUENTIAL PHOTOGRAPHS

MASH TEST 3-36 SUMMARY

Test Article: Work Area Protection SCI Smart Cushion

Project No. P36052-01

3-36 (2270P)	<p>Test Date 3-10-2016 - Karco Test #TR-P36052-01-A Complete Report KARCO Test No. P36052-01. Test 3-36 involves a 2270P pickup impacting the crash cushion at a nominal impact speed of 100 km/h (62.2 mph) and an impact at 25 degrees with the CIP at the point directed at the rear transition of a wide, rigid backup structure. This test is primarily intended to evaluate the capacity for redirection of heavy vehicles at the rear of the system where it protects wide rigid objects. For this test a 2011 Ram 1500 weighing 4,950.4 lbs (2,245.5 kg) impacted the SCI Smart Cushion at a speed of 62.08 mph (99.91 km/h) and an angle of 24.9 degrees. The impact point was 15' downstream of the front delineator plate. Upon impact the vehicle was smoothly redirected. The test vehicle sustained damage to its right front corner, doors and rear quarter panel. The occupant compartment was not penetrated and the deformation was within allowable limits. The maximum roll and pitch angles did not exceed 75 deg. and the occupant risk values were within limits per the MASH specifications for Occupant Impact Velocity (OIV) and Ridedown Acceleration (RA). The SCI Smart Cushion redirective crash cushion passed all evaluation criteria for test 3-36.</p>	PASS

GENERAL INFORMATION		EXIT CONDITIONS		
TEST AGENCY	KARCO Engineering, LLC.	EXIT VELOCITY	52.95 mph (85.21 km/h)	
TEST NUMBER	P36052-01	EXIT ANGLE (°)	15.3	
TEST DESIGNATION	3-36	VEHICLE STABILITY	Satisfactory	
TEST DATE	3/10/16	FINAL VEHICLE POSITION	221.3 ft (67.4 m) downstream, 13.3 ft. (4.1 m) left side	
TEST ARTICLE		VEHICLE SNAGGING	None	
NAME / MODEL	SCI Smart Cushion	VEHICLE POCKETING	None	
TYPE	Redirective Crash Cushion	MAXIMUM ROLL ANGLE (°)	-14.5	
KEY ELEMENTS	Base Structure, Sled, Wire Rope Cable, Sheaves, Shock Arresting Cylinder	MAXIMUM PITCH ANGLE (°)	26.4	
		MAXIMUM YAW ANGLE (°)	-38.5	
ARTICLE LENGTH	21.7 ft (6.6 m)	KINETIC ENERGY	113.1 kips-ft (153.3 kJ)	
TOTAL INSTALLATION LENGTH	41.5 ft (12.7 m)	OCCUPANT RISK VALUES		
HEIGHT	33.5 in (851 mm)	OCCUPANT IMPACT VELOCITY	Longitudinal	18.0 ft/s (5.5 m/s)
MAXIMUM WIDTH	37.4 in (951 mm)		Lateral	29.5 ft/s (9.0 m/s)
ROAD SURFACE	Concrete	RIDEDOWN ACCELERATION	Longitudinal	-10.5 g

TEST VEHICLE			Lateral	-12.3 g
TYPE / DESIGNATION	2270P	THIV	33.5 ft/s (10.2 m/s)	
YEAR, MAKE AND MODEL	2011 RAM 1500	PHD	12.3 g	
CURB MASS	4877.6 lbs (2212.5 kg)	ASI	1.76	
TEST INERTIAL MASS	4950.4 lbs (2245.5 kg)	TEST ARTICLE DEFLECTIONS		
GROSS STATIC MASS	4950.4 lbs (2245.5 kg)	STATIC	4.3 in (108 mm)	
IMPACT CONDITIONS		DYNAMIC	4.5 in (114 mm)	
IMPACT VELOCITY	62.08 mph (99.91 km/h)	ARTICLE DAMAGE	Moderate	
IMPACT ANGLE (°)	24.9	VEHICLE DAMAGE		
IMPACT LOCATION / ORIENTATION	15.0 ft (4.6 m) downstream from crash cushion front face	VEHICLE DAMAGE SCALE	1-RFQ-3	
		COLLISION DAMAGE CLASSIFICATION	01RDEW3

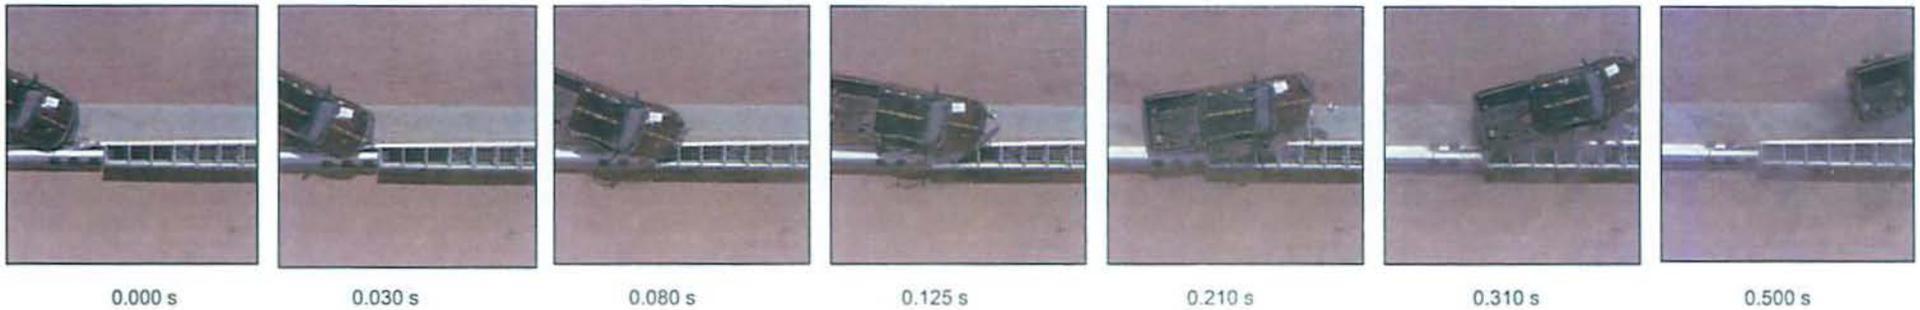
SEQUENTIAL PHOTOGRAPHS

MASH TEST 3-37 SUMMARY

Test Article: Work Area Protection SCI Smart Cushion

Project No. P36021-01

3-37 (2270P)	<p>Test Date 3-11-2016 - Karco Test #TR-P36021-01-A Complete Report KARCO Test No. P36021-01. Test 3-37 involves a 2270P pickup impacting the crash cushion in the reverse direction at a nominal impact speed of 100 km/h (62.2 mph) and an impact at 25 degrees with the CIP at the point directed at the beginning of the rear transition protecting a narrow concrete median barrier. This test is primarily intended to evaluate the potential for snagging and capacity for redirection of heavy vehicles at the rear of the system where vehicle can impact the rear of the attenuator.</p> <p>For this test a 2010 Ram 1500 weighing 4,976.9 lbs (2,257.5 kg) impacted the SCI Smart Cushion at a speed of 62.09 mph (99.92 km/h) and an angle of 24.5 degrees. The impact point was at the leading edge of the transition to the attenuator. Upon impact the vehicle was smoothly redirected with no snagging.</p> <p>The test vehicle sustained damage to its right front corner, doors and rear quarter panel. The occupant compartment was not penetrated and the deformation was within allowable limits. The maximum roll and pitch angles did not exceed 75 deg. and the occupant risk values were within limits per the MASH specifications for Occupant Impact Velocity (OIV) and Ridedown Acceleration (RA). The SCI Smart Cushion redirecive crash cushion passed all evaluation criteria for test 3-37.</p>	PASS

GENERAL INFORMATION		EXIT CONDITIONS		
TEST AGENCY	KARCO Engineering, LLC.	EXIT VELOCITY	42.80 mph (68.88 km/h)	
TEST NUMBER	P36021-01	EXIT ANGLE (°)	14.3	
TEST DESIGNATION	3-37	VEHICLE STABILITY	Satisfactory	
TEST DATE	3/11/16	FINAL VEHICLE POSITION	124.6 ft (38.0 m) downstream, 57.7 ft (17.6 m) left side	
TEST ARTICLE		VEHICLE SNAGGING	None	
NAME / MODEL	SCI Smart Cushion	VEHICLE POCKETING	None	
TYPE	Redirective Crash Cushion	MAXIMUM ROLL ANGLE (°)	-11.8	
KEY ELEMENTS	Base Structure, Sled, Wire Rope Cable, Sheaves, Shock Arresting Cylinder	MAXIMUM PITCH ANGLE (°)	19.3	
		MAXIMUM YAW ANGLE (°)	-41.9	
ARTICLE LENGTH	21.7 ft (6.6 m)	KINETIC ENERGY	110.3 kips-ft (149.5 kJ)	
TOTAL INSTALLATION LENGTH	41.5 ft (12.7 m)	OCCUPANT RISK VALUES		
HEIGHT	33.5 in (851 mm)	OCCUPANT IMPACT VELOCITY	Longitudinal	26.2 ft/s (8.0 m/s)
MAXIMUM WIDTH	37.4 in (951 mm)		Lateral	32.2 ft/s (9.8 m/s)
ROAD SURFACE	Concrete	RIDEDOWN ACCELERATION	Longitudinal	-11.3 g

TEST VEHICLE			Lateral	-11.4 g
TYPE / DESIGNATION	2270P	THIV	40.7 ft/s (12.4 m/s)	
YEAR, MAKE AND MODEL	2010 RAM 1500	PHD	13.4 g	
CURB MASS	5017.6 lbs (2276.0 kg)	ASI	2.18	
TEST INERTIAL MASS	4,976.9 lbs (2,257.5 kg)	TEST ARTICLE DEFLECTIONS		
GROSS STATIC MASS	4,976.9 lbs (2,257.5 kg)	STATIC	0.6 in (16 mm)	
IMPACT CONDITIONS		DYNAMIC	3.4 in (86 mm)	
IMPACT VELOCITY	62.09 mph (99.92 km/h)	ARTICLE DAMAGE	Moderate	
IMPACT ANGLE (°)	24.5	VEHICLE DAMAGE		
IMPACT LOCATION / ORIENTATION	13.7 ft (4.2 m) downstream of concrete barrier	VEHICLE DAMAGE SCALE	1-RFQ-5	
		COLLISION DAMAGE CLASSIFICATION	01RDEW4

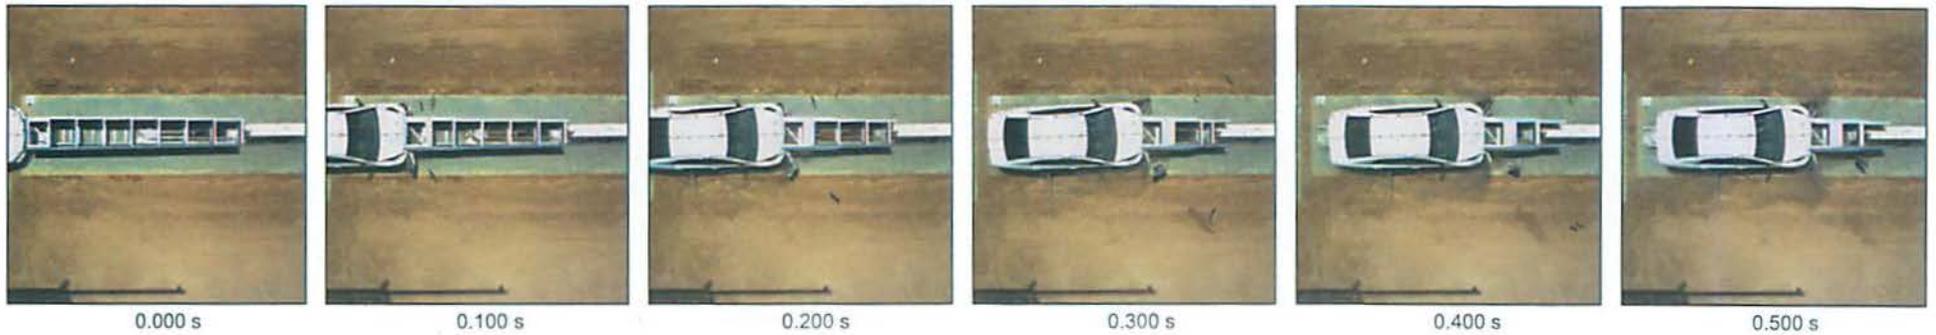
SEQUENTIAL PHOTOGRAPHS

MASH TEST 3-38 SUMMARY

Test Article: Work Area Protection SCI Smart Cushion

Project No. P36142-01

Required Test Number	Narrative Description	Evaluation Results
3-38 (1500A)	<p>Test Date 5-9-2016 - Karco Test #TR-P36142-01 Complete Report KARCO Test No. P36142-01. Test 3-38 involves a 1500A sedan impacting the crash cushion at a nominal impact speed of 100 km/h (62.2 mph) and an impact at 0 degrees with the centerline of the vehicle aligned with the center line of the crash cushion. This test is primarily intended to evaluate occupant risk and vehicle trajectory criteria for a mid-size vehicle.</p> <p>For this test, a 2010 Chevrolet Malibu weighing 3,301.4 lbs (1,497.5 kg) impacted the SCI Smart Cushion at a speed of 60.57 mph (97.48 km/h) and an angle of .6 degrees. Upon impact the vehicle forced the SCI Smart Cushion's sled rearward and began to collapse the sections in between the support frames. The crash cushion brought the vehicle to a controlled stop. The test vehicle sustained damage to its front end. The occupant compartment was not penetrated and the deformation was within allowable limits. The maximum roll and pitch angles did not exceed 75 deg. and the occupant risk values were within limits per the MASH specifications for Occupant Impact Velocity (OIV) and Ridedown Acceleration (RA). The SCI Smart Cushion redirective crash cushion passed all evaluation criteria for test 3-38.</p>	PASS

GENERAL INFORMATION		EXIT CONDITIONS		
TEST AGENCY	KARCO Engineering, LLC.	EXIT VELOCITY	N/A	
TEST NUMBER	P36142-01	EXIT ANGLE	N/A	
TEST DESIGNATION	3-38	VEHICLE STABILITY	Satisfactory	
TEST DATE	5/9/16	FINAL VEHICLE POSITION	15.7 ft (4.8 m) downstream	
TEST ARTICLE		VEHICLE SNAGGING	None	
NAME / MODEL	SCI Smart Cushion	VEHICLE POCKETING	None	
TYPE	Redirective Crash Cushion	MAXIMUM ROLL ANGLE (°)	-1.1	
KEY ELEMENTS	Base Structure, Sled, Wire Rope Cable, Sheaves, Shock Arresting Cylinder	MAXIMUM PITCH ANGLE (°)	-2.3	
		MAXIMUM YAW ANGLE (°)	2.1	
ARTICLE LENGTH	21.7 ft (6.6 m)	KINETIC ENERGY	404.9 kip-ft (549.0 kJ)	
TOTAL INSTALLATION LENGTH	41.5 ft (12.7 m)	OCCUPANT RISK VALUES		
HEIGHT	33.5 in (851 mm)	OCCUPANT IMPACT VELOCITY	Longitudinal	28.9 ft/s (8.8 m/s)
MAXIMUM WIDTH	37.4 in (951 mm)		Lateral	0.3 ft/s (0.1 m/s)
ROAD SURFACE	Concrete	RIDEDOWN ACCELERATION	Longitudinal	-11.3 g
			Lateral	-1.6 g
TEST VEHICLE		THIV	28.9 ft/s (8.8 m/s)

TYPE / DESIGNATION	1500A	PHD	11.4 g	
YEAR, MAKE AND MODEL	2010 Chevrolet Malibu	ASI	1.37	
CURB MASS	3,392.9 lbs (1,539.0 kg)	TEST ARTICLE DEFLECTIONS		
TEST INERTIAL MASS	3,301.4 lbs (1,497.5 kg)	STATIC	15.7 ft (4.8 m)	
GROSS STATIC MASS	3,301.4 lbs (1,497.5 kg)	DYNAMIC	15.7 ft (4.8 m)	
IMPACT CONDITIONS		ARTICLE DAMAGE	Minor	
IMPACT VELOCITY	60.57 mph (97.48 km/h)	VEHICLE DAMAGE		
IMPACT ANGLE (°)	0.6	VEHICLE DAMAGE SCALE	12-FD-3	
IMPACT LOCATION / ORIENTATION	Centerline of crash cushion sled	COLLISION DAMAGE CLASSIFICATION	12FDEW2

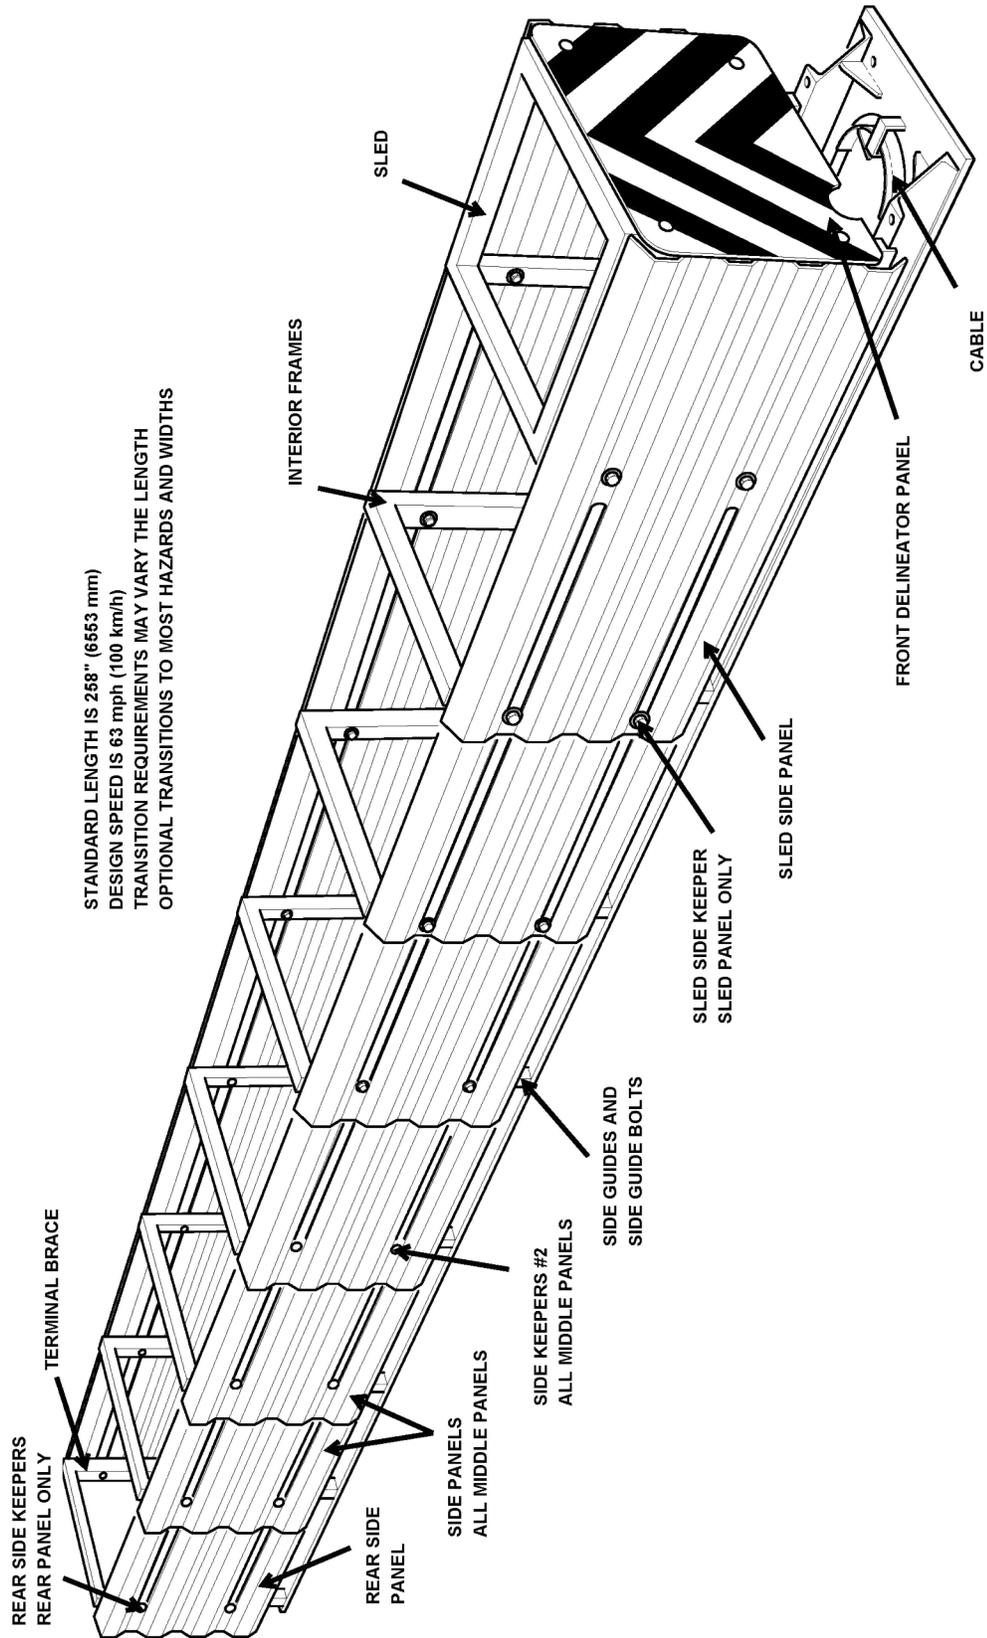
SCI100GM IMPACT ATTENUATOR

The SCI100GM impact attenuator was designed to provide a variable stopping force based on speed to give a smooth ridedown for a wide variety of speeds and masses. It passed all MASH tests including optional test #3-38 setting record ridedown G forces for small vehicles. This system was first tested to NCHRP 350 and passed all MASH tests with no changes.

The SCI100GM uses a hydraulic shock-absorbing cylinder to give a speed dependent, smooth ridedown. The telescoping fender panels are slightly tapered to allow a smooth stress-free nesting during collapse. The SCI100GM uses a 1.125" (29mm) IWRC galvanized cable to control the front sled's rearward travel. Galvanizing and Welding meet standards ASTM A123 and AWS D1.1, respectively.

The SCI100GM only requires the replacement of two 1/4" (6mm) x 1.75" (44mm) grade 8 shear bolts after a frontal impact within MASH design criteria. A reset can be performed in less than 30 minutes by an experienced repair crew.

The SCI Smart Cushion is a fully redirective crash cushion approved under NCHRP 350 and now tested to MASH criteria with no changes. It uses a hydraulic cylinder and cable assembly to provide a variable stopping force based on speed. It has 7 collapsible bays utilizing 3/16" tubular steel frames that support 10 gauge side panels that have 4 flutes. The dimensions are 258 inches (6556mm) long X 31.8 inches (808mm) wide at the rear X 33.4 inches (847 mm) high. The front sled structure is braced to minimize damage on angled or offset frontal impacts. This is a low maintenance system that requires very few repair parts.
