U.S. Department
of Transportation
**Federal Highway
Administration**

In Reply Refer To:
HSST-1/B-287

- Defender Barrier™ 70

Request for Federal Aid Reimbursement Eligibility of Highway Safety Hardware

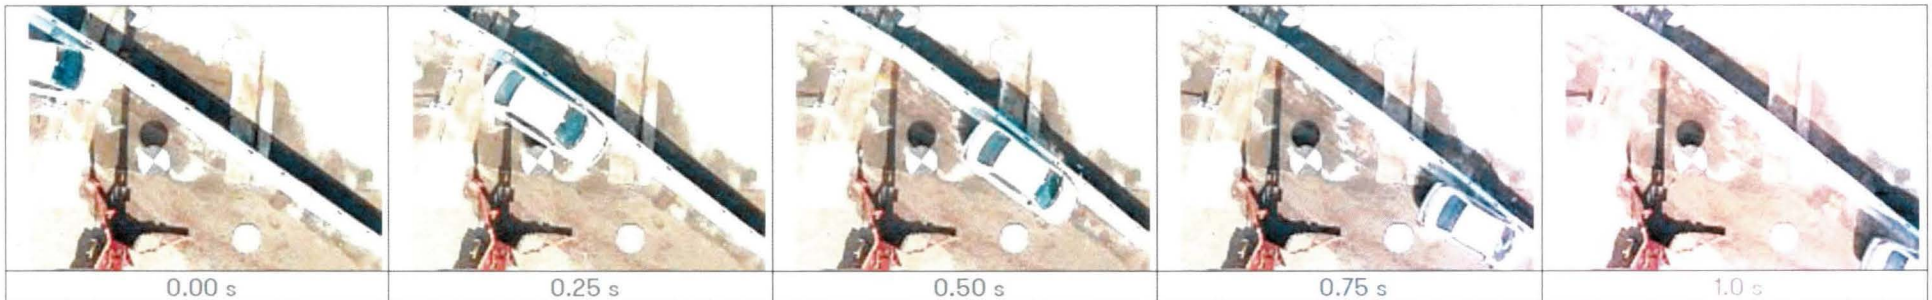
Test Article:	Safe Barriers Ballasted STBS - Defender 70	Post Impact Vehicle Behaviour	
Total Length	105.3 m	Vehicle Stability	Good
Key Elements - Barrier	Test 2-10	Stopping Distance	24.0 m
Description	Steel Temporary Barrier System	Vehicle Snagging	None
Length of Barrier Installation	105.3 m length of need	Vehicle Pocketing	None
Height	0.80 m	Occupant Impact Velocity (m/s)	0.1289 seconds right side of interior
Length of Barrier Segments	3.9 m	Longitudinal	-3.4
Test Vehicle		Lateral (optional)	4.6
Designation	1100C	Occupant Ride-down Deceleration	
Make/Model	Nissan Tiida	X-direction (g)	3.2 [0.1350 - 0.1450 seconds]
Dimensions (LxWxH)	4350 mm x 1695 mm x 1535 mm	Y-direction (g)	-5.8 [0.3520 - 0.3620 seconds]
Curb Wt	1096.0 kg	THIV (optional) (m/s)	6.2
Test Inertial Wt	1083.0 kg	PHD (optional) (g)	6.3 [0.3523 - 0.3623 seconds]
Gross Static	1158.0 kg	ASI (optional)	0.93 [0.0326 - 0.0826 seconds]
Impact Conditions		Test Article Damage	Minor

Speed	69.4 km/h	Test Article Deflections	
Angle	24.7 degrees	Dynamic	0.74 m
Impact Point	1100 mm upstream of barrier joint 10B	Permanent	0.74 m
Exit Conditions		Working Width	0.74 m
Exit Speed:	41 km/h	Vehicle Damage Exterior	
Exit Angle:	1.0° Est	VDS	11FL-1
		CDC	11LFEE1
		Maximum Deformation	80 mm

Required Test Number	Narrative Description	Evaluation Results
2-10 (1100C)	<p>Holmes Crash Test No. 131393.2-10 was performed on 27th April 2017. The Defender Barrier™ 70 successfully contained and redirected the 1100c vehicle impacting the test article at 24.7 degrees and a velocity of 69.4km/h (43.1mph). Maximum dynamic deflection during the test was 0.74m (29.1").</p> <p>The test vehicle impacted the test installation 1100mm upstream of barrier joint 10B. The CIP was chosen to maximize the potential to snag a wheel on the adjoining barriers and also to increase the Occupant Impact Velocity (OIV).</p> <p>No debris or detached elements penetrated or showed potential to penetrate the occupant compartment. No fragments were distributed outside of the vehicle trajectory. The trajectory of the vehicle was such that it did not present any undue hazard to other traffic, pedestrians or work zone personnel.</p> <p>The vehicle remained upright during and after the impact and vehicle stability was considered satisfactory. Occupant risk factors satisfied the test criteria and the vehicle exit trajectory remained within acceptable limits.</p>	PASS

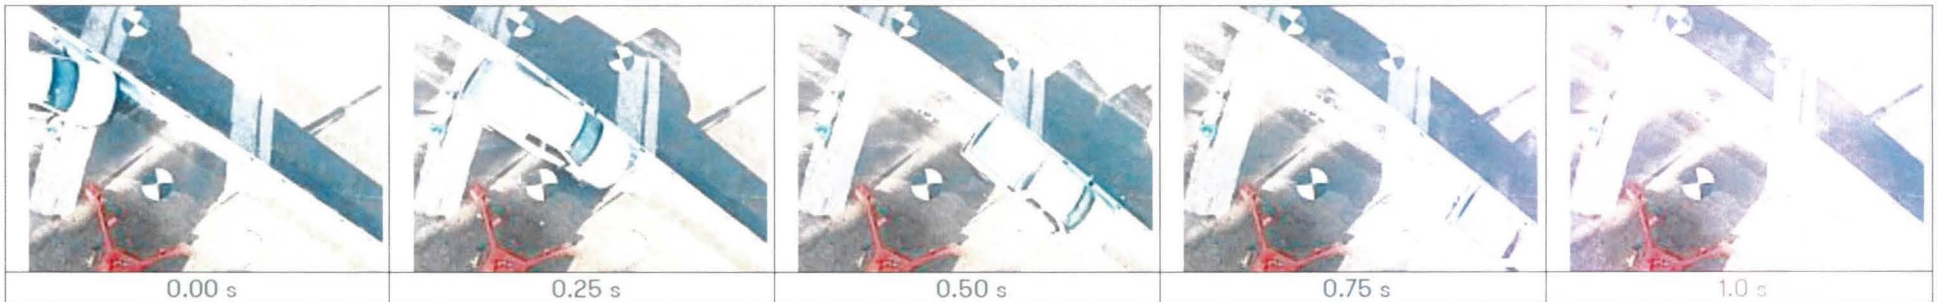
Test Article:	Safe Barriers Ballasted STBS - Defender 70	Post Impact Vehicle Behaviour	
Total Length	105.3 m	Vehicle Stability	Good
Key Elements - Barrier	Test 2-11	Stopping Distance	48.0 m
Description	Steel Temporary Barrier System	Vehicle Snagging	None
Length of Barrier Installation	105.3 m length of need	Vehicle Pocketing	None
Height	0.80 m	Occupant Impact Velocity (m/s)	0.1443 seconds right side of interior
Length of Barrier Segments	3.9 m	Longitudinal	-2.8
Test Vehicle		Lateral (optional)	3.8
Designation	2270P	Occupant Ride-down Deceleration	
Make/Model	Dodge Ram 1500 Quad Cab	X-direction (g)	2.7 (6.4877 - 6.4977 seconds)
Dimensions (LxWxH)	5785 mm x 1995 mm x 1890 mm	Y-direction (g)	-5.8 (0.3602 - 0.3702 seconds)
Curb Wt	2203.0 kg	THIV (optional) (m/s)	5.2
Test Inertial Wt	2277.0 kg	PHD (optional) (g)	5.8 (0.3602 - 0.3702 seconds)
Gross Static	2277.0 kg	ASI (optional)	0.81 (0.0386 - 0.0886 seconds)

Impact Conditions		Test Article Damage	Minor
Speed	70.2 km /h	Test Article Deflections	
Angle	24.7 degrees	Dynamic	1.20 m
Impact Point	600 mm upstream of barrier joint 10B	Permanent	1.20 m
Exit Conditions		Working Width	1.20 m
Exit Speed:	48 km/h	Vehicle Damage Exterior	
Exit Angle:	12.0° Est	VDS	11FL-1
		CDC	11LFEE1
		Maximum Deformation	180 mm

Required Test Number	Narrative Description	Evaluation Results
2-11 (2270P)	<p>Holmes Crash Test No. 131393.2-11 was performed on 27th April 2017. The Defender Barrier™ 70 successfully contained and redirected the 2270P vehicle impacting the test article at 24.7 degrees and a velocity of 70.2km/h (43.6mph). Maximum dynamic deflection during the test was 1.20m (47.2").</p> <p>The test vehicle impacted the test installation 600mm upstream of barrier joint 10B. The CIP was chosen to test the containment and vehicle stability, while also imparting the most amount of load on the connection joint.</p> <p>No debris or detached elements penetrated or showed potential to penetrate the occupant compartment. No fragments were distributed outside of the vehicle trajectory. The trajectory of the vehicle was such that it did not present any undue hazard to other traffic, pedestrians or work zone personnel.</p> <p>The vehicle remained upright during and after the impact and vehicle stability was considered satisfactory. Occupant risk factors satisfied the test criteria and the vehicle exit trajectory remained within acceptable limits.</p>	PASS

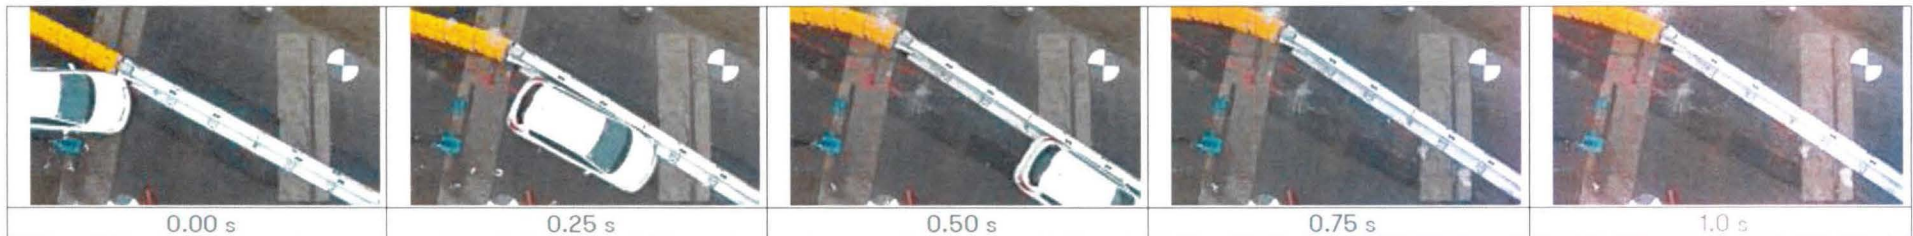
Test Article:	Safe Barriers Ballasted STBS with Absorb™	Post Impact Vehicle Behaviour	
Total Length	112.3 m	Vehicle Stability	Good
Key Elements - Barrier	Test 2-20	Stopping Distance	40.0 m
Description	Steel Temporary Barrier System	Vehicle Snagging	None
Length of Barrier Installation	105.3 m length of need	Vehicle Pocketing	None
Height	0.80 m	Occupant Impact Velocity (m/s)	0.1231 seconds right side of interior
Length of Barrier Segments	3.9 m	Longitudinal	-2.5
Test Vehicle		Lateral (optional)	3.9
Designation	1100C	Occupant Ride-down Deceleration	
Make/Model	Nissan Tiida	X-direction (g)	3.6 [0.2434 - 0.2534 seconds]
Dimensions (LxWxH)	4150 mm x 1695 mm x 1520 mm	Y-direction (g)	-9.3 [0.2504 - 0.2604 seconds]
Curb Wt	1107.5 kg	THIV (optional) (m/s)	5.2
Test Inertial Wt	1090.5 kg	PHD (optional) (g)	9.5 [0.2503 - 0.2603 seconds]
Gross Static	1165.5 kg	ASI (optional)	0.56 [0.2353 - 0.2853 seconds]
Impact Conditions		Test Article Damage	Minor

Speed	71.5 km /h	Test Article Deflections	
Angle	24.8 degrees	Dynamic	1.20 m
Impact Point	0 mm upstream of transition section	Permanent	1.20 m
Exit Conditions		Working Width	1.20 m
Exit Speed:	37 km/h	Vehicle Damage Exterior	
Exit Angle:	1.0° Est	VDS	11FL-1
		CDC	11LFEE1
		Maximum Deformation	60 mm

2-20 (1100C)	<p>Holmes Crash Test No. 131393.2-20 was performed on 11th May 2017. The Defender Barrier™ 70 successfully contained and redirected the 1100c vehicle impacting the test article at 24.8 degrees and a velocity of 71.5 km/h (44.4 mph). Maximum dynamic deflection during the test was 1.20m (47.2").</p> <p>The test vehicle impacted the test installation 0mm upstream of barrier transition assembly. The CIP was chosen to maximize the potential to snag a wheel on the adjoining barriers, verify vehicle trajectory and also to increase the Occupant Impact Velocity (OIV).</p> <p>No debris or detached elements penetrated or showed potential to penetrate the occupant compartment. No fragments were distributed outside of the vehicle trajectory. The trajectory of the vehicle was such that it did not present any undue hazard to other traffic, pedestrians or work zone personnel.</p> <p>The vehicle remained upright during and after the impact and vehicle stability was considered satisfactory. Occupant risk factors satisfied the test criteria and the vehicle exit trajectory remained within acceptable limits.</p>	PASS
