# Yellowstone River Bridge

WY NPS YELL 12(2)

## Project Description

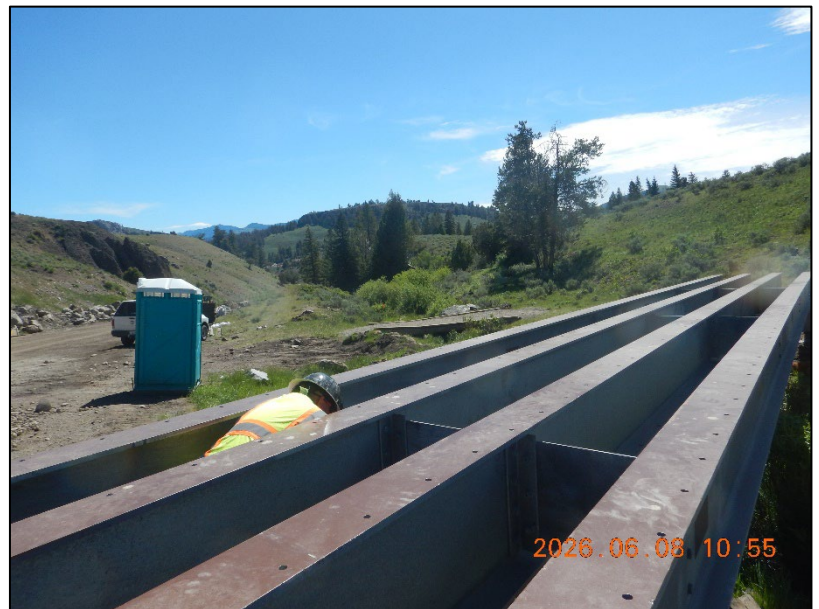
Construction crews install bridge girders at the Equestrian Bridge as work progresses on this key project component within Yellowstone National Park.

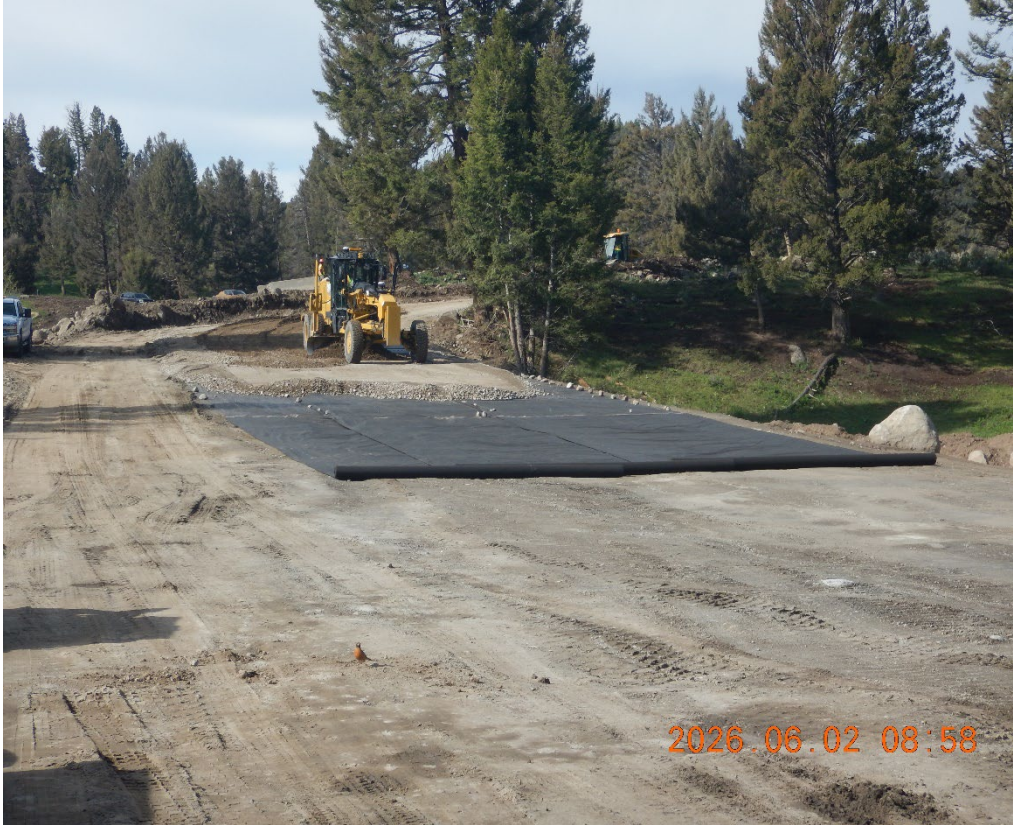
**Wrecker Circle Road:** Crews roll out heavy-duty geotextile fabric and cover it with structural rock. This crucial step prevents the newly laid stone from sinking into the soil underneath, creating a long-lasting foundation that resists rutting and reduces the need for future maintenance.

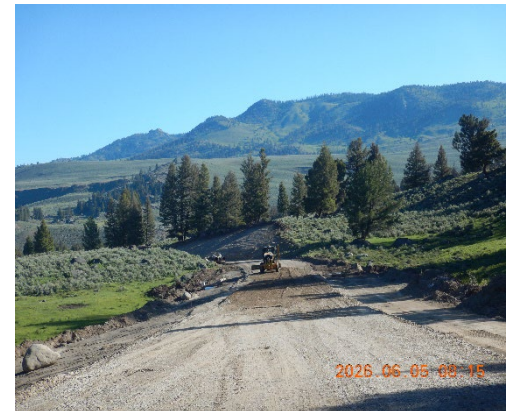
**Subexcavation work continues on Wrecker Circle Road.** This process clears out unstable soil to build a solid, long-lasting foundation that can withstand heavy loads and harsh winters.

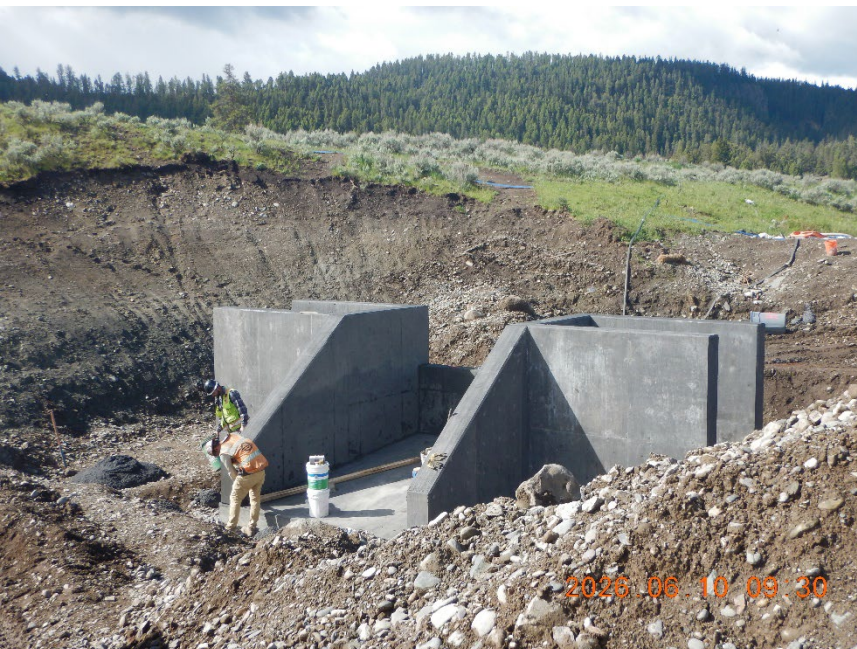
**Lost Creek Fish Barrier:** Ready to be backfilled, this newly placed concrete barrier sits in an excavated stream bed at Yellowstone National Park. Crews temporarily diverted the creek to allow for a dry installation. Once complete, the structure will prevent non-native fish from migrating upstream, protecting the park's native trout populations.
