TECHBRIEF

Investigation of Increase in Roughness Due to Environmental Factors in Flexible Pavements Using Profile Data From Long-Term Pavement Performance Specific Pavement Studies 1 Experiment

FHWA Publication No.: FHWA-HRT-17-120

This document is a technical summary of the Federal Highway Administration Long-Term Pavement Performance Program report *Investigation of Increase in Roughness Due to Environmental Factors in Flexible Pavements Using Profile Data From Long-Term Pavement Performance Specific Pavement Studies 1 Experiment* (FHWA-HRT-17-049).

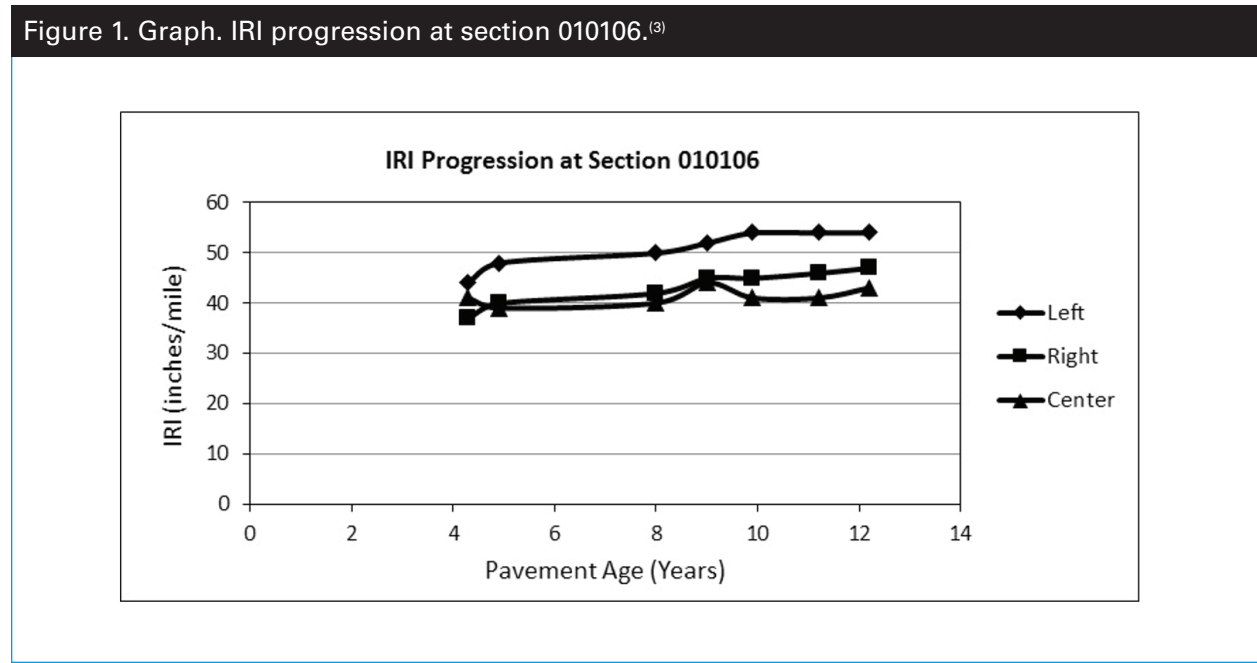
IRI versus pavement age plots were developed for each test section to evaluate how the IRI of the left wheelpath, right wheelpath, and center of the lane changed over time. Figure 1 shows an example of such a plot for section

010106. The horizontal axis of this plot represents the pavement age, with the pavement age being assigned a value of 0 for the traffic open date. The first IRI value shown in this plot corresponds to the date when center of the lane profile data were first collected at this section. The time series IRI values at each test section were visually examined to evaluate the changes in IRI over time. The IRI values before and after a change in construction number were reviewed to evaluate if the activity impacted the IRI. If the activity had an impact on IRI, a sharp change in IRI would be noticed between the IRI before and after the activity. If a sharp increase or decrease in IRI occurred between visits and there was no maintenance or rehabilitation activity indicated in the PPDB table, such data points were closely evaluated to determine the cause for the sharp increase or decrease in IRI. When investigating the cause for the change in IRI, in addition to evaluating the profile data, distress data, cracks maps, photographs, and videos obtained during the distress surveys were used as appropriate to determine the cause for the sudden change in IRI.

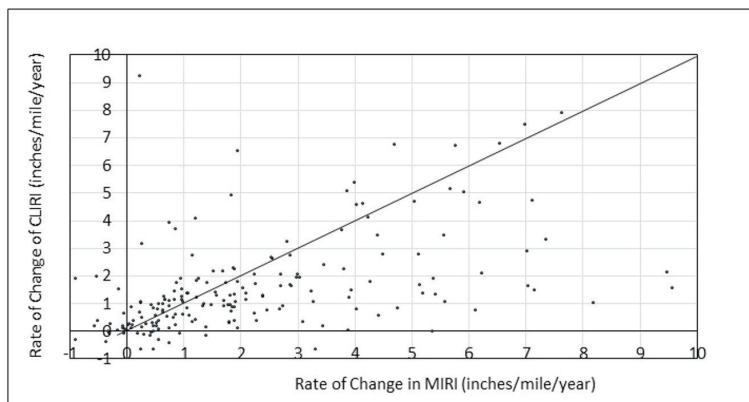
Figure 2. Graph. Relationship between the rate of change of CLIRI and MIRI.⁽³⁾

Figure 2 shows the relationship between the rate of change of MIRI and CLIRI at the SPS-1 test sections. When all SPS-1 test sections were considered, the median value of the rate of change of MIRI and CLIRI was 1.56 and 1.05 inches/mi/yr, respectively, while the third quartile values for these parameters were 3.22 and 1.19 inches/mi/yr, respectively. The rate of change of MIRI was greater than the rate of change of CLIRI at 62 percent of the test sections.

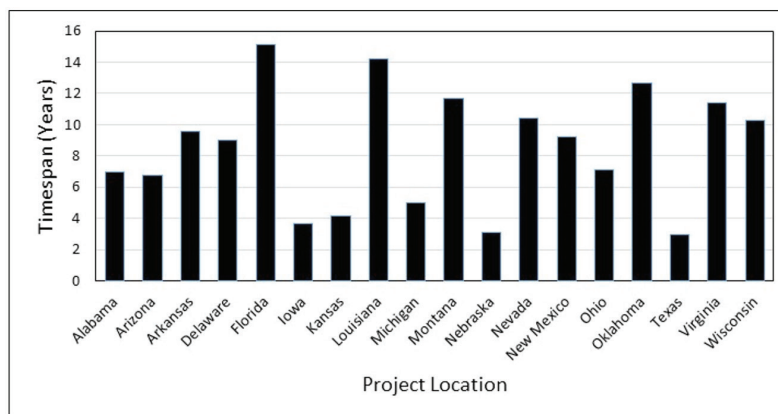
Figure 3. Bar graph. Average timespan over which CLIRI data were available for test sections in SPS-1 projects.⁽³⁾

Figure 3 shows the average timespan over which IRI data were collected at the test sections

in each SPS-1 project. The average timespan was computed by averaging the timespan over which data were collected at each test section in the SPS-1 project. Figure 4 and figure 5 show box plots of the rate of change of MIRI and CLIRI at the sections in each SPS-1 project, respectively. A box plot is a simple graphical representation that shows the distribution of data. For each SPS-1 project, the box plot shows the distribution of the change in IRI values for the test sections located in the SPS-1 project. The horizontal line located within the box shows the median of the data. The bottom of the box shows the value of the first quartile of the data (i.e., 25th-percentile value), while the top of the

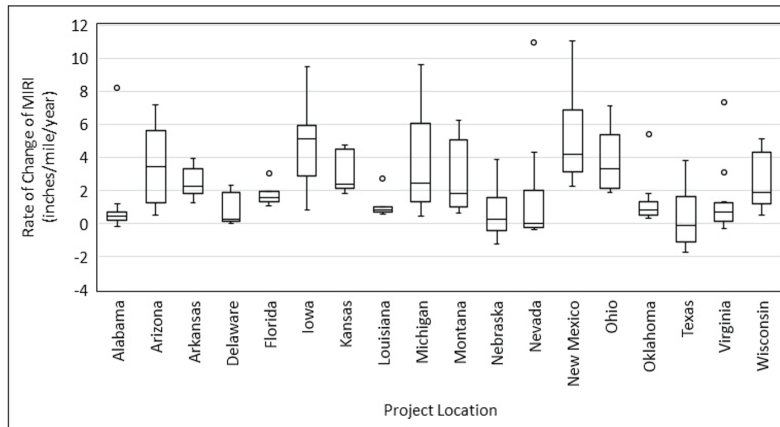
Figure 4. Box plots. Rate of change of MIRI at test sections in each SPS 1 project.⁽³⁾

box shows the value of the third quartile of the data (i.e., 75th-percentile value). The whiskers (i.e., the horizontal lines) in the plot at the top and the bottom show the range of the data. An outlier is shown as a circle above or below the whiskers. The magnitude of the rate of change of MIRI as well as CLIRI at test sections in a project varied from project to project. In some projects, the rate of change of CLIRI fell within a narrow range, while in others, the range was wider.

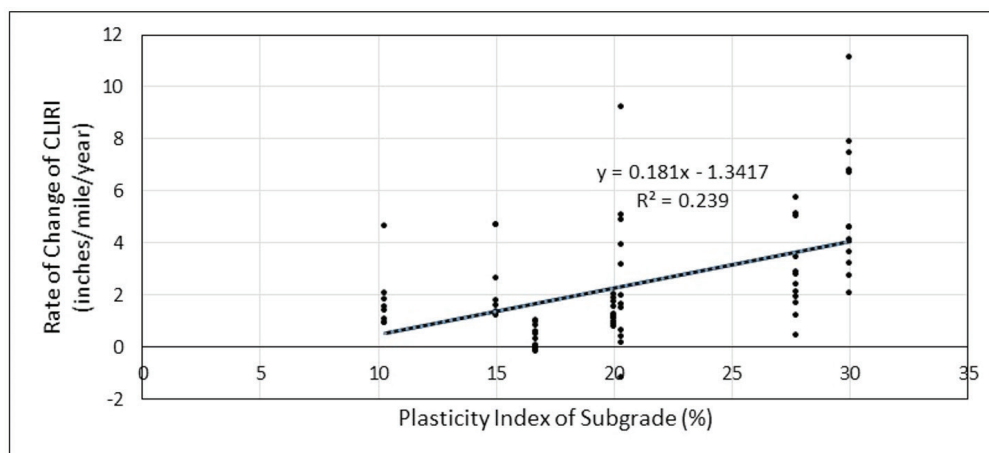
Figure 6. Graph. Rate of change of CLIRI of test sections located on fine-grained subgrade versus the PI of the subgrade.⁽³⁾

For sections on fine-grained subgrade, the rate of increase of CLIRI and MIRI showed an increasing trend with the increase in PI values of the subgrade. Figure 6 shows the rate of change of CLIRI of test sections plotted with the PI of the subgrade for the SPS-1 projects located on fine-

grained subgrade. The rate of change of CLIRI values shown vertically for a specific value of PI are those for the various test sections in that SPS-1 project.
